**An Inventory of Pinckney and Waterloo Recreation Areas
to Identify Significant Aquatic Natural Features**

Prepared by:
Amy Derosier

Michigan Natural Features Inventory
P.O. Box 30444
Lansing, MI 48909-7944

Report Number 2008-12

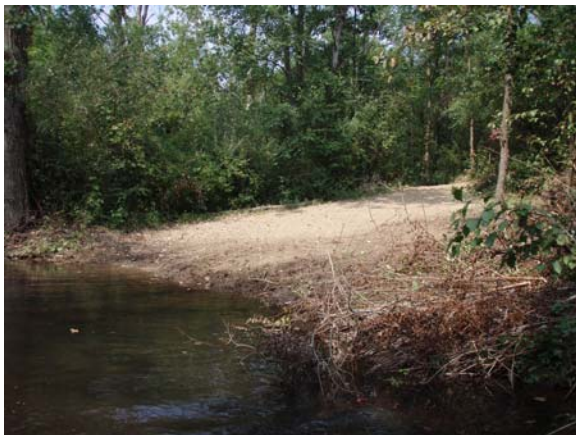
Figure 7. Horse crossing showing de-vegetated stream bank.

On grand3500, there is an inadequate horse crossing that will cause major stream bank erosion if not dealt with immediately (Figure 7 and 8). As mentioned above, the small rock dam

created there appears to be well placed and small enough to not cause major changes to the stream channel. However, the stream banks at this horse crossing have been bulldozed to remove all vegetation for about 10 m on one side and 20 m on the other. This has created loose soil that will be eroded and transported downstream, especially during high flows. This practice will not only cause the loss of soil and land at the site but will change the sediment loads downstream, which may change the amount and distribution of substrates, islands, and bars in the stream channel. Replanting native vegetation along most of the stream bank at this site to limit erosion is recommended. Horse and stream crossings can be easily designed to benefit the users while not being a detriment to the stream ecosystem with just a little thought about how stream ecosystems function.

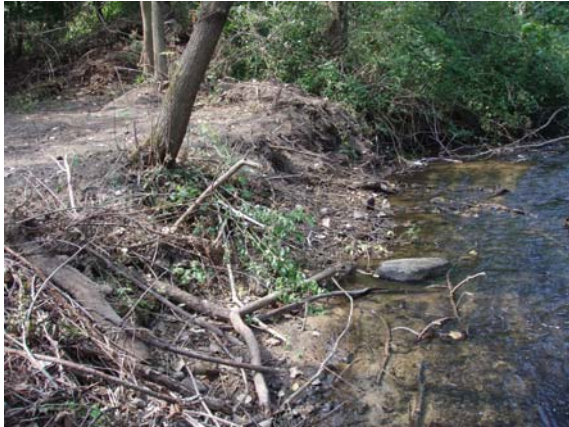
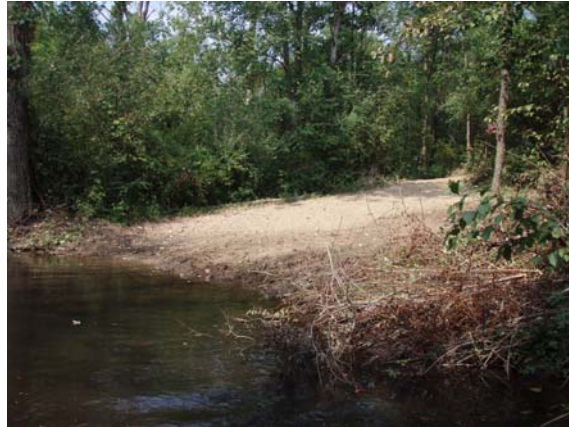
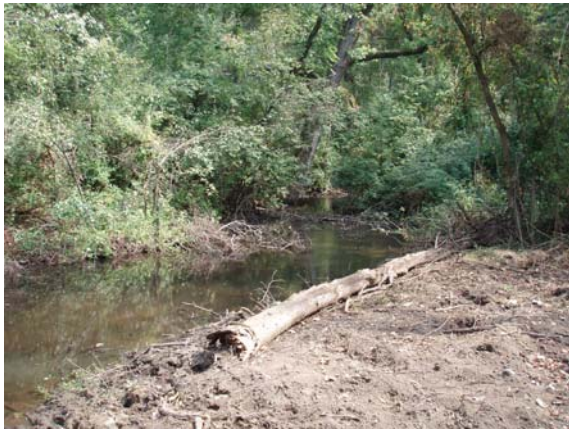
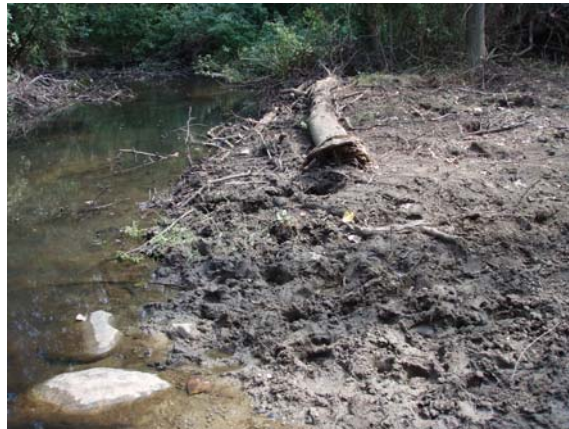
There is a horse crossing just upstream of Seymour Road that has the potential for becoming a significant threat to the stream and the biota within the stream. There is a small hand-made dam using rocks to create a pool for horses to water. However, at the crossing, about 20 m of one stream bank and 10 m of the other stream bank have been bulldozed and all vegetation has been removed (see pictures below). With the potential energy that this stream appears to get during high flows, this crossing is going to become an issue for the stream and the horse crossing area. With the un-stabilized bank and high energy flow, much of the stream bank will be eroded away and swept downstream.

It is recommended that the stream crossing be as small as possible. The small hand-made dam to create a pool for the horses to water is a natural way to accommodate different uses. However, for the stream banks and crossing to remain stable, management actions to stabilize the banks are needed. Stream side vegetation should be maintained or re-planted.

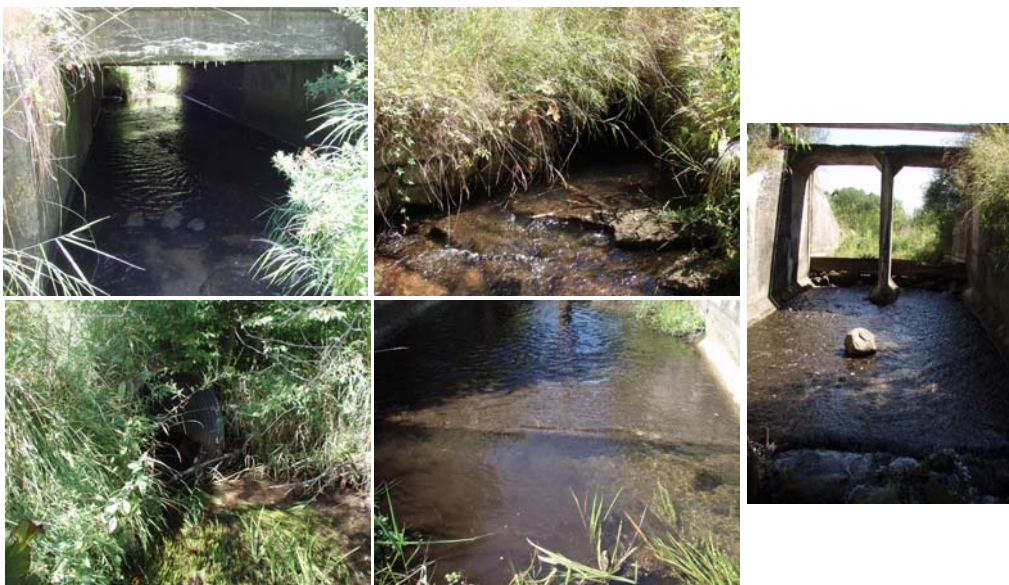
The main threats to this stream are the inadequate stream and road crossings and the adjacent roads. The Seymour Road crossing is a concrete box bridge that is generally adequate. However, the Willis Road crossing is a small round culvert that is not big enough for the channel. This culvert is restricting flows and altering sediment movements.

The walking bridge across the stream off of Willis Road has a dam constructed of 2 or 3 boards. This dam doesn't appear to be really holding back water. There is some undercutting of the concrete platform at the upstream end, which may become an issue for the dam and bridge by undermining its integrity. It is recommended that when it comes time to upgrade this bridge that the dam and concrete platform is removed and the bridge is constructed to allow for the stream channel to shift.

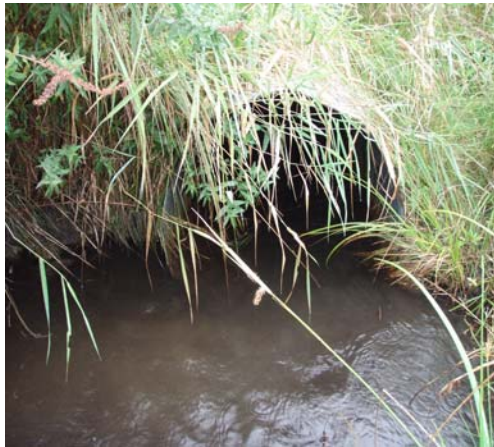
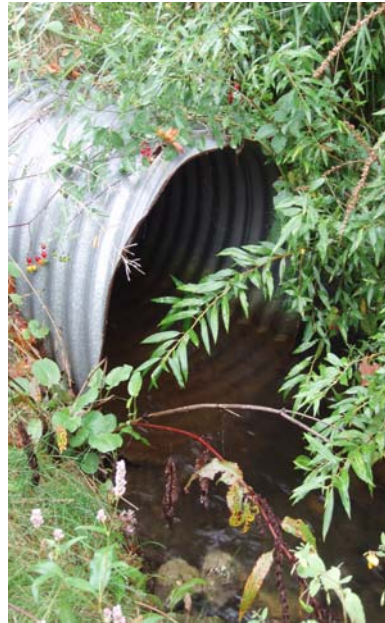
The major threats to this stream are the culvert (see below photos) and road that runs along the stream for a short distance. The existing culvert restricts water and sediment flows; water is pooling up behind the upstream side of the culvert. This culvert should be replaced with a more adequate road crossing. Additionally, the dirt

road may pose a threat if the road is oiled often. It is recommended that the road section near the road crossing and where the road follows the stream not be oiled down. This type of pollution can have significant negative impacts of stream biota.

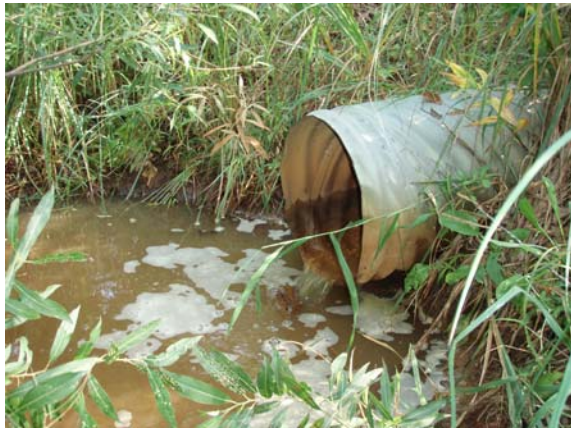
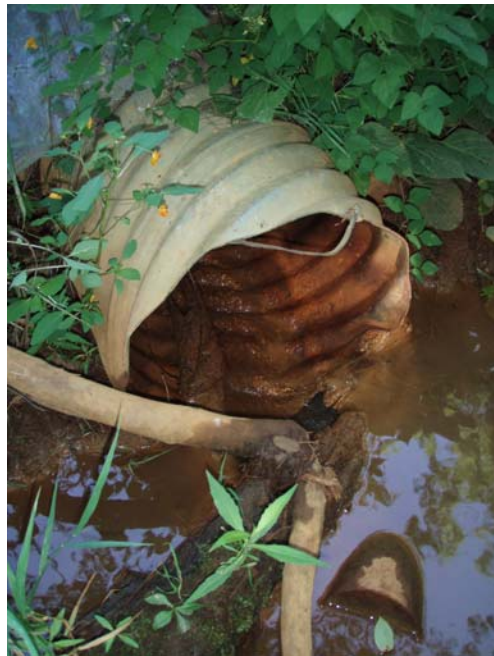
The only threat to this stream reach is the culvert crossing Upton Road (see below photos). The ~2 ft round culvert is not adequate for this stream. The culvert has created a pool upstream of the road crossing. Additionally, the stream bed has been undercut and now the bottom of the round culvert is within only a couple of inches of the water surface, yet the stream bed is much deeper. On the downstream side of the road, the culvert is perched and there is at least a 4 inch drop to the water surface. When possible, replacing this stream crossing with an adequate culvert or bridge would allow for natural exchange of water flows and sediment between the stream and its headwater wetland.

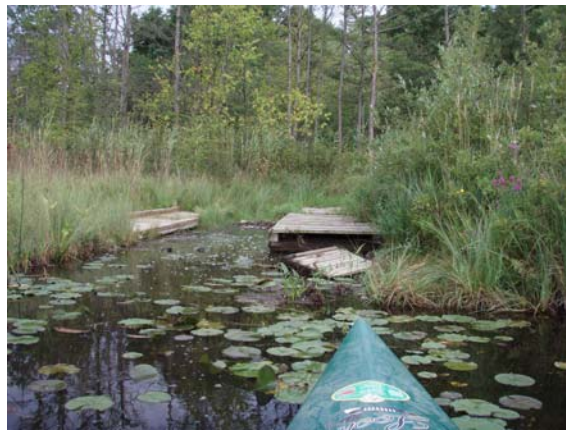
Additionally, it is recommended that a more permanent dock structure be installed. Currently, the hand launch at the lake has disturbed the shore due to the hap-hazard nature of the existing structures (see photo below). It is recommended that the launch continue to be only a hand launch and by installing a more permanent structure shoreline disturbance can be abated.

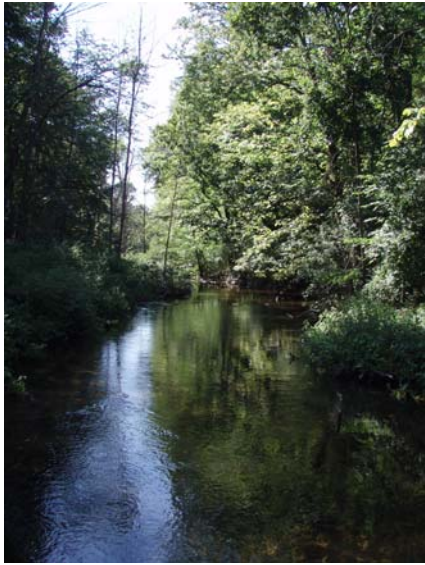
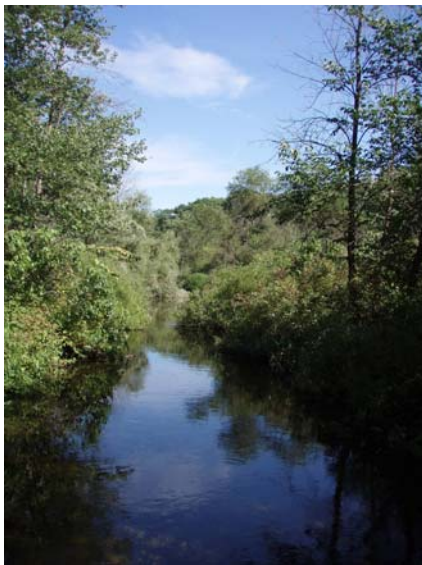
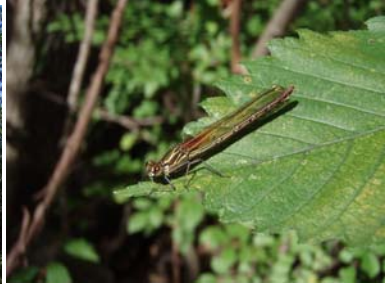
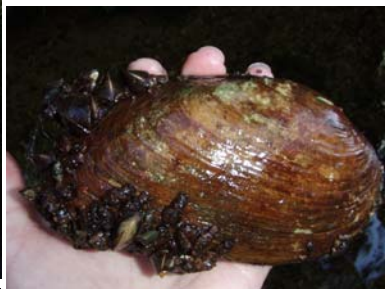
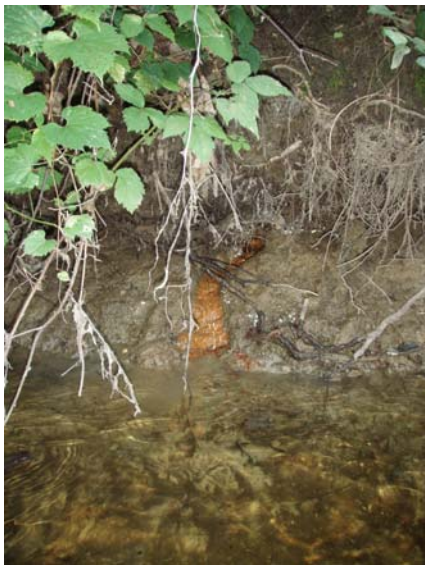
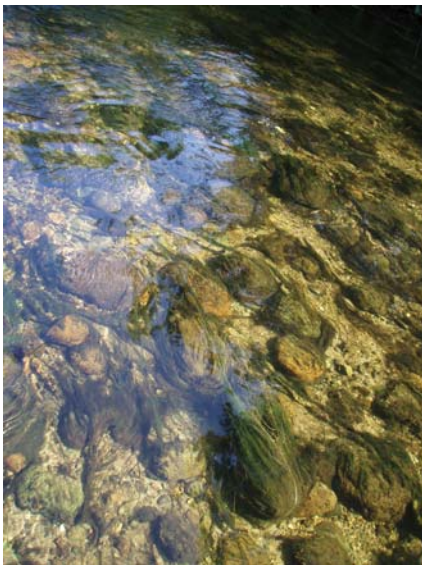
Portage Creek, Huron441

This wide (average 10 m), sand/ gravel stream has lots of varied habitats and good flow. Water depth is also varied; on average water depth is about 0.3 m but there are areas of the stream where it is ankle deep, as well as over 0.5 m. Substrates consist mainly of sand with gravel, cobble, and clay mixed in. Structural habitat is abundant and includes overhanging vegetation and shrubs, macrophytes, and woody structure. *Vallisneria spp.* and *Cladophora spp.* are common and sago pondweed (*Stuckenia pectinata*) (*Stuckenia pectinata*) and arum (*Peltandra virginicum*) are found occasionally. This stream appears to have a lot of energy moving through it during high flows given the heavily scoured stream banks. Roots are often exposed along the banks. But these flows are likely natural given there is a small lake (TNCID 6955) upstream of the reach which should help buffer the stream from extreme flows due to upstream impervious surfaces. The landscape surrounding this reach is natural and mainly forested with deciduous trees and pine plantations. This is a beautiful stream reach.

Lots of animals were observed during the survey. Bluegill (*Lepomis macrochirus*), largemouth bass (*Micropterus salmoides*), northern hog suckers (*Hypentelium nigricans*), and a small black striped minnow were seen. A fairly large (~10" in diameter) spiny soft shell turtle (*Apalone spinifera spinifera*) was observed, as well as many frogs. Tricoptera caddisfly were abundant on all rocks and mussel shell; waterpenny (Psephenidae) were also observed. Native mussels were fairly abundant. Live mussels found include: spike (*Elliptio dilatata*), pocketbook (*Lampsilis ventricosa*), kidneyshell (*Ptychobranchus fasciolaris*, SGCN), Fatmucket (*Lampsilis siliquidea*). Unfortunately, zebra mussel (*Dreissena polymorpha*) and Asiatic clams (*Corbicula fluminea*) are also common in the stream. There were at least 3 zebra mussels on each live native mussel found. At this point, zebra mussels are not so abundant that they are killing native mussels but this is always a concern when the two co-exist. Typically Asiatic clam have a minor affect on native mussels.

The horse/ foot bridge crossing the stream seems adequate. Large rocks have been used to stabilize the stream banks under the bridge, and they have been relatively successful. But due to the high energy flows of this stream, it is a good idea to monitor the bridge to ensure that it stays intact and adequate. There is an area on the north side of the stream next to the bridge where horses are watered. So far, this hasn't created too much of an erosional issue. However, it is recommended that the impact be kept contained to ensure that the stream bank isn't damaged to badly. Because this can not only cause issues for the stream but also for the bridge since the impact is just upstream of the bridge.

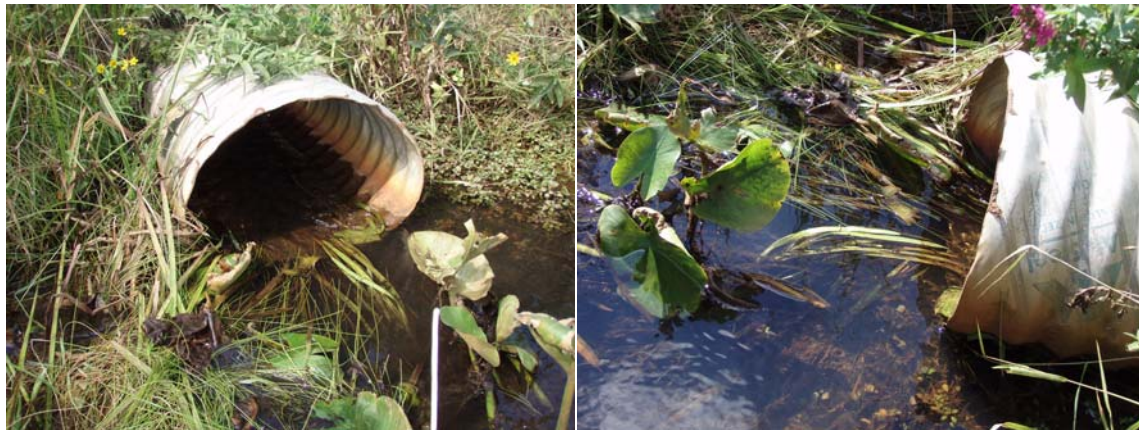
The only management issue at this stream reach is the stream / road crossing. The culvert is too small and is currently restricting flows, both water and sediment. At the upstream end of the culvert water is pooled up, yet only about 4 in of water is going through the culvert when the water is at least 10 in deep. Water is eroding under the culvert. It is suggested that when possible the culvert be replaced by a more adequate stream / road crossing. Inadequate stream / road crossings can alter hydrology, sediment movements, and species movements.
