Sullivant's Milkweed Restoration for the Michigan Department of Transportation: I-75 between Erie and Otter Creek, Monroe County, Michigan

Michigan Department of Transportation

12/19/2019

MNFI Report No. 2019-37

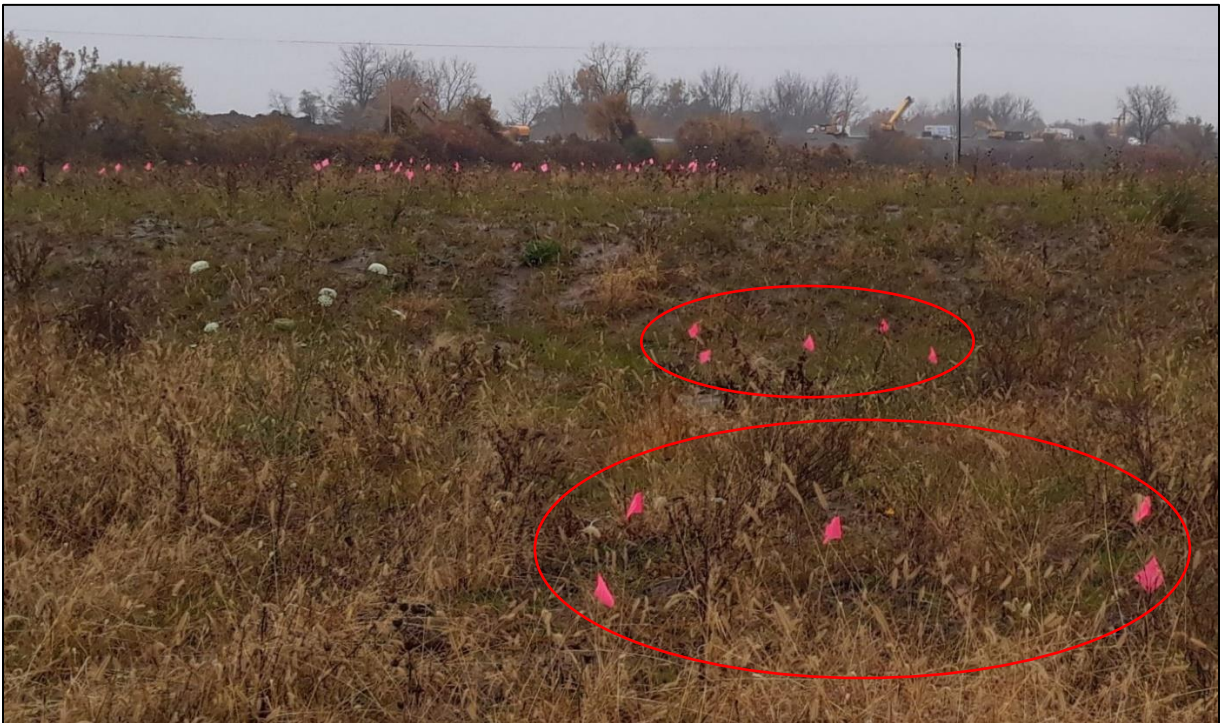
Figure 3. Middle terrace at the restoration site showing marked plants in groups of five.

The permit was secured prior to the transplanting date of September 12 and a crew of four was assembled, including the MNFI survey lead and three MNFI Americorps volunteers. The entire crew worked together to dig up the first load of plants and transport them to the restoration site. Two of the crew stayed at the site to dig holes and plant, while two of the crew returned to the I-75 corridor to dig up additional plants and transport them to the restoration site. This cycle was repeated until 154 plants had been moved and planted. A fifth MNFI botanist helped for the last several hours of the effort. Individual plants were planted in groupings of five, distributed in the

upper and middle terraces of the restoration site and were marked with pin flags (Figure 3); each group was marked by a GPS point (Figure 4).

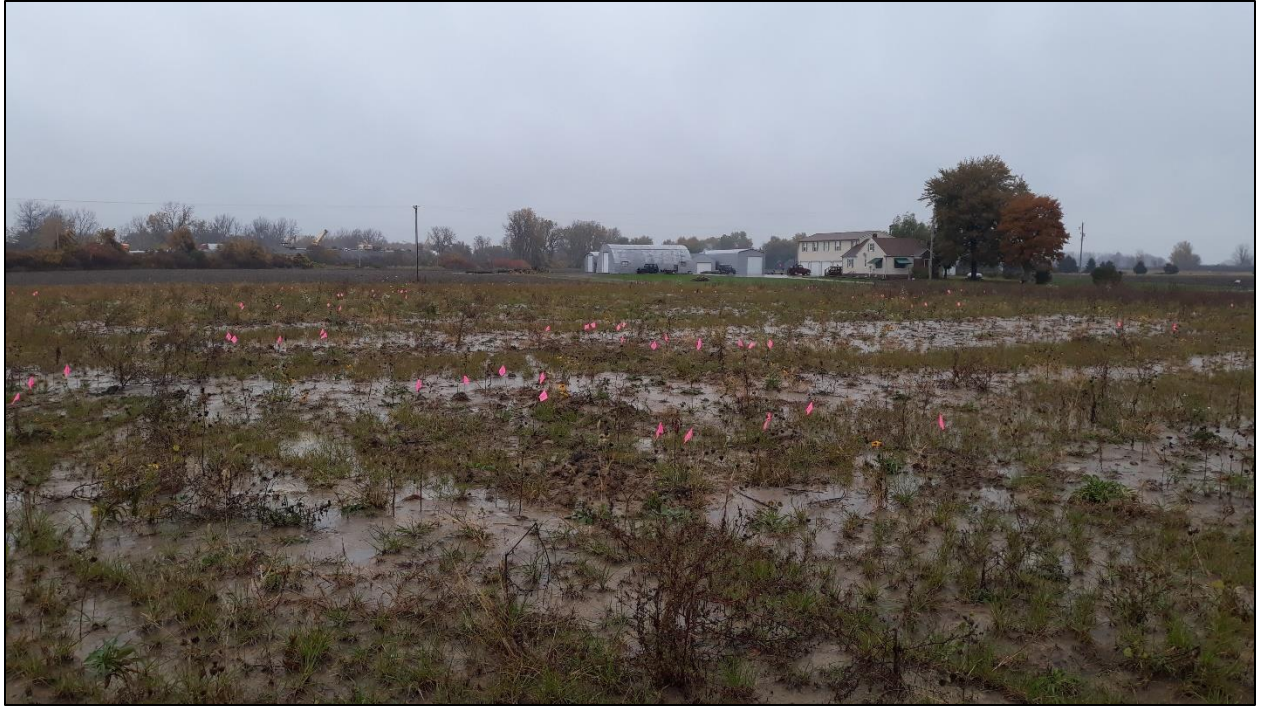
Figure 5. Upper terrace of the transplant site showing sparser vegetation.
