# Rare Plant Surveys for the Michigan Department of Transportation: US-2 Cut River (208607) and Brevort Lake Rd. (203752), Mackinac County, Michigan

MNFI Report No. 2020-21

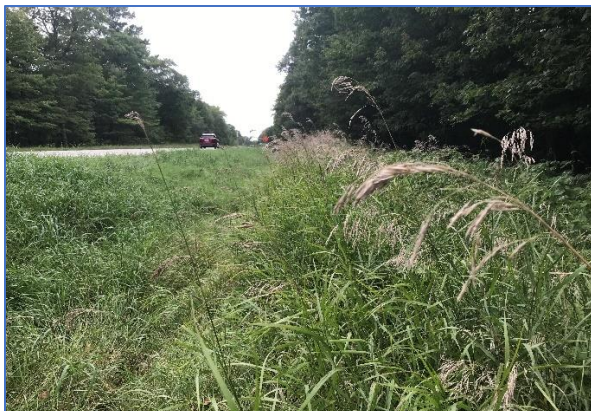
**Figure 2.** North side with brome grass.

This segment is dominated by non-native grasses including smooth brome (*Bromus inermis*), Kentucky bluegrass (*Poa pratensis*), bentgrass (*Agrostis* sp.) and reed canary grass (*Phalaris arundinacea*), and non-native forbs including black-bindweed (*Fallopia* sp.), common ragweed (*Ambrosia artemisiifolia*), yellow and white sweet clover (*Melilotus officinalis* & *M. albus*), and spotted knapweed (*Centaurea stoebe*). Some native plants are intermixed, becoming more common and sometimes dominant further from the right-of-way. These include wild red raspberry (*Rubus strigosus*), goldenrods (*Solidago* spp.) common milkweed (*Asclepias syriaca*), wild sarsaparilla (*Aralia nudicaulis*), and large-leaved aster (*Eurybia macrophylla*). On the south side there were two areas of concern with invasive species including leafy spurge (*Euphorbia virgata*; *Figure 2*) and Canada thistle (*Cirsium arvense*; *Figure 3*). No listed species were observed in this segment during surveys.

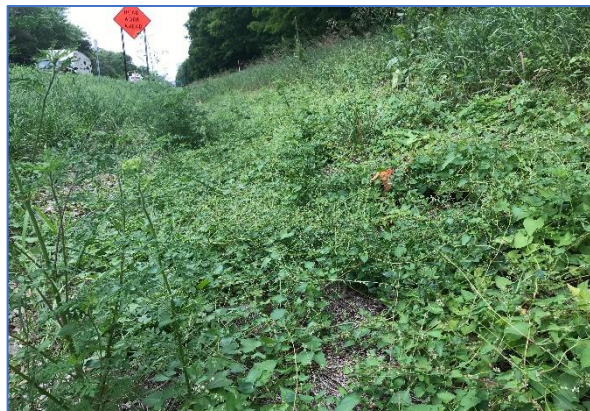
**Figure 3.** South side with black bindweed.

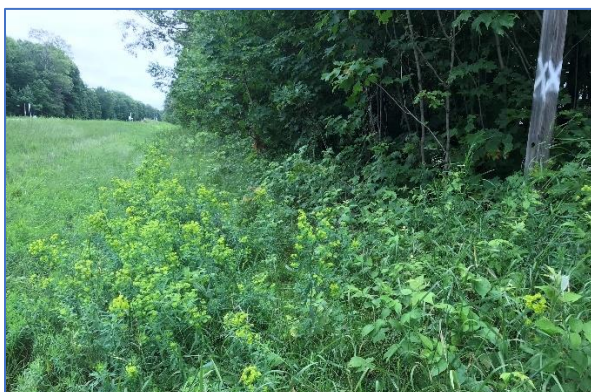
**Figure 4.** Dense patch of leafy spurge.

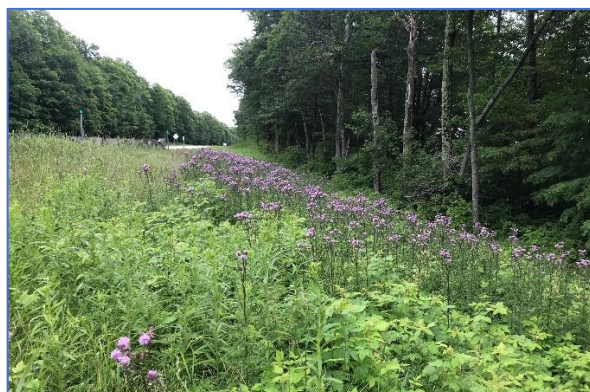
**Figure 5.** Dense patch of Canada thistle.

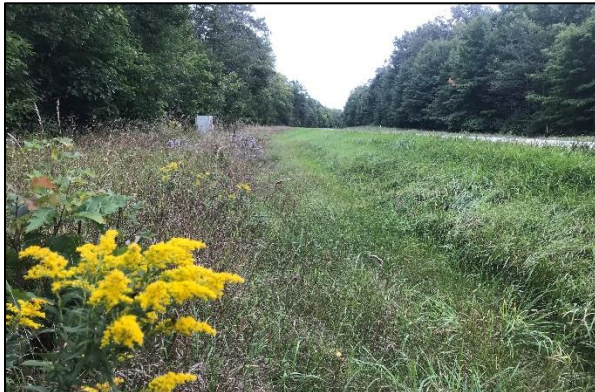
This segment is similar to Segment 1 with mostly non-native species (Figure 6). On the outside of the ROW toward the forested edge, large patches of wild red raspberry (*Rubus strigosus*; Figure 7) and bush honeysuckle (*Diervilla lonicera*) occur. No listed plants were observed in this segment during this survey.

**Figure 6.** Non-native grasses dominate.

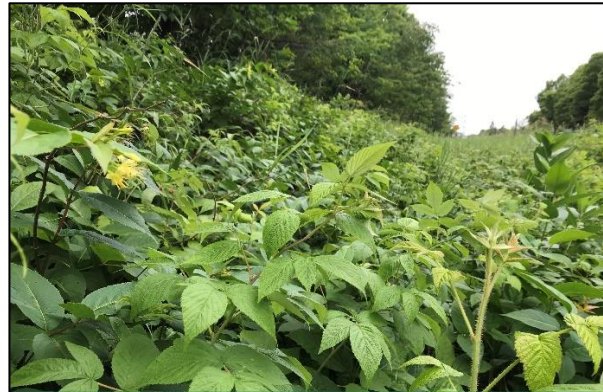
**Figure 7.** Dense patch of wild raspberry.

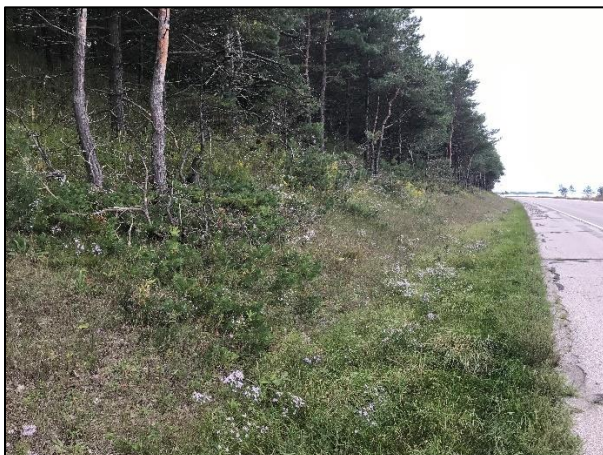
The north side of this segment slopes steeply upward to mesic northern forest and is dominated by non-native species including smooth brome (*Bromus inermis*), bentgrass (*Agrostis* sp.), rye grass (*Lolium perenne*), white sweet clover (*Melilotus albus*), common ragweed (*Ambrosia artemisiifolia*), and crown vetch (*Securigera varia*). Native species on the north side include horsetail (*Equisetum* sp.), wild rose (*Rosa* sp.), cherry (*Prunus* sp.), large-leaved aster (*Eurybia macrophylla*), poison ivy (*Toxicodendron rydbergii*), and common milkweed (*Asclepias syriaca*). The south side has a narrow strip of degraded open dune with a rocky border at the Lakeward edge. It is dominated by a mix of native and non-native species including sand cherry (*Prunus pumila*), common milkweed (*Asclepias syriaca*), wormwood (*Artemisia campestris*) horsetail (*Equisetum* sp.), spotted knapweed (*Centaurea stoebe*), smooth brome grass (*Bromus inermis*) and sweet clover (*Melilotis alba*).

No listed plant species were observed in this segment during this survey.

**Figure 9.** Sloping right-of-way.

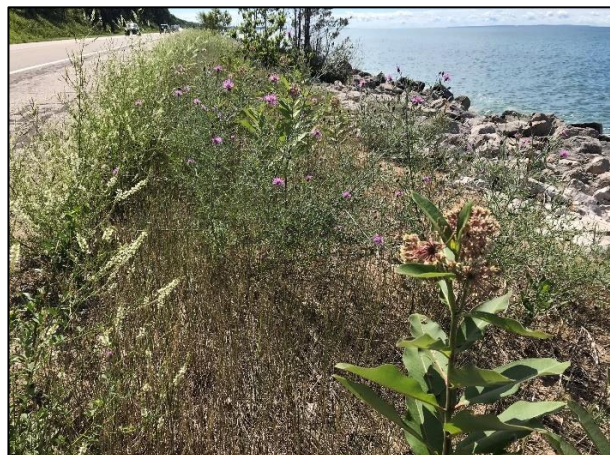
**Figure 10.** Narrow dune strip with rocks.

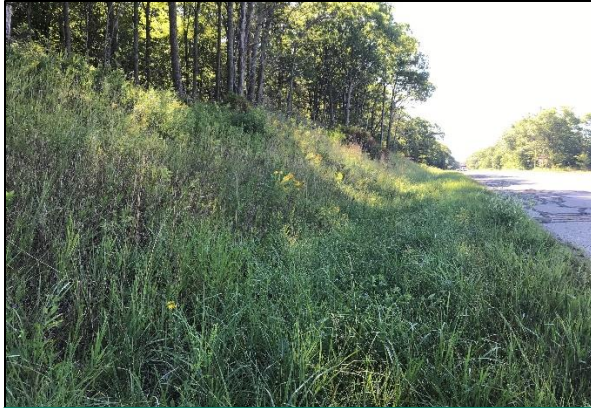
This segment is very similar to Segment 1, dominated by non-native species such as smooth brome, bentgrass, rye grass, white sweet clover, and common plantain (*Plantago major*). The right-of-way is mostly surrounded by mesic forest with the exception of the northwestern portion which is open dune both in and outside the right-of-way. The highway runs very close to the shoreline here. Native species in the dune include sand cherry, beach grass (*Ammophila breviligulata*), sand reed grass (*Calamovilfa longifolia*), common milkweed, wormwood, and horsetail. Non-native spotted knapweed and smooth brome grass are present. Closer to the highway edge, silverweed (*Potentilla anserina*), ragweed, and white sweet clover alternate in dominance.

No listed plants were observed in this segment during this survey.

**Figure 11.** Sloping right-of-way.

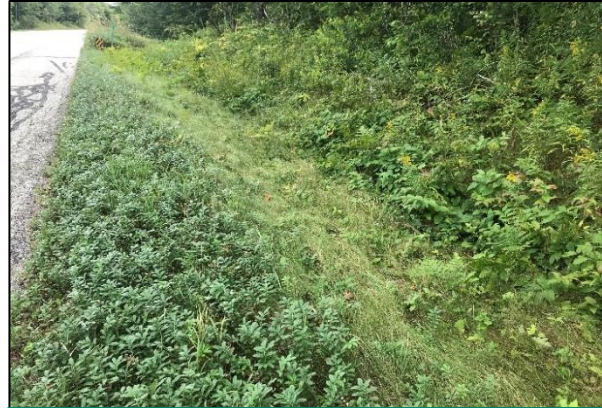
**Figure 12.** Silverweed next to US-2.

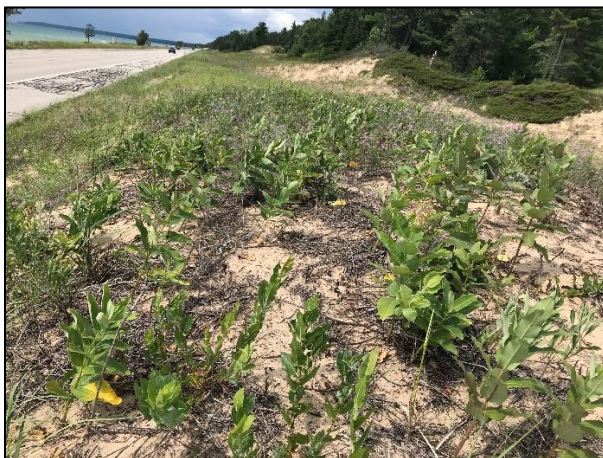
Portions of this segment on the north side of US-2 contain superb examples of northern Lake Michigan open dunes natural community, dominated by native plants such as sand cherry beach grass, sand reed grass, common milkweed, wormwood, and horsetail (Figure 13). Non-native spotted knapweed and smooth brome grass occur sporadically. Closer to the highway edge silverweed, ragweed, and white sweet clover alternate in dominance. In the northern portion of this segment, the right-of-way is bordered by mesic northern forest, and other species become dominant in the right-of-way including, wild rose, bracken fern (*Pteridium aquilinum*), goldenrods, wild sarsaparilla, large-leaved aster, poison ivy, starry false solomon-seal (*Maianthemum stellatum*), and non-native sow thistle (*Sonchus* sp.). On the south side of US-2, there is a lot of gravel mixed in with the dune sands and it is primarily dominated by non-native plants.

**Figure 13.** Open dune with native species.

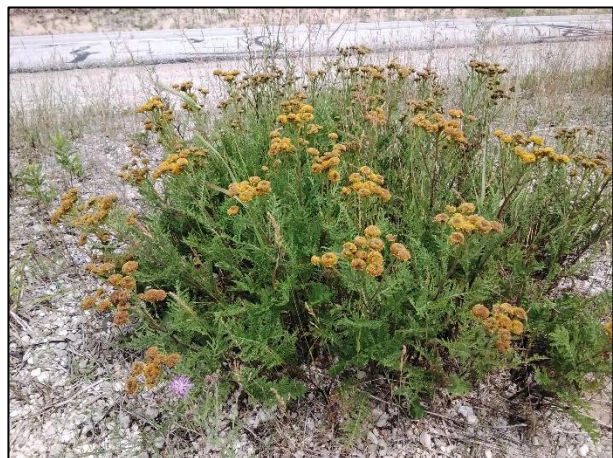
Five occurrences of Lake Huron tansy were mapped in the open dunes, including four on the southwest side and one on the northeast side of US-2 (Figure 8, Figure 14). One of these lies just outside the survey area (Appendix 1).

**Figure 14.** A patch of Lake Huron tansy.

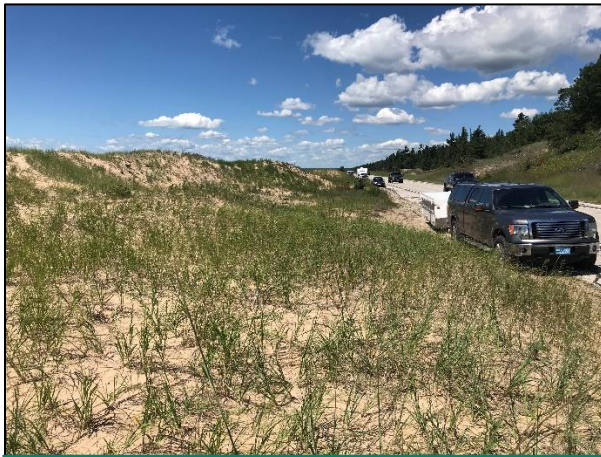
This entire segment is a superb example of northern Lake Michigan open dunes natural community (Figure 15). Dominant plant species are primarily native, including sand cherry, beach grass, sand reed grass, common milkweed, and wormwood, with occasional spotted knapweed and smooth brome grass. Closer to the highway edge, silverweed, ragweed, and white sweet clover alternate in dominance. The south side of US-2 is similar to segment 3 with a lot of gravel mixed in with the dune sands and it is primarily dominated by non-native plants.

**Figure 15.** High quality open dune.

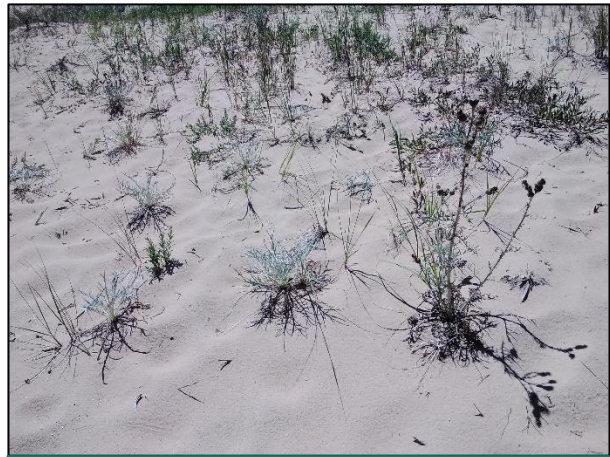
One occurrence of Pitcher's thistle was mapped on the southwest side of US-2 in this segment (Figure 8, Figure 16, Appendix 1).

**Figure 16.** Pitcher's thistle on the dune.

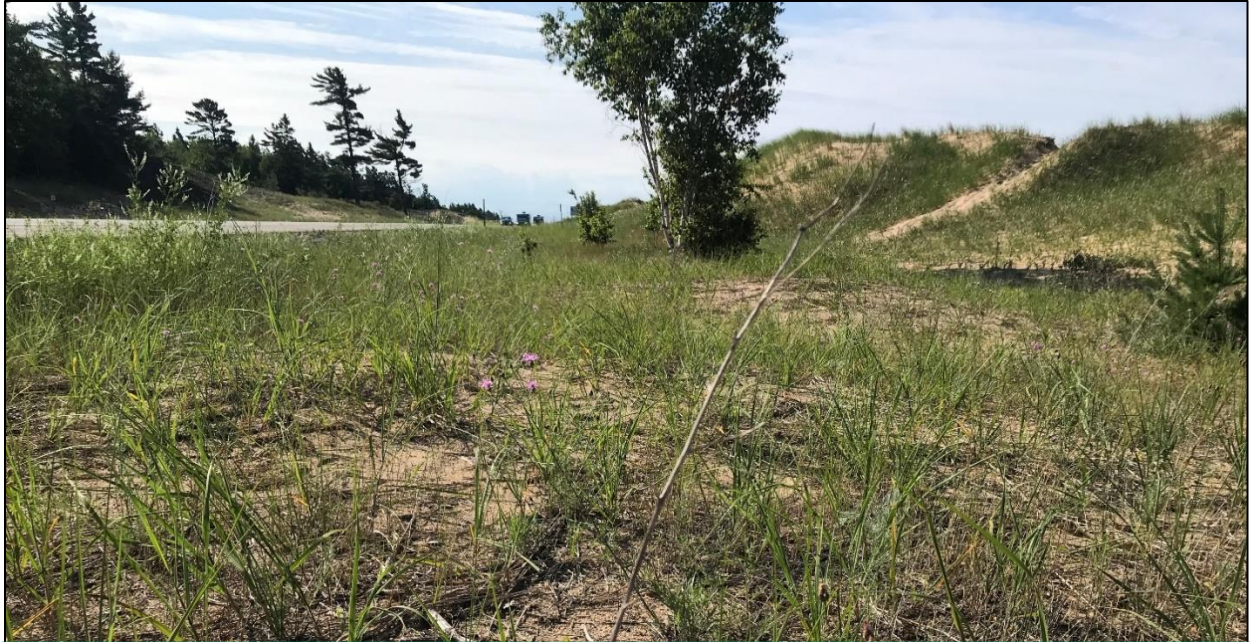
This segment is a continuation of high-quality open dune dominated by native sand cherry, beach grass, common milkweed, and wormwood, with some infestations of spotted knapweed and smooth brome grass (Figure 17). The northern portion of this segment is forested at the edge of the right-of-way and species observed along this edge include poison ivy, wild rose, red-raspberry, and meadow rue. Closer to the highway, large patches of silverweed, ragweed, and white sweet clover dominate.

**Figure 17.** High quality open dunes.

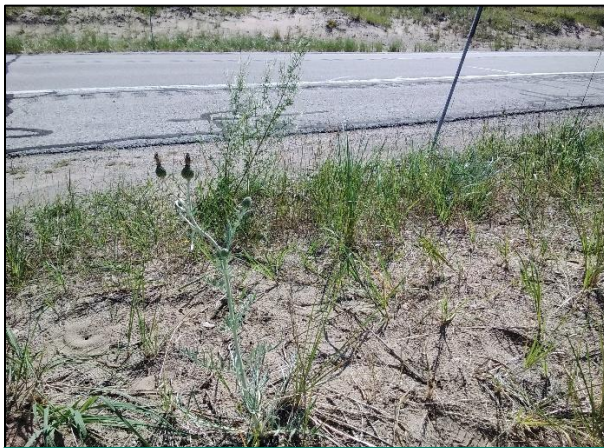
Seven occurrences of Pitcher's thistle and two of Lake Huron tansy were mapped in this area. The majority of these are on the southwest side of US-2, but a few Pitcher's thistle plants were observed on the northeast side as well (Figure 8, 18 and 19).

**Figure 18.** Pitcher's thistle along US-2.

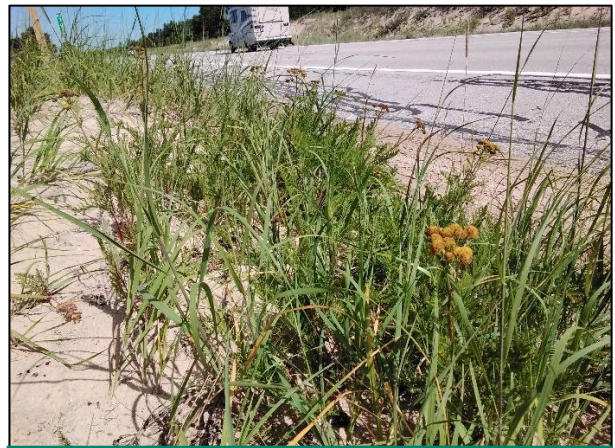
**Figure 19.** Lake Huron tansy along US-2.

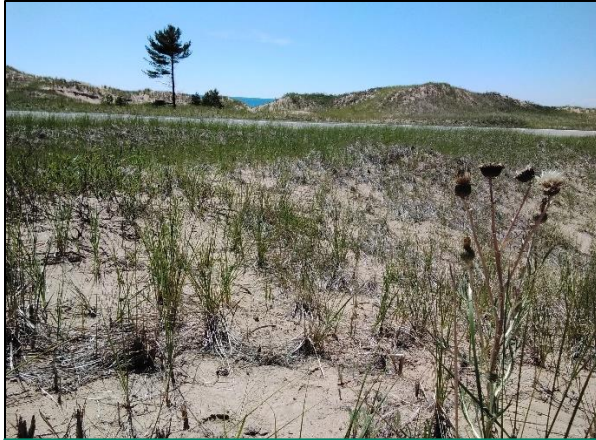
**Figure 20.** Pitcher's thistle in open dunes.

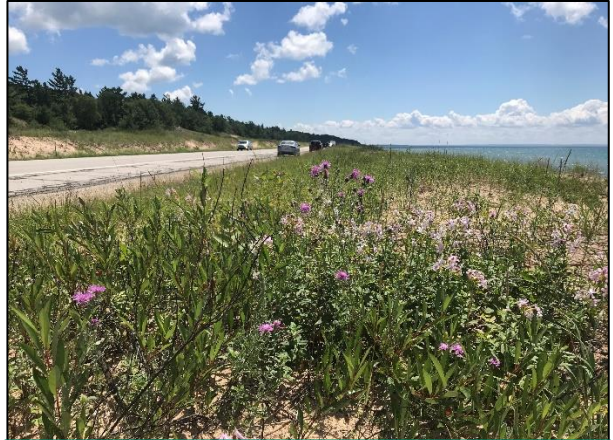
**Figure 21.** Weedy edge on lakeside.

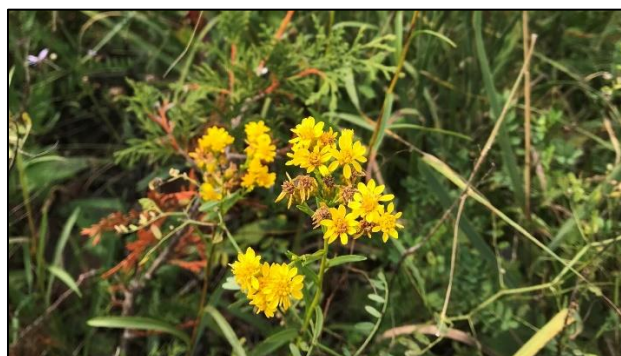
Two occurrences of Houghton's goldenrod were mapped in this segment during this survey (Figure 8, 22).

**Figure 22.** Houghton's goldenrod.
