Rare Plant Surveys for the Michigan Department of Transportation: Railroad Crossing Culvert in Ann Arbor. Project #1004E, Washtenaw County

MNFI Report No. 2021-25

Foot surveys for rare plant species were conducted in the area around the railroad crossing culvert near Barton and Plymouth Roads in Ann Arbor, Washtenaw County which is proposed for replacement.

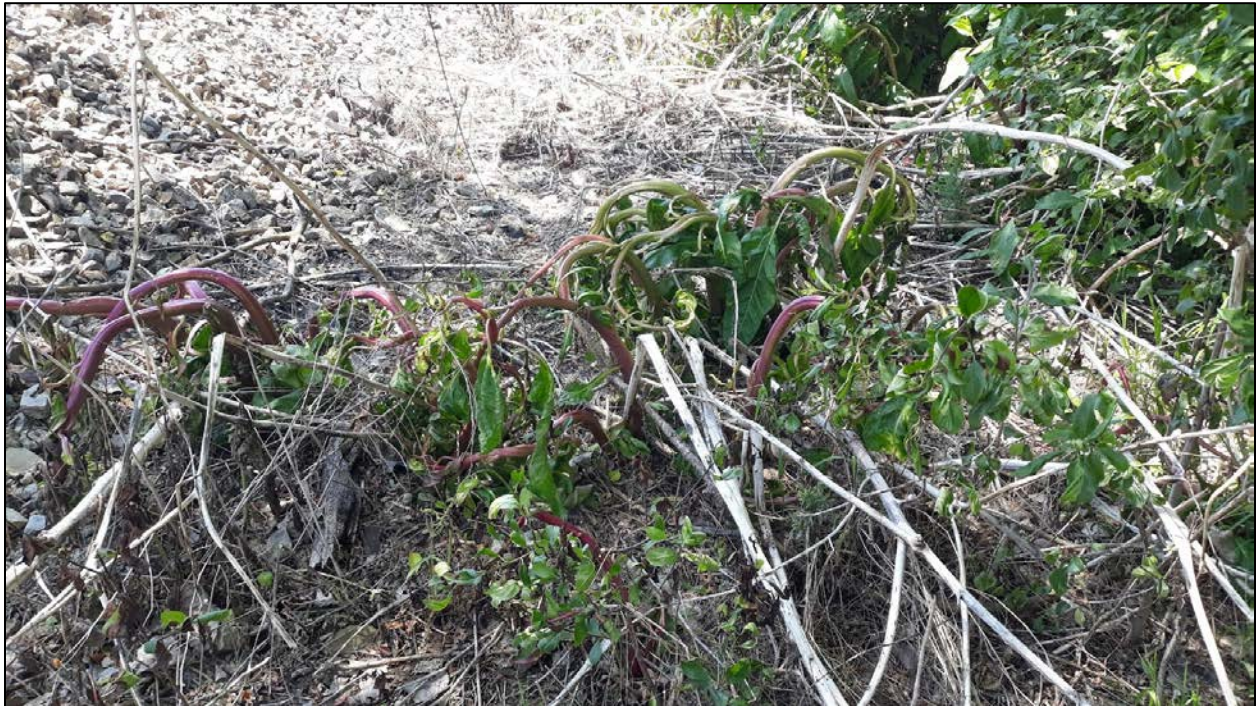
Figure 3. Pokeweed presumably damaged by broadcasted herbicide.

Much of the project area is unsuitable habitat with dense thickets and tangles of non-native species throughout. The southern half of the railroad ROW on the east side of the tracks in Segment 1 and the east side of Segment 2 where the culvert crosses the tracks are also unsuitable habitat due to severe erosion and habitat degradation. There also appears to be pesticide damage to the first two to three feet of vegetation at the ballast edge, running along

both sides of the tracks in Segment one and in scattered locations elsewhere along the railroad ROW (Figs. 3, 4).

The riparian area of Traver Creek runs parallel to and is downslope of the railroad tracks, though outside of the project area by approximately 20-30 feet. It is likely that herbicide and invasive species seeds travel down the slope and enter the riparian zone with negative impacts to native species. It is recommended to stop or limit herbicide use especially along the west side of the railroad ROW. The invasive species infestations are so widespread that aggressive treatment (broadcast herbicide applications, mechanical removal of woody plants) seems futile, and it is better recommended to target individuals/populations at 1-3-year intervals by means of hand pulling and cutting.

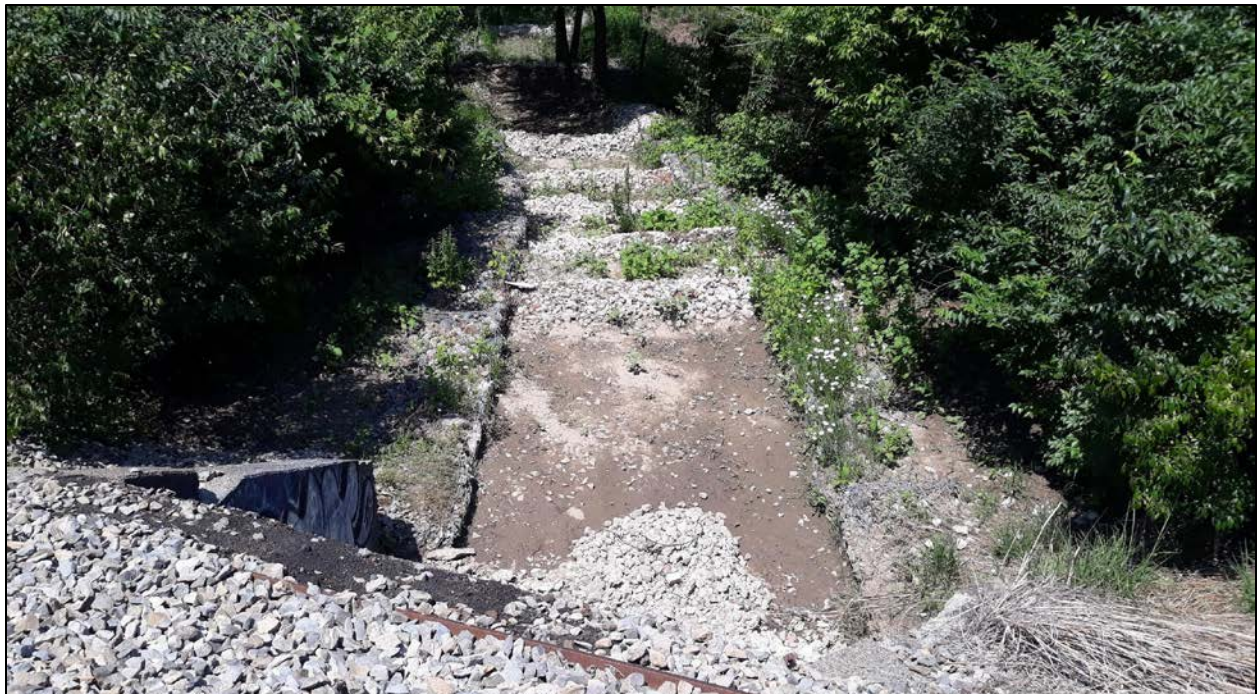
Figure 5. Gabion wall stepped foundation leading down to Traver Creek in Segment 2.

On the west side of the culvert crossing that leads down to Traver Creek, there is a Gabion wall—a stepped foundation to control erosion at the culvert (Figure 5). It is basically a large cage of rocks formed in a series of steps from the culvert pipe down to the creek. This cage of rocks has vegetation, even trees, growing up through it which resulted from organic matter getting into the rock cracks and is harmless to the structure.

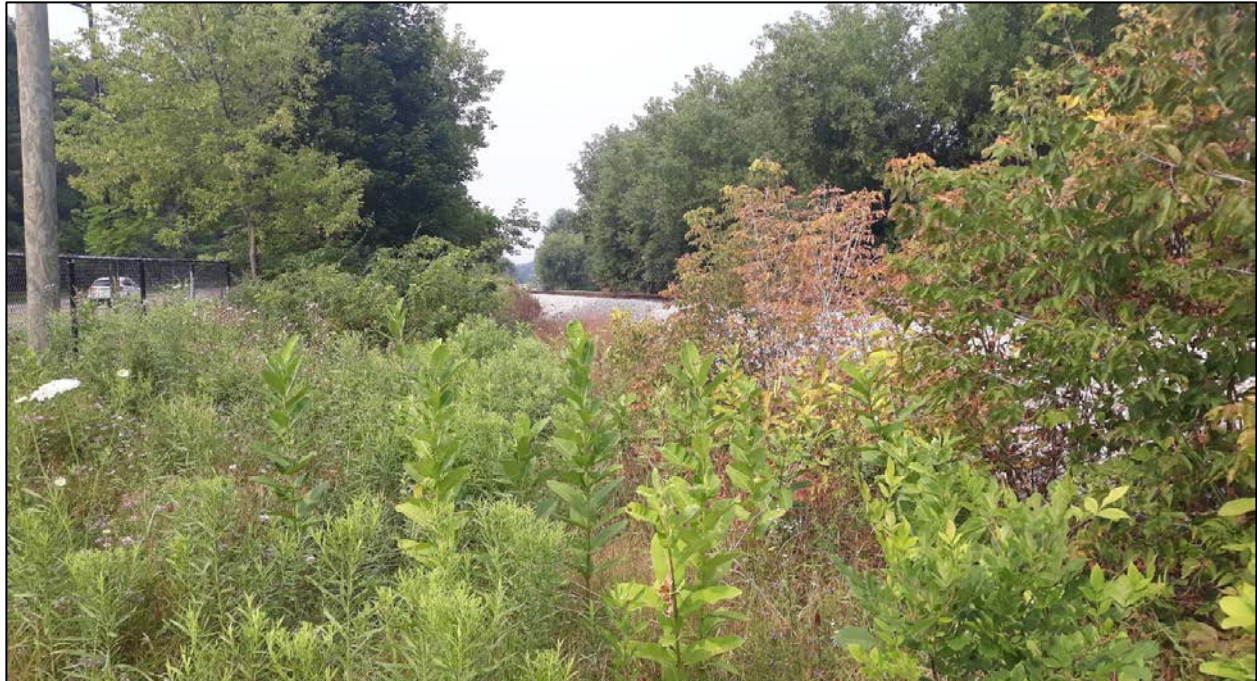
Figure 6. East side of Segment 1 showing early successional meadow species.

Each side of the railroad tracks in this segment is generally composed of a mix of native early successional herbaceous species and non-native invasive species (Fig. 6). The west side of the tracks is more degraded with shrubby thickets of Amur honeysuckle (*Lonicera maackii*) and

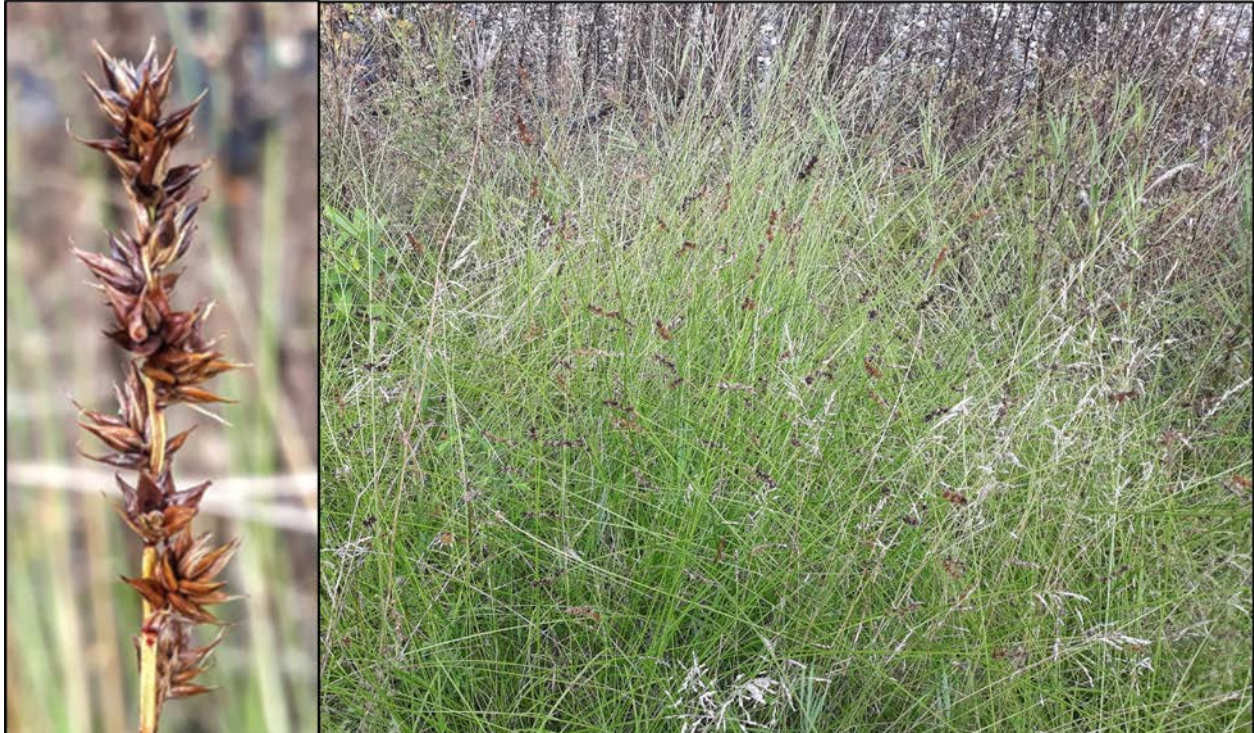
Figure 7. *Carex spicata* in Segment 1.

Particularly noteworthy elements: An introduced (non-native) sedge species (*Carex spicata*) was observed along the southeast side of the railroad track ROW (Figure 7). This species is one of only a few non-native sedges that are known to be introduced in Michigan; there are only four previous documentations of this species in the state. One of these was also found in Ann Arbor, several miles away from this new occurrence. *Carex spicata* can be distinguished by its dark, blackish purple perigynia just past maturity. Along both sides of the railroad tracks the vegetation appears to be suffering from herbicide damage as seen in Figures 3 and 4.

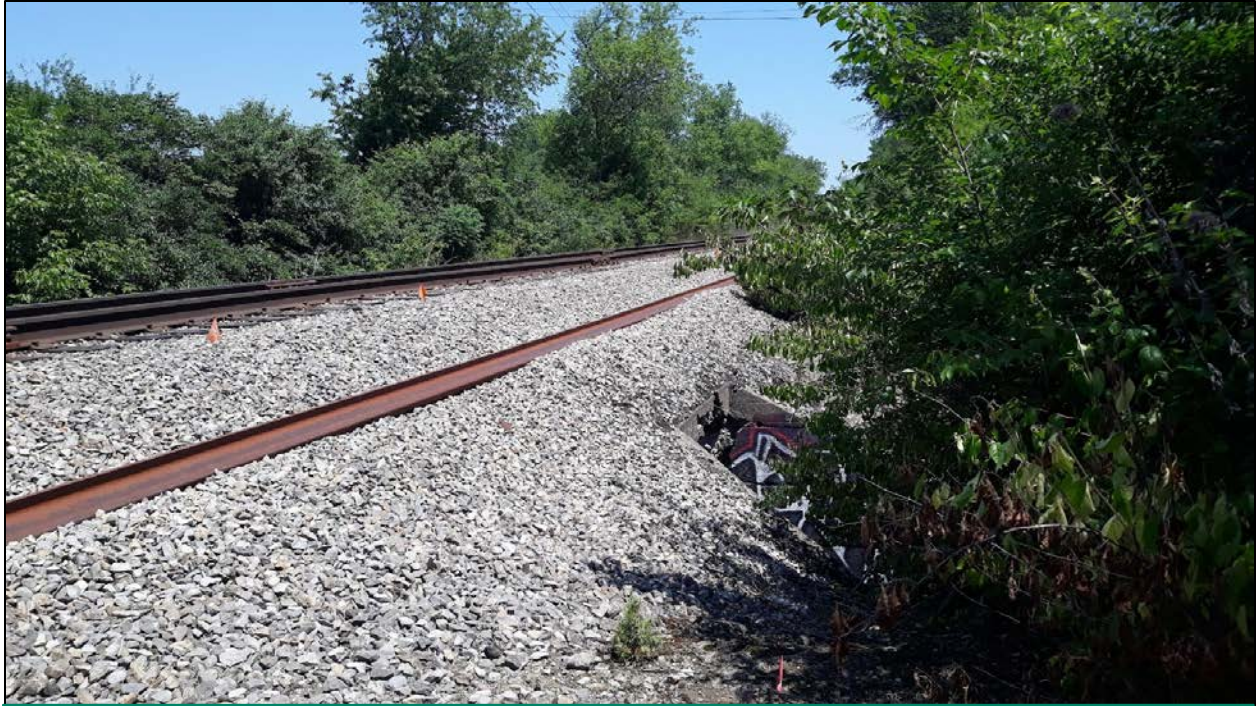
Figure 8. Culvert area in Segment 2.

The immediate area around the culvert is highly disturbed and severely degraded habitat (Fig. 9-11). The east side of the culvert consists of downed trees and log debris amongst a very dense “forest” of mature Amur honeysuckle and common buckthorn. These shrubs have created such deep shade that little to no ground vegetation is present. On the west side of the tracks along the Gabion wall stepped foundation there is a steep slope that grades from the ballast into dense vegetative thickets of similar weedy species listed in Segment 1 above.

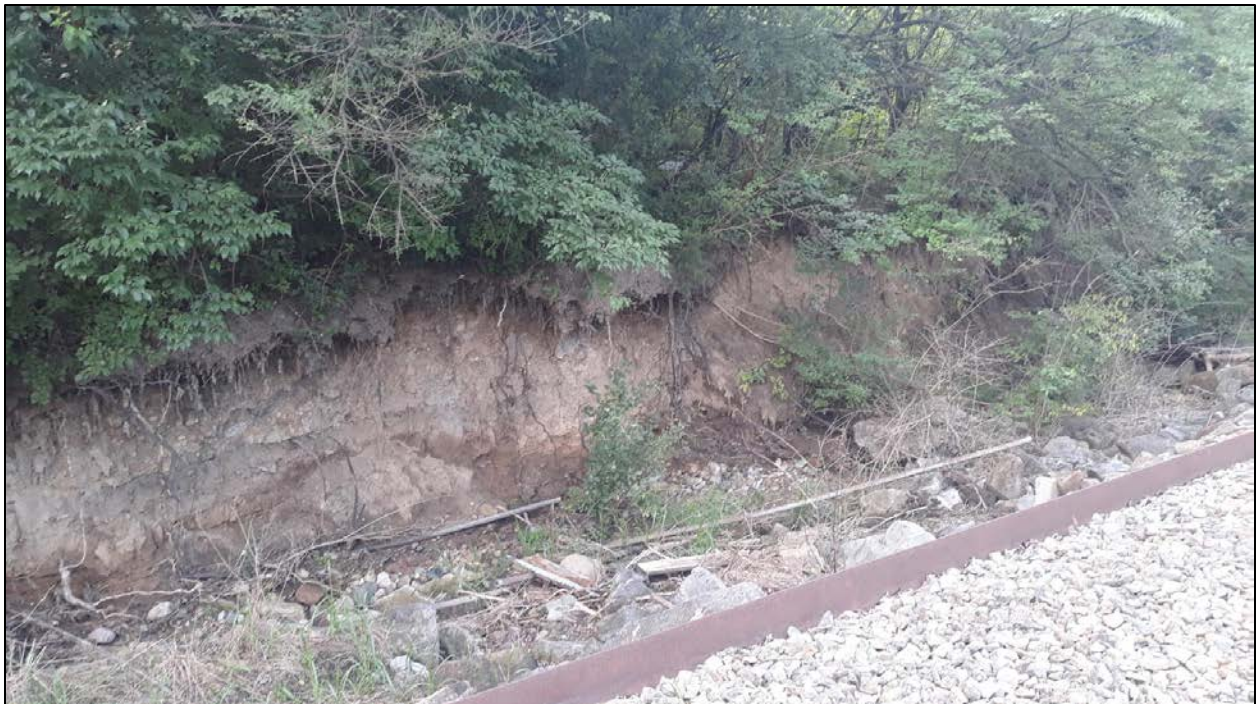
Figure 9. Severe erosion on east side of railroad tracks just south of the culvert in Segment 2.

Particularly noteworthy elements: There is severe erosion and habitat degradation on the east side of culvert (Fig. 9 & 10); it has been used as a dumping ground or possibly an encampment of sorts, indicated by significant amounts of garbage (Figure 12).

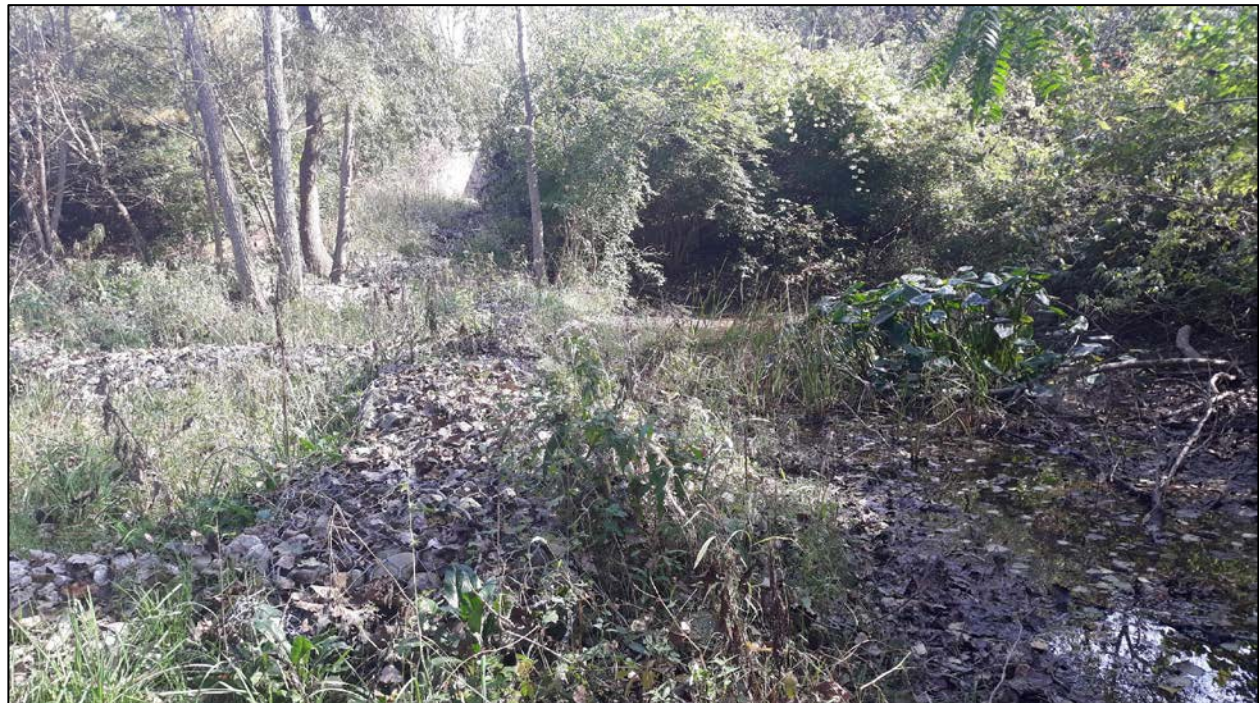
Figure 11: Vegetated Gabion foundation, showing small pond with pickerel-weed on the right side.

There is an open small pond on the southeast side of the Gabion foundation with aquatic species including water plantain (*Alisma* sp.), duckweeds (*Lemna* spp.) and pickerel-weed (*Pontederia cordata*) (Fig. 11). The Gabion foundation was once part of a rich prairie fen remnant that has been destroyed through intensive land use (Appendix A).
