# Rare Plant Surveys for the Michigan Department of Transportation: M-14 Sheldon Rd. to Newburgh Rd. Wayne County, Michigan. MDOT Project #208481

12/01/2022

MNFI Report No. 2022-37

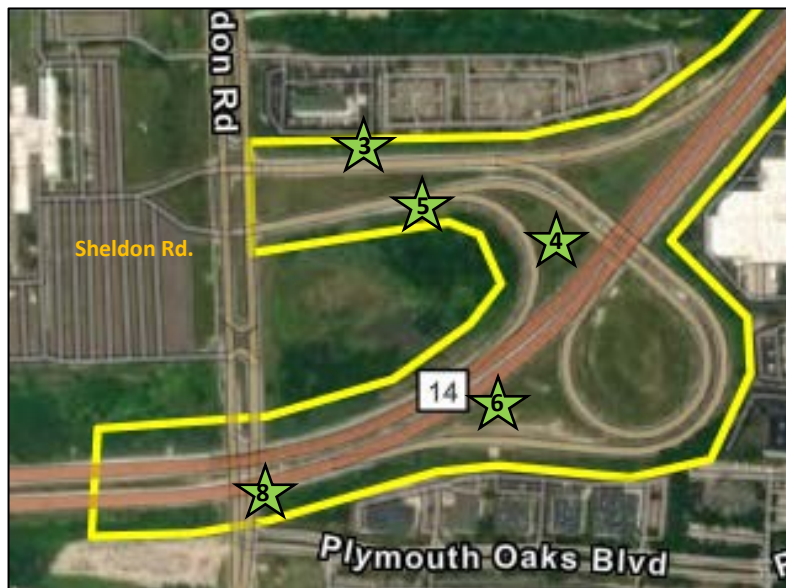
**Figure 2.** Segment 1: Sheldon Rd. interchanges. Stars denote photo locations and figure numbers.

The right-of-way and interchange triangles and circles at Sheldon Road are maintained and mowed, except in low, wet spots and on the steepest slopes. They are dominated by weedy grasses and forbs in the open areas, with scattered or occasional clumps of woody trees and shrubs.

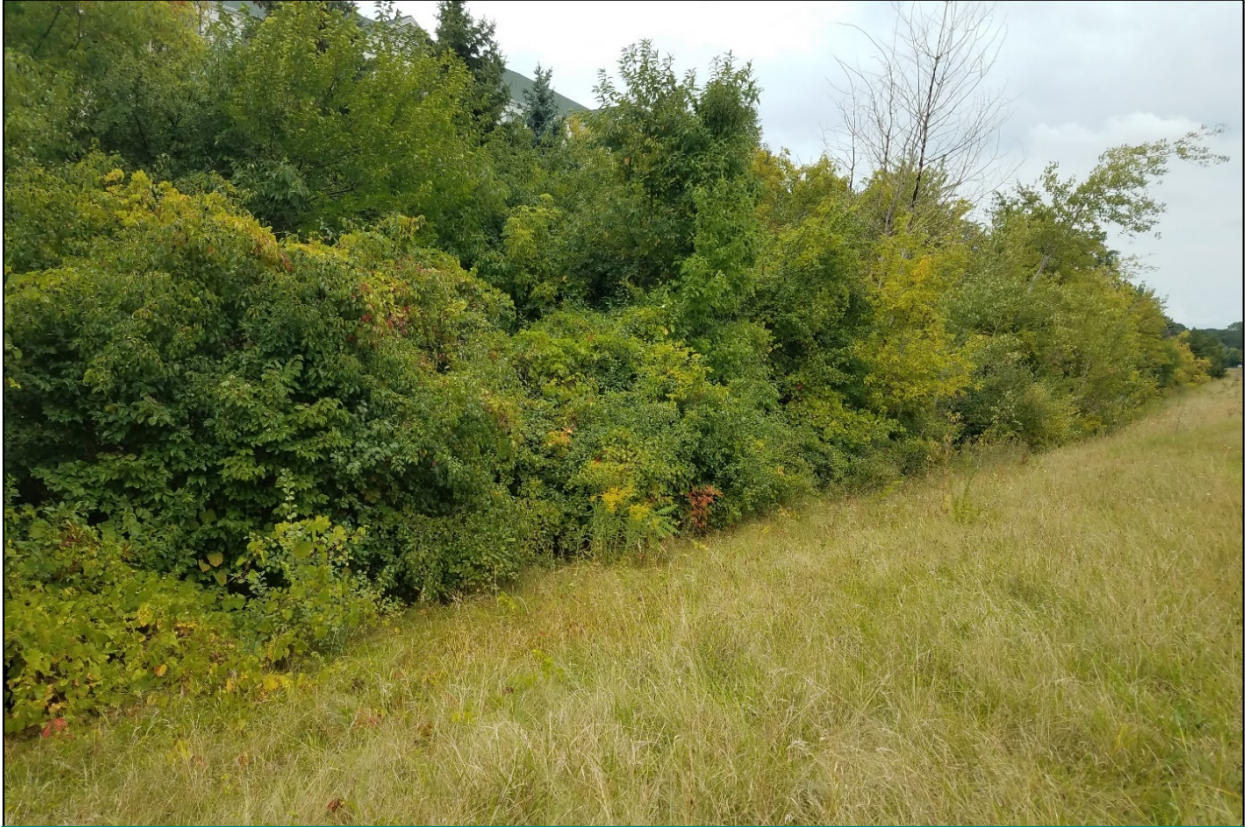
On the north side, there is a steep slope from the fenceline at the ridge down to the highway. Portions of this slope are dominated by gray dogwood (*Cornus foemina*), white mulberry (*Morus rubra*), and abundant invasive Oriental bitter-sweet (*Celastrus scandens*),

common buckthorn (*Rhamnus cathartica*), and multiflora rose (*Rosa multiflora*) (Fig. 3). In other areas the slopes are dominated by Eurasian grasses and weedy forbs, as are the interchange circles and triangles (Fig 4).

**Figure 3.** North side of M-14 off-ramp to Sheldon Rd, looking east with the Hilton Garden Inn Plymouth at the top of the ridge.

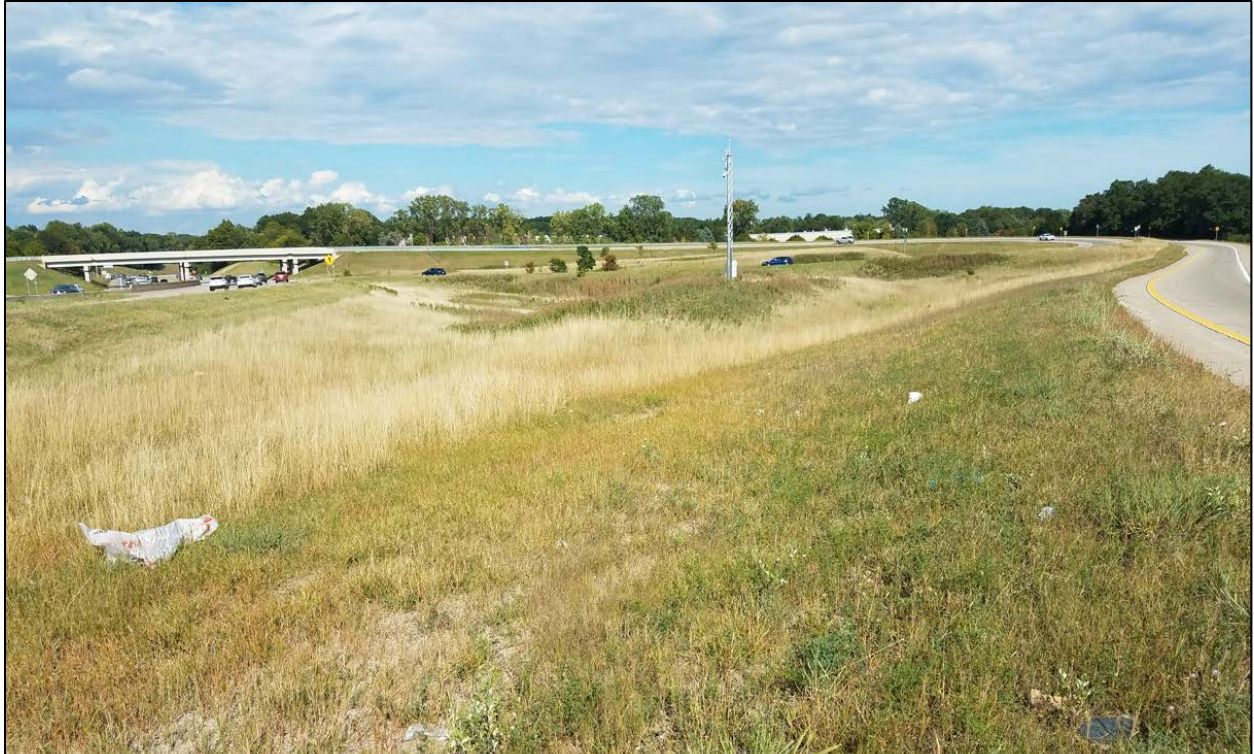
**Figure 4.** Interchange at Sheldon Rd. looking east, with a few scattered trees and shrubs.

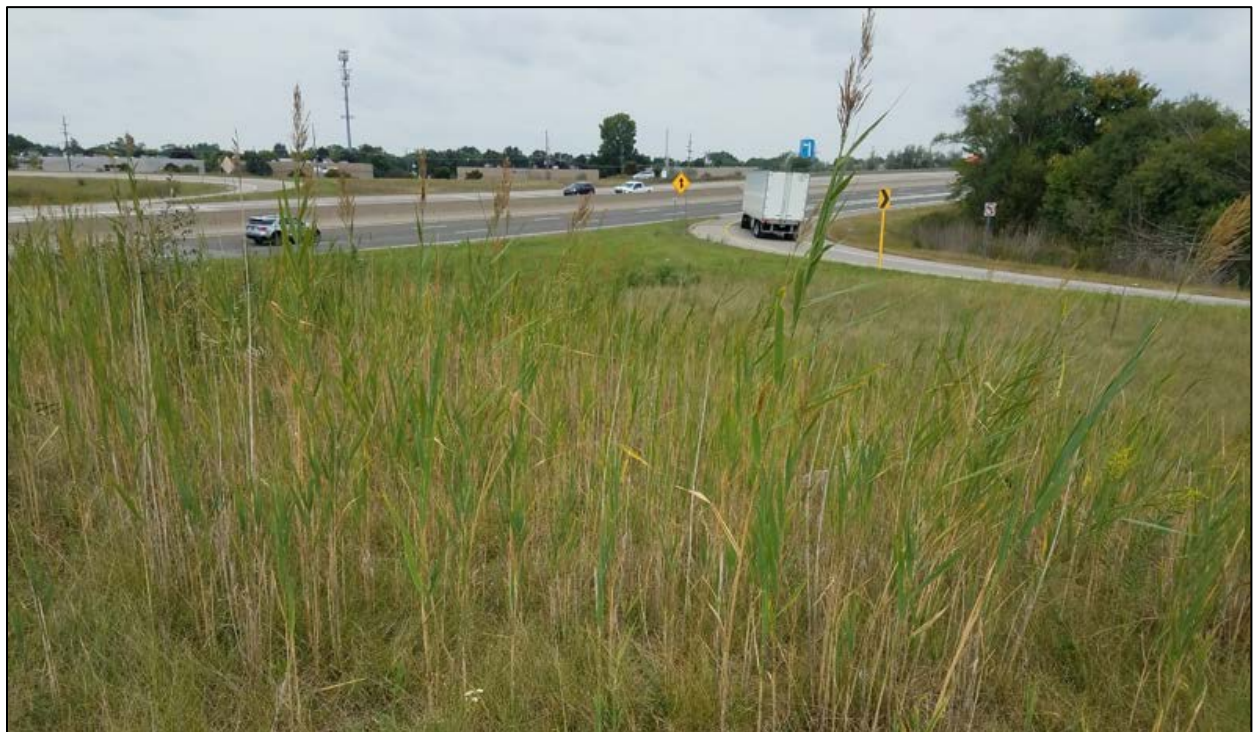
Wetter zones in depressions and ditches are occupied by cottonwood (*Populus deltoides*), Russian olive (*Elaeagnus angustifolia*), trembling aspen (*Populus tremuloides*), glossy buckthorn (*Frangula alnus*), narrow-leaved cat-tail (*Typha angustifolia*), hybrid cat-tail (*T. xglauca*), grass-leaved goldenrod (*Euthamia graminifolia*), non-native phragmites (*Phragmites australis*), and reed canary grass (*Phalaris arundinacea*) (Figs. 5, 6).

**Figure 5.** Interchange at Sheldon Rd. with non-native phragmites in a depression.

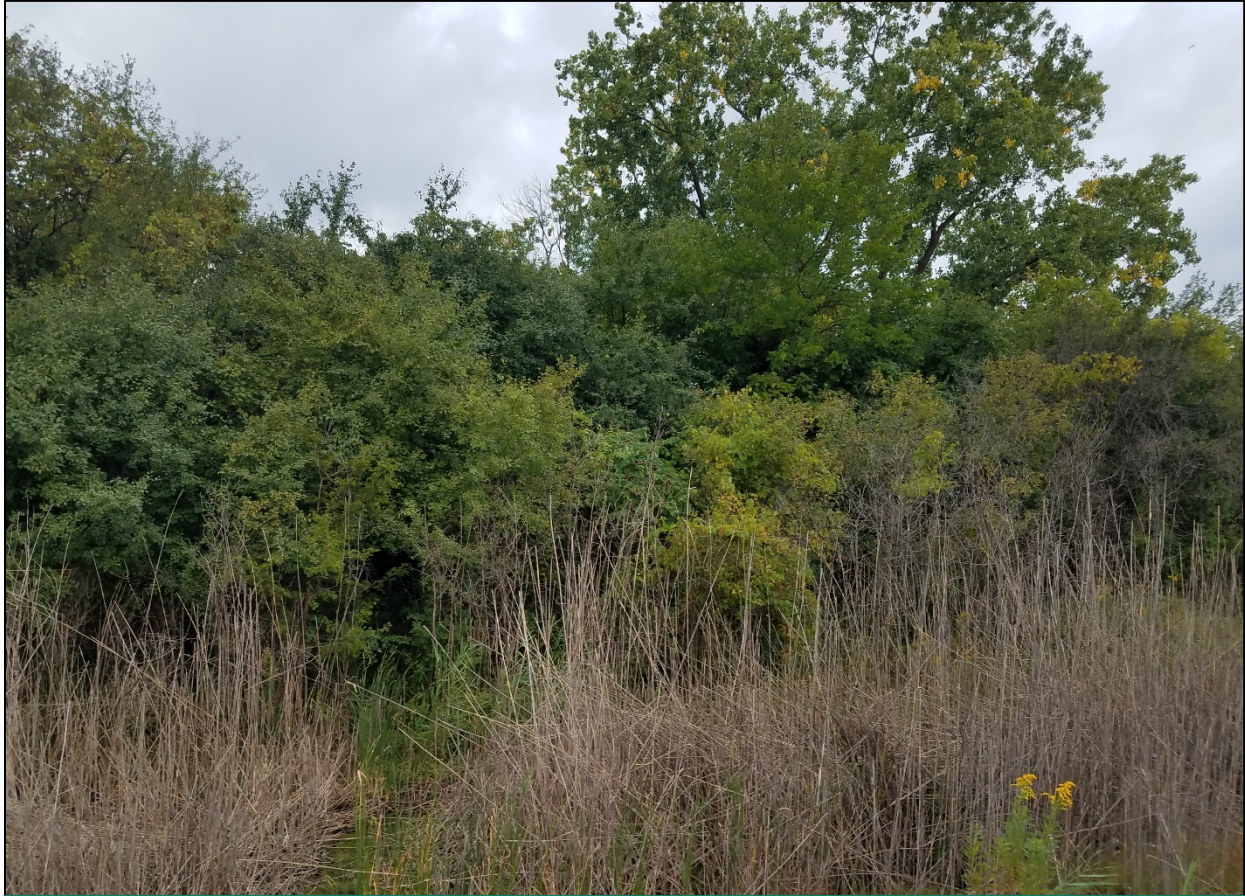
**Figure 6.** Wetland with cottonwood, common buckthorn, and non-native phragmites bordering the right-of-way in the center of the Sheldon Rd. interchange.

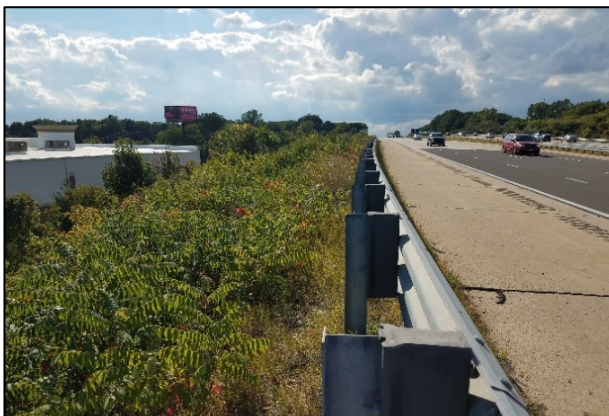
On the south side of the interchange along M-14, there is a narrow, mowed zone that merges to a steep, densely vegetated slope downward with cottonwood, box elder, staghorn sumac, gray dogwood, Amur honeysuckle (*Lonicera maackii*), common buckthorn, river-bank grape, thicket creeper, and teasel. (Figs. 7, 8).

**Figure 7.** Steep downward slopes south of M-14, looking west from Sheldon Rd.

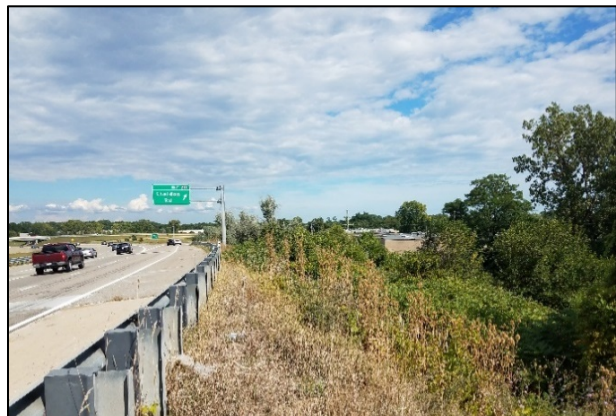
**Figure 8.** Steep downward slopes south of M-14, looking east from Sheldon Rd.

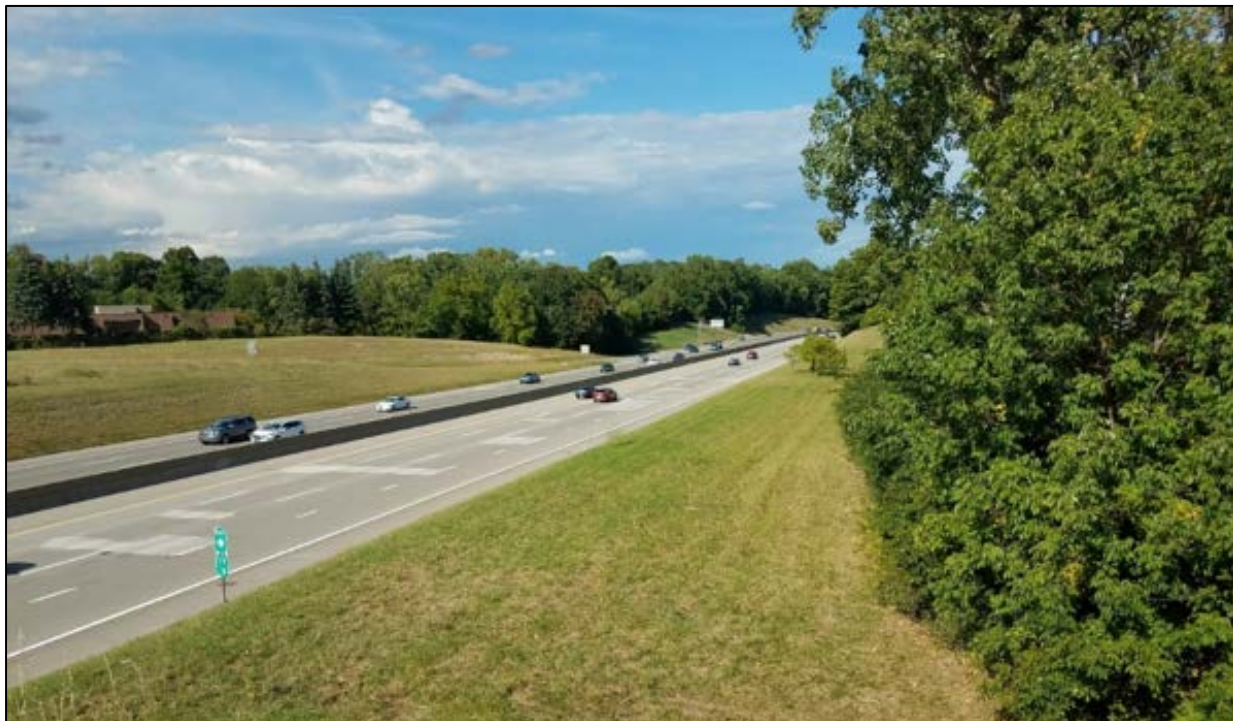
At the east end of the interchange as M-14 approaches Segment 2, there are open, maintained slopes up to a wooded border at the fence line along the ridge (Fig. 9). No suitable habitat was observed in this segment and no rare species were found.

**Figure 9.** M-14 looking northeast from Segment 1 to Segment 2.

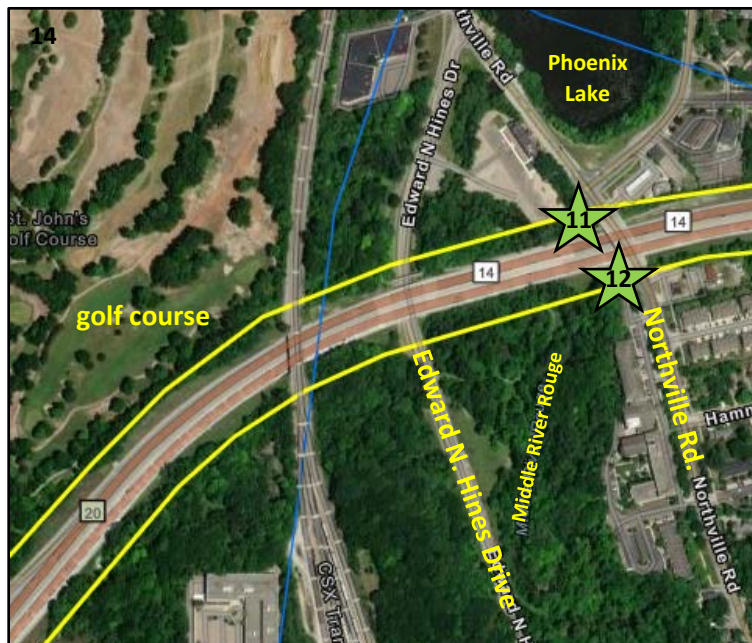
**Figure 10.** Segment 2: Wooded zone west of Northville Rd. Stars denote photo locations and figure numbers.

This segment extends east from the Sheldon Rd. interchanges to Northville Rd. and is bisected by a set of railroad tracks and Edward N. Hines Drive, that run perpendicular to M-14 and parallel to Northville Road (Fig. 10).

The northwest portion of this segment has a narrow fringe of woody species bordering a golf course to the north and an open maintained slope down to the highway (Fig. 10). Canopy trees barely reach over into the right-of-way and include sugar maple (*Acer*

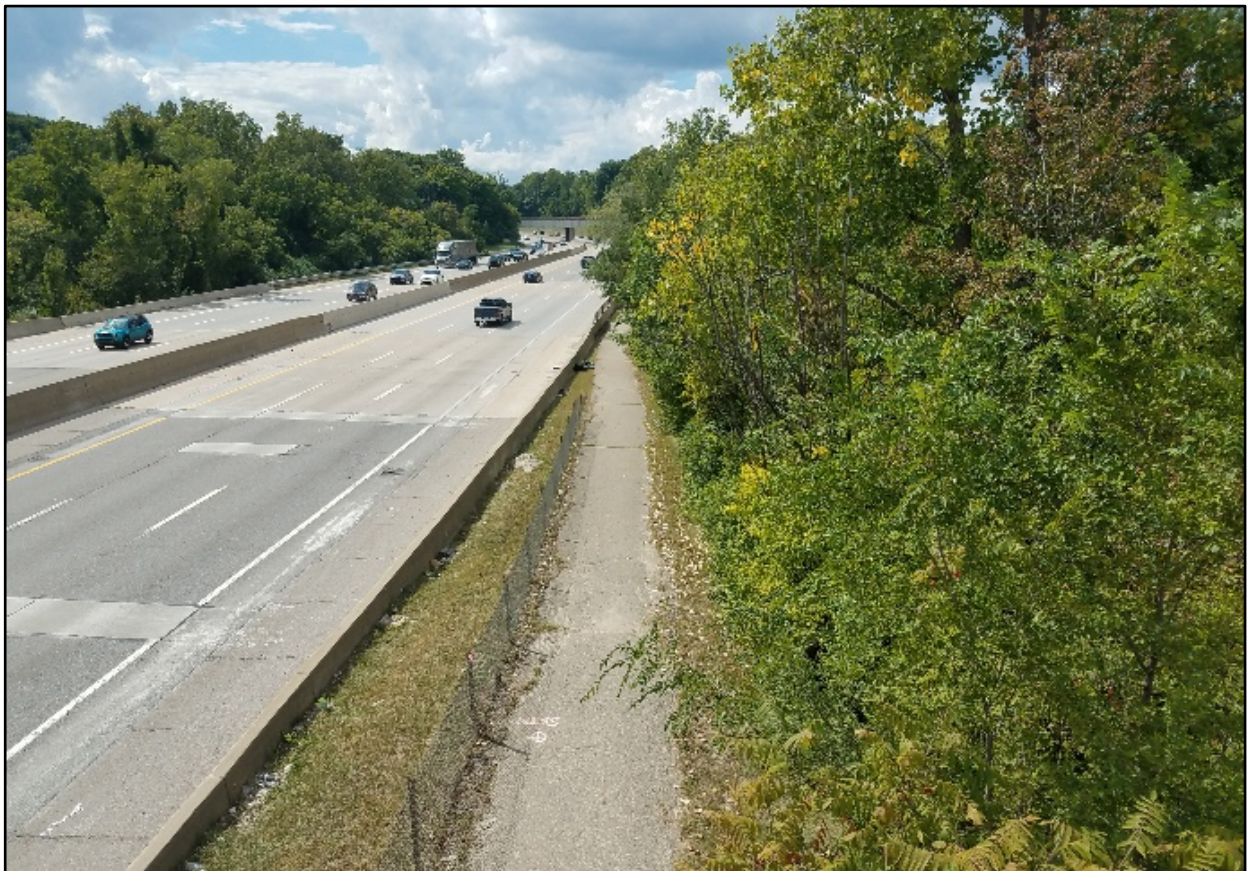
A mesic northern forest spans most of the remainder of this segment on both the north and south sides of M-14, and the Middle River Rouge meanders through it northward to Phoenix Lake (Figs. 10, 11). The canopy is dominated by sugar maple, American beech (*Fagus grandifolia*), white ash, red oak, with occasional white and black oak. Near the river, sycamore (*Acer platanoides*), pin oak (*Quercus palustris*), cottonwood, American elm (*Ulmus americana*), and box elder are more common.

**Figure 11.** Looking west from Northville Rd. on the north side of M-14, Segment 2.

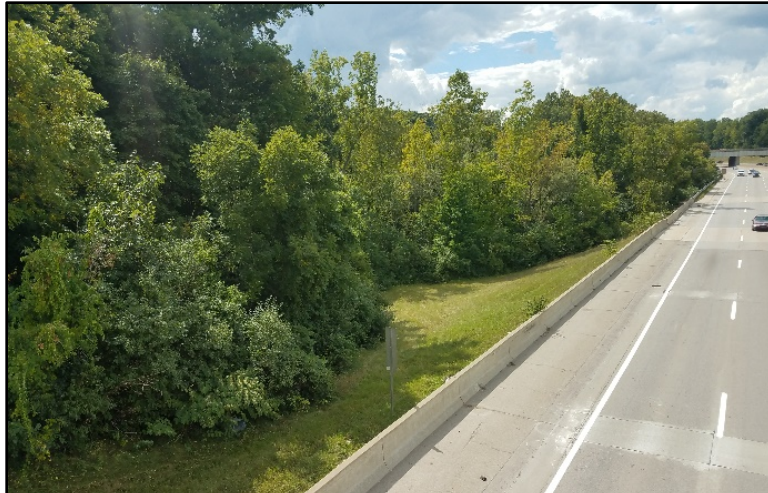
**Figure 12.** Looking east from Northville Rd. on the south side of M-14, Segment 2.

The rights-of-way directly adjacent to the M-14 are mowed and dominated by weedy grasses and forbs like those in Segment 1 (Fig. 12). Woody species extend into the mowed zone in some places, but there are only a few spots where any of the mesic forest canopy trees and associated species are rooted in the right-of-way. These areas were scoured for showy orchis (*Galearis spectabilis*), twinleaf (*Jeffersonia diphylla*), green violet (*Hybanthus concolor*), and nodding mandarin (*Prosartes maculata*).

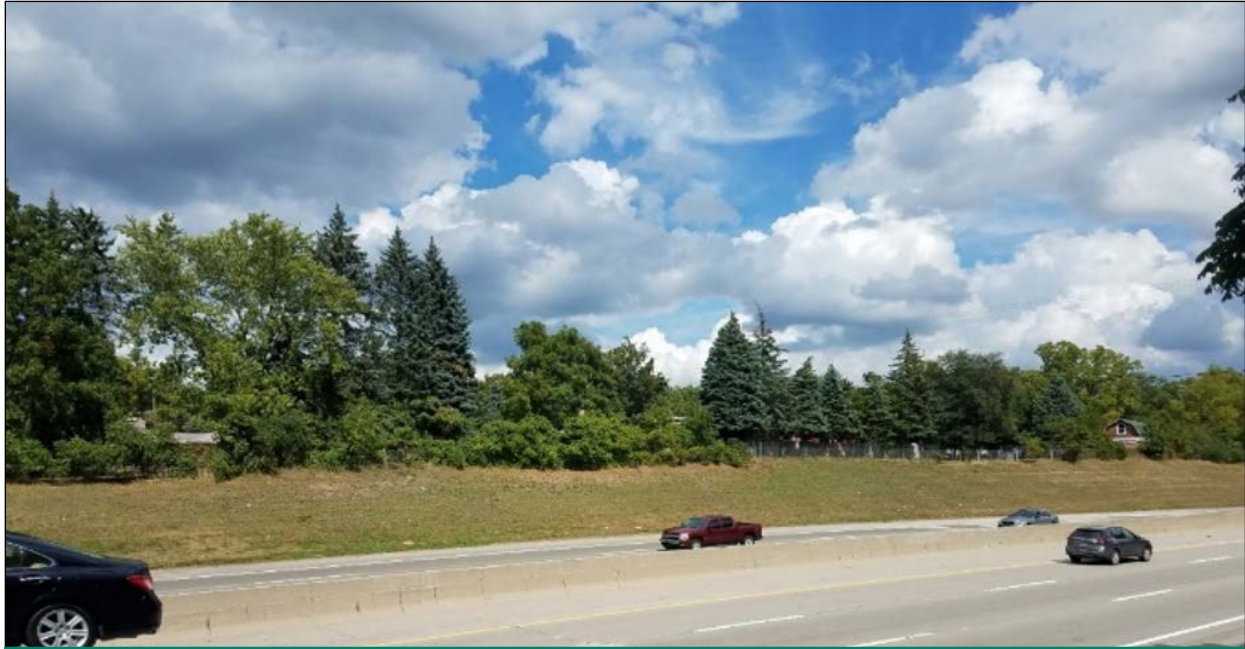
**Figure 14.** Looking northeast from Northville Rd. from the south side of M-14, Segment 3.

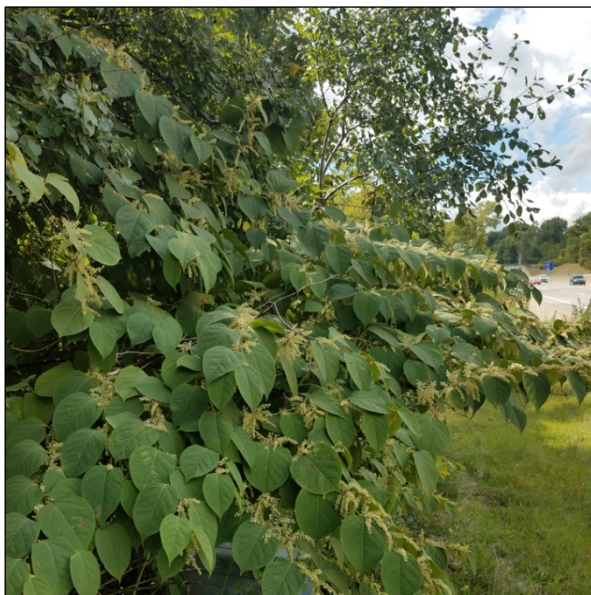
line into the right-of-way include walnut, white mulberry, box elder, staghorn sumac, common buckthorn, thicket creeper, Amur honeysuckle, and Oriental bittersweet. There are occasional ironwood, white pine, Norway maple, spruce (*Picea sp.*), and red cedar (*Juniperus virginiana*). The rectangular wooded zone on the south side of M-14 west of Robinwood Dr. identified as potential habitat (Fig. 13) is dominated by these weedy species instead. A small, isolated patch of Japanese knotweed was mapped at M-14 and Robinwood Dr. (Figs. 13, 15).

**Figure 15.** Japanese knotweed at the southwest corner of Robinwood Dr. and M-14 in Segment 3.

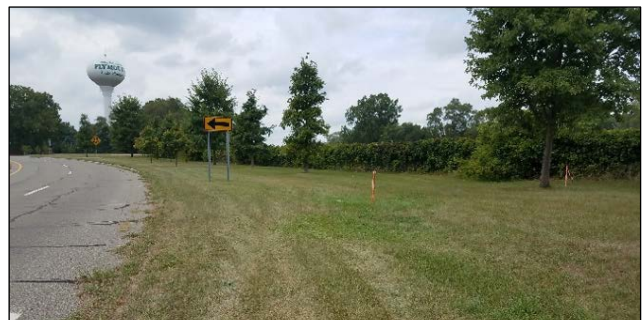
**Figure 16.** Schoolcraft Rd. looking west as it merges into Wilcox Road. Segment 3.

The open areas at the Schoolcraft Rd. crossing on the south side of M-14 is mowed and has scattered shrubs and trees (Fig,16) including silver maple basswood, river-bank grape, and thicket creeper.

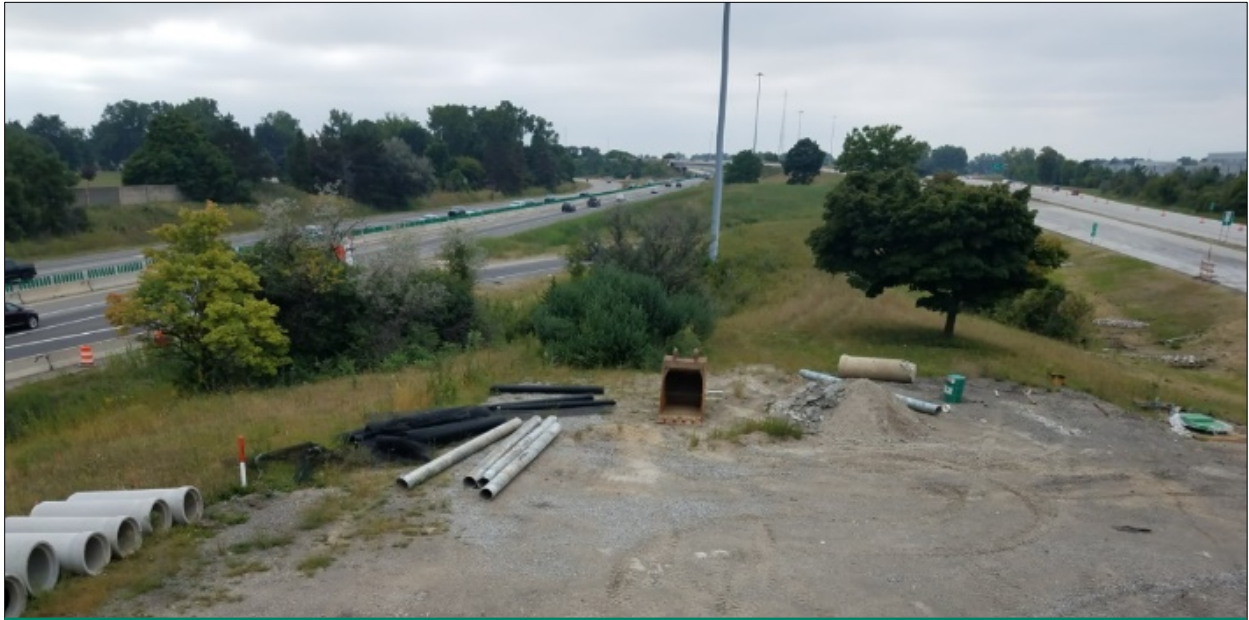
The median is similarly dominated by weedy grasses and forbs, with occasional clumps of shrubs and trees. The topography is undulating with wetland species in depressions (Fig. 19).

**Figure 19.** The median between north and south-bound I-275, north of M-14 in Segment 4.

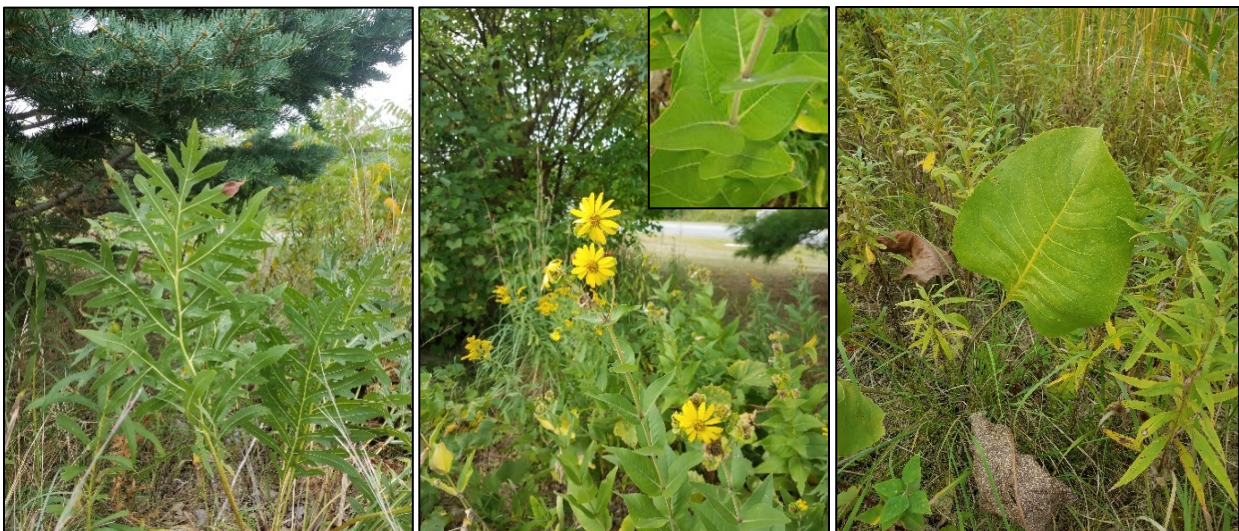
There is a prairie planting along the entire east side of the Bosch Plant parking lot just outside of the right-of-way (Fig.17). State threatened compass plant (*Silphium laciniatum*) and rosin weed (*Silphium integrifolium*) were observed in the planting, as was the unlisted prairie dock (*Silphium terebinthinaceum*) and numerous additional prairie plants (Fig. 19). In spite of extensive searching, these were not observed in the right-of-way; however, several occurrences of big bluestem (*Andropogon gerardii*), Indian grass (*Sorghastrum nutans*), butterfly weed (*Asclepias tuberosa*), and New England aster (*Symphyotrichum novae-angliae*) were observed (Fig. 20).

**Figure 20.** State threatened compass plant and rosin weed, and non-listed prairie dock in a prairie planting just outside the right-of-way in Segment 4, northwest quadrant.

The predominance of open grass and forb dominated areas throughout the project area could result in pockets of both wet and dry prairie for species such as compass plant and rosin weed or other rare prairie species. However, these areas are degraded by multiple non-native and invasive species, as well as general disturbance from road work, precluding any quality habitat for these species. The prairie planting in the northwest quadrant of the M-14/I-275 interchange harbors occurrences of compass plant and rosin weed, but it is just outside of the survey zone. Disturbance in this area should also be limited to avoid degradation of the planting.

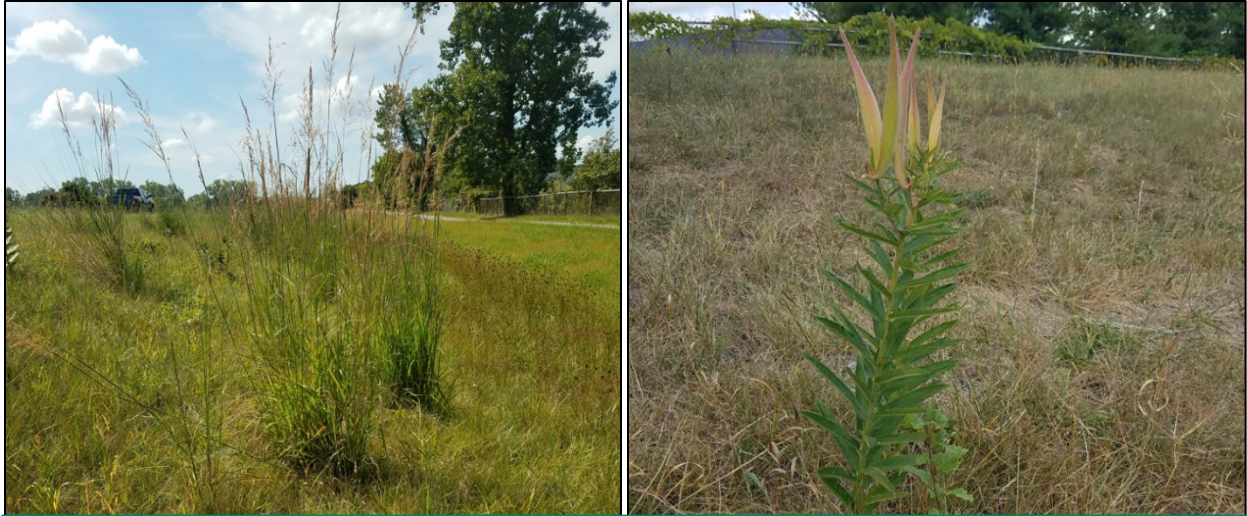
**Figure 21.** Indian grass and butterfly weed in the median where I-275 merges west to M-14, in the northwest quadrant of Segment 4.

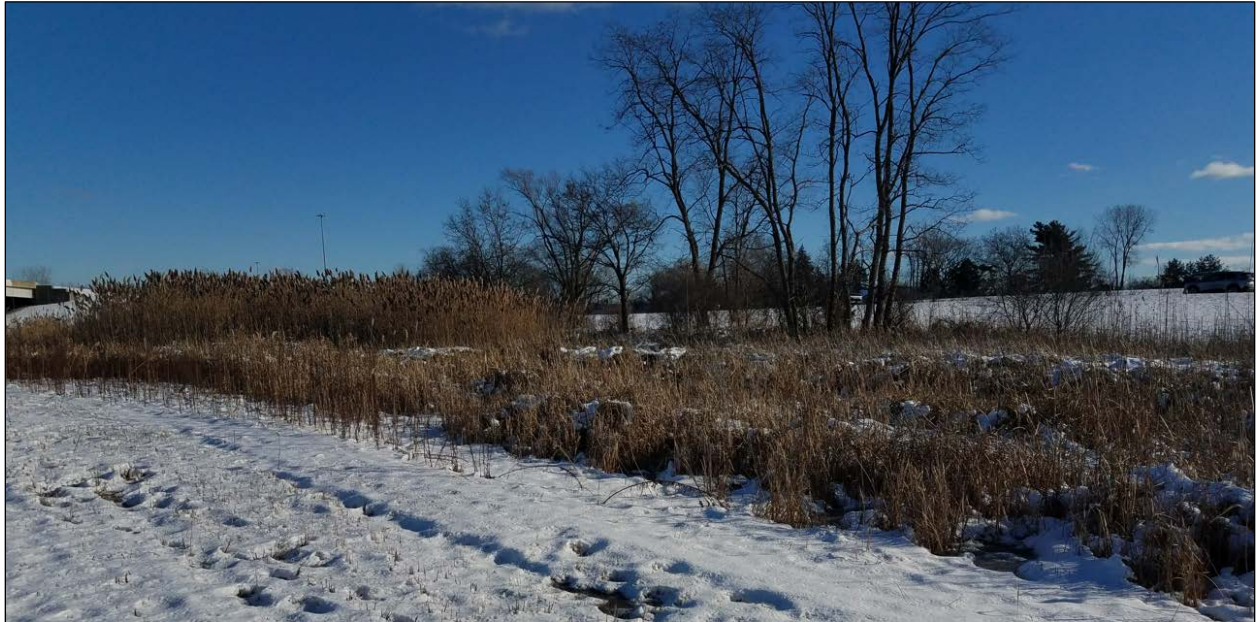
The median between east and west-bound M-14 at the east end of the segment has extensive depressions with even larger wet infestations of phragmites (Fig. 23). The trees and shrubs scattered here include sycamore (*Platanus occidentalis*), *Quercus rubra*, Russian olive, white mulberry, red cedar, staghorn sumac, Siberian crab, common buckthorn, and Amur honey-

**Figure 23.** Median between east and west-bound M-14 with large infestations of phragmites and non-native cat-tails, and scattered trees in the northwest quadrant of Segment 4.

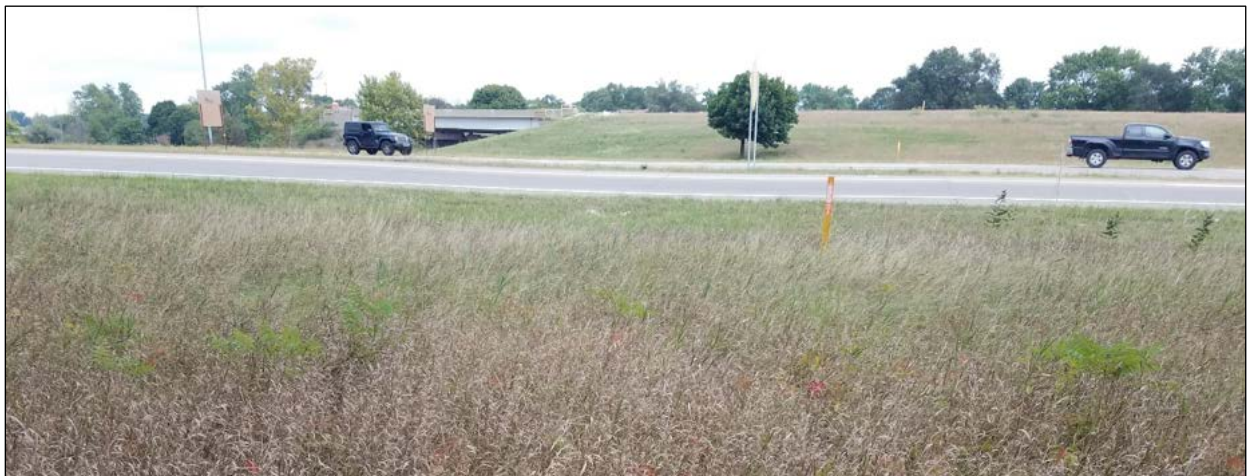
**Figure 24.** Interchange area in the southeast quadrant of Segment 4 dominated by smooth brome, tall fescue, and sand dropseed.

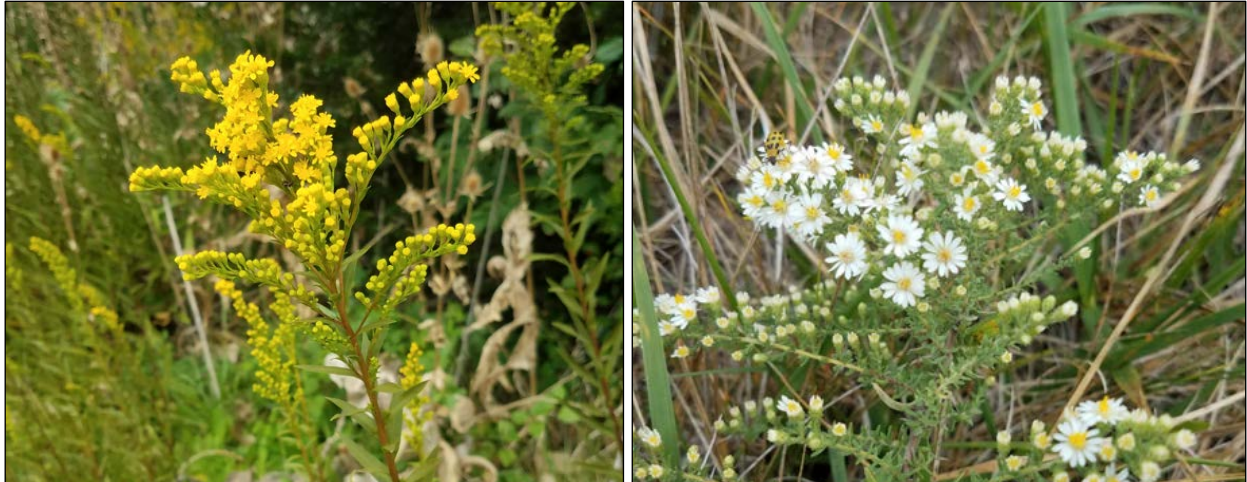
Similar, scattered trees and shrubs occur amidst a sea of weedy grasses and forbs in the outer rights-of-way in this quadrant, although species with higher wetland coefficients are more common, such as cottonwood, willow (*Salix sp.*), pin oak, and sycamore. The interchange circles and triangles are dominated by Eurasian grasses with sparse occurrences of trees and shrubs (Fig. 24). Seaside goldenrod (*Solidago sempervirens*) and heath aster (*Symphyotrichum ericoides*) were prominent at the time of survey (Fig. 25).

**Figure 25.** Seaside goldenrod and heath aster are common in the southeast quadrant of Segment 4.

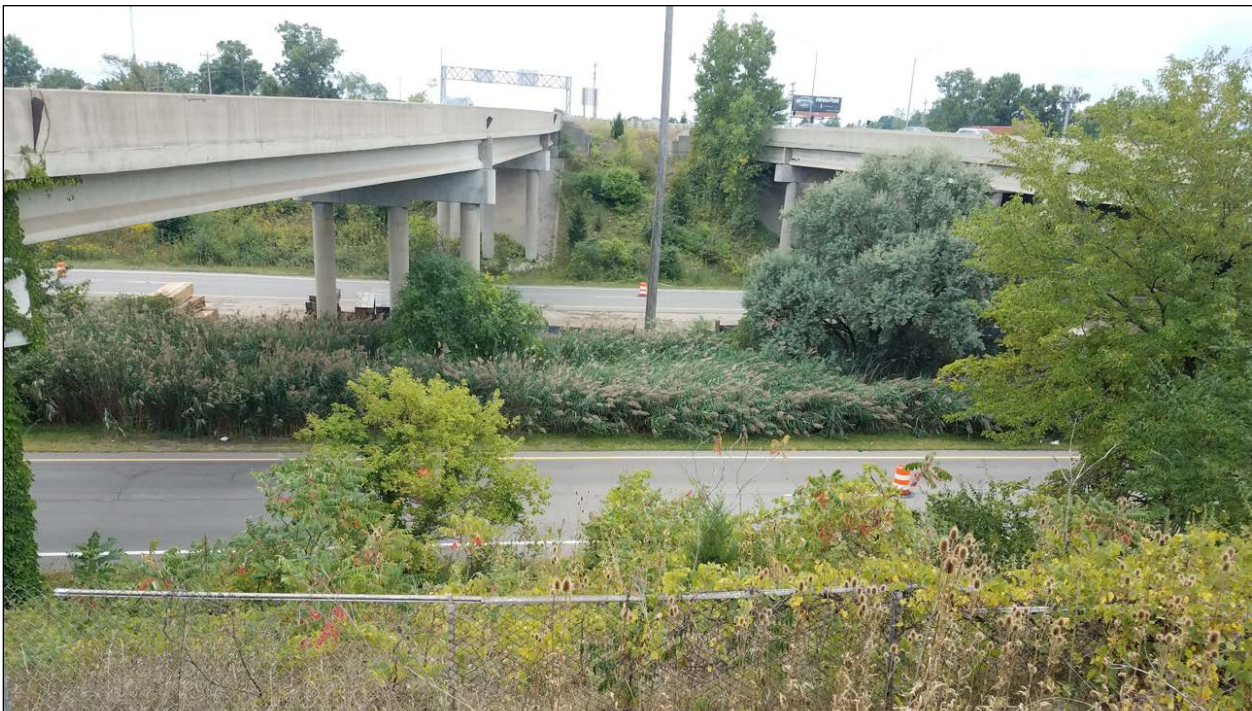
**Figure 26.** Schoolcraft Rd. crossing under I-275 in the southeast quadrant of Segment 4 with steep vegetated slopes down to a wet zone with invasive phragmites.

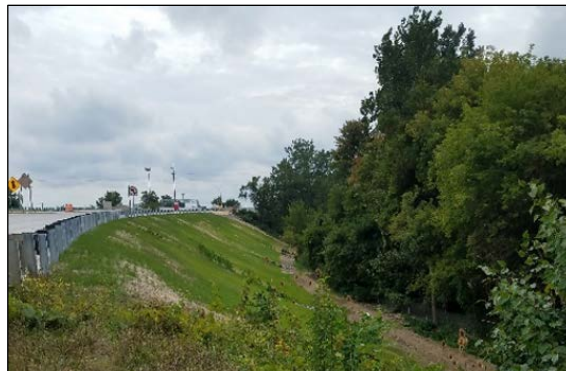
This quadrant is similar to the southeast quadrant; generally wet and weedy. It is highly disturbed along I-275 to the south with railroad tracks and development, and steeply sloped downward from the highway (Fig. 27) all the way to Schoolcraft Rd. The slopes lessen as the highway curves westward, but a wet ditch zone infested by invasive phragmites remains (Fig. 30). In this area Indian-potato (*Apios americana*) was observed in full bloom (Fig. 31) and Amur honey-suckle was bearing its signature fruit (Fig. 32).

**Figure 27.** Steep slopes in the southwest quadrant of Segment 4.

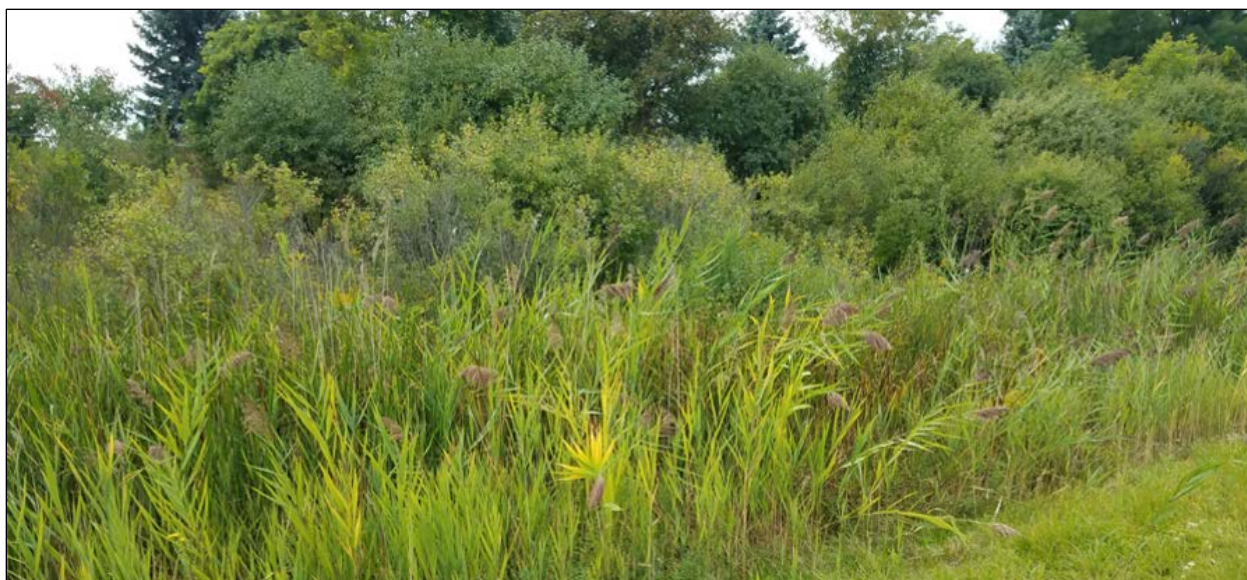
**Figure 28.** Wet ditch with invasive phragmites where M-14 merges to I-275 south in the southwest quadrant of Segment 4.

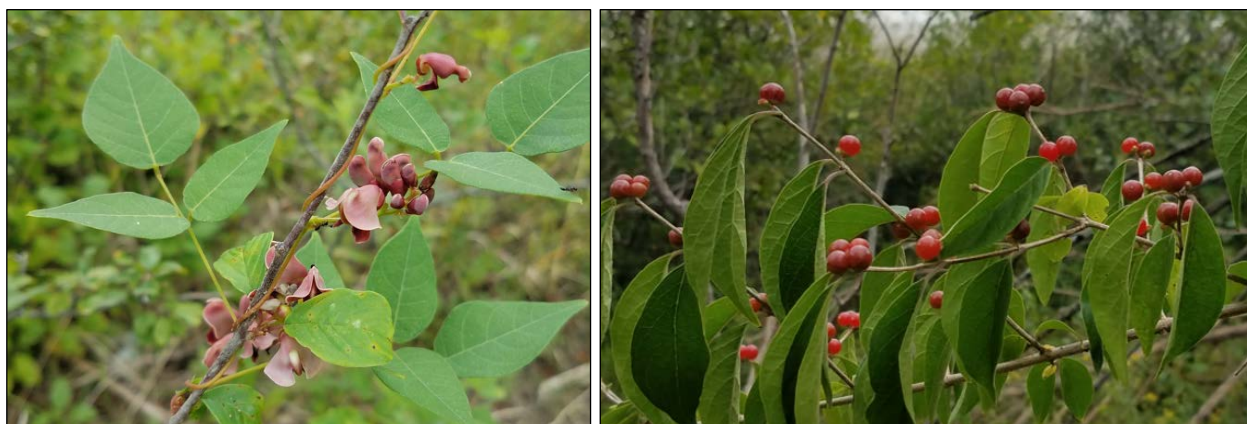
**Figure 29.** Indian potato (left) and Amur honeysuckle (right) observed in the southwest quadrant of Segment 4.

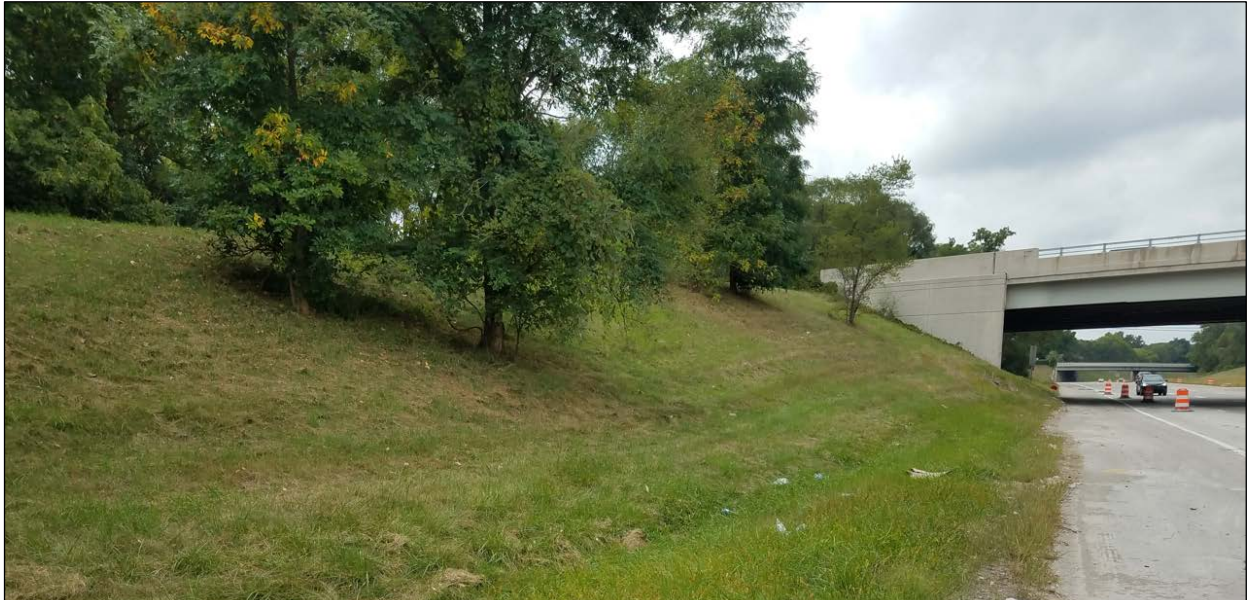
Further west towards Haggerty Rd. the slope transitions to uplands with scattered trees and shrubs that are maintained by mowing (Fig. 30). Like other segments, the medians are dominated by weedy grasses and forbs, a few scattered trees and shrubs, and depressions with invasive phragmites (Fig. 31).

**Figure 30.** Slopes rise up from the highway near the intersection of Haggerty Rd. and M-14 in the southwest quadrant of Segment 4.

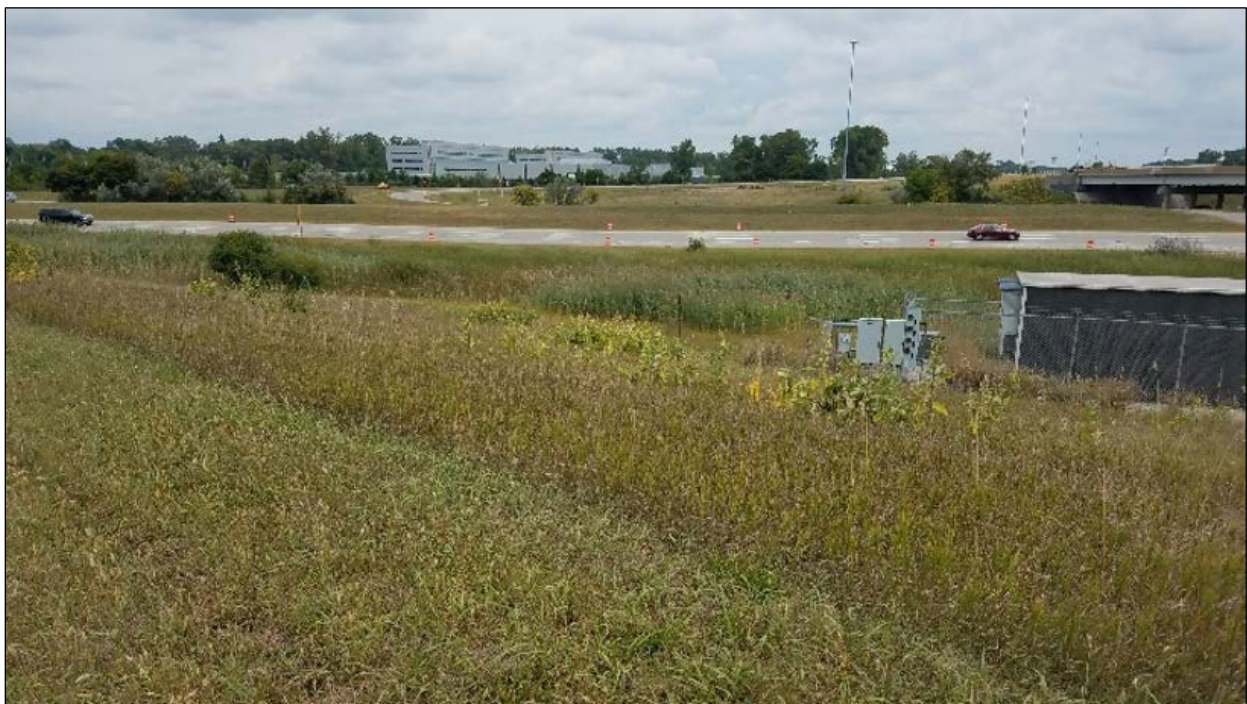
**Figure 31.** Interchange triangle in the southwest quadrant with weedy grasses and forbs, a few shrubs, and wet depressions with invasive phragmites.

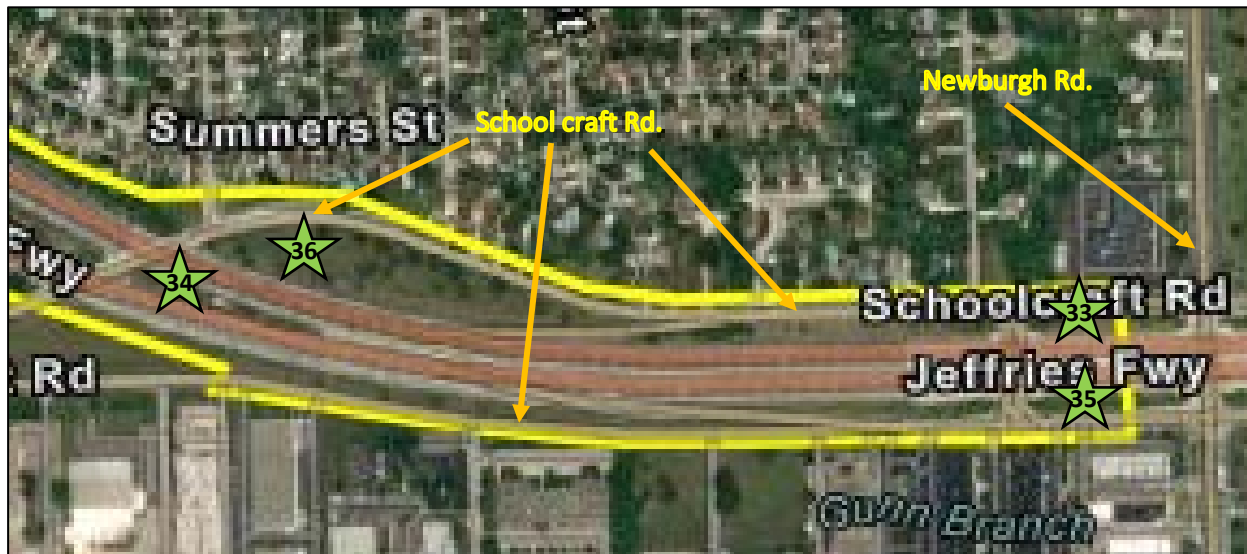
**Figure 32.** Segment 5: Schoolcraft Rd to Newburgh Rd.

This segment of the project area has steep, maintained slopes from the road edge to the fence line at the top of the ridge surrounded by housing and business (Fig. 32). It includes the on and off ramps to M-14 and adjacent Schoolcraft Rd. on both north and south sides and where it crosses the highway. Similar to the other segments, the vegetation is dominated by weedy grasses and forbs with clumps of woody species and occasional mature trees (Fig. 33, 34).

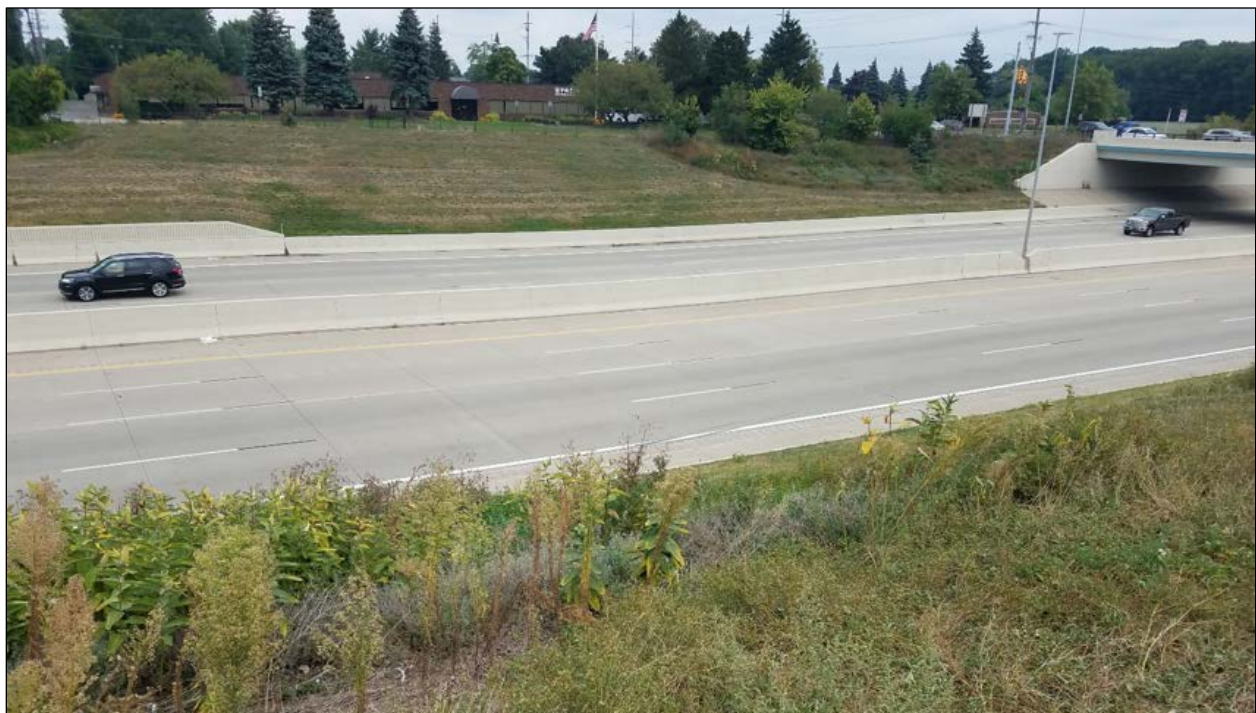
**Figure 33.** Steep maintained slopes with weedy grasses and forbs and occasional clumps of trees and shrubs in Segment 5.

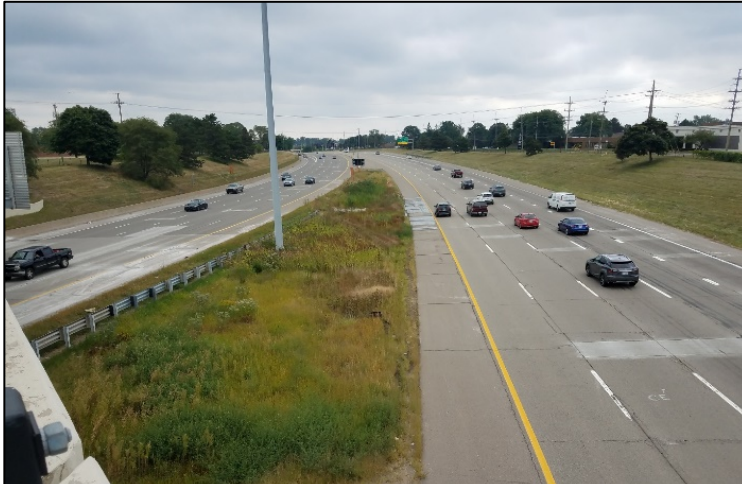
**Figure 34.** M-14 East with weedy forbs and grasses and occasional trees and shrubs in Segment 5.

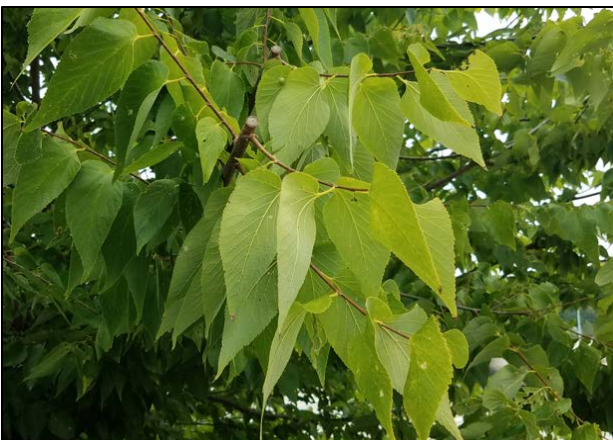
Common woody species include, cottonwood, white ash, hackberry, white mulberry, Norway maple, black pine, black locust, Siberian elm (*Ulmus pumila*), Tartarian honeysuckle (*Lonicera tatarica*), and the ubiquitous river-bank grape, thicket creeper, Amur honeysuckle, and common buckthorn. Hackberry (Fig. 35) and Siberian elm are noticeably more frequent in this segment than in other segments of this project area.

milkweed, bush honeysuckle (*Diervilla lonicera*), late boneset (*Eupatorium serotinum*; Fig. 35), horseweed, wild carrot, mugwort, crown vetch, bouncing bet, butter and eggs, sow thistle (*Sonchus* sp.), spotted knapweed (*Centaurea stoebe*), fescues, foxtails, and smooth brome.

**Figure 35.** Hackberry (left) and late boneset (right) are common along M-14 in Segment 5.
