Rare Plant Surveys for the Michigan Department of Transportation: I-94 at M-127, Lansing Ave. and Elm Ave., Jackson, Michigan

Prepared By: Phyllis J. Higman Michigan Natural Features Inventory Michigan State University Extension P.O. Box 13036 Lansing, MI 48901

Prepared For: Michigan Department of Transportation

MNFI Report No. 2019-35

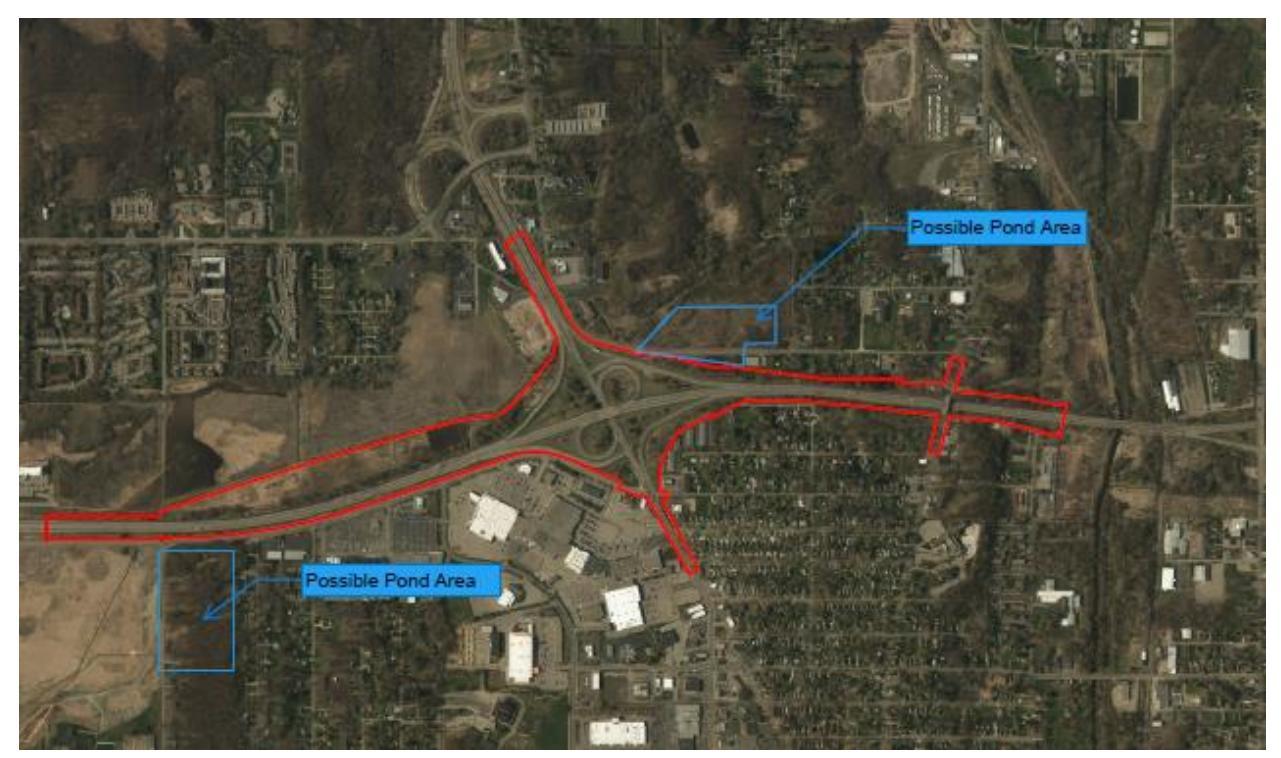
Figure 1. West survey area at US-127 and I-94 including potential pond areas.

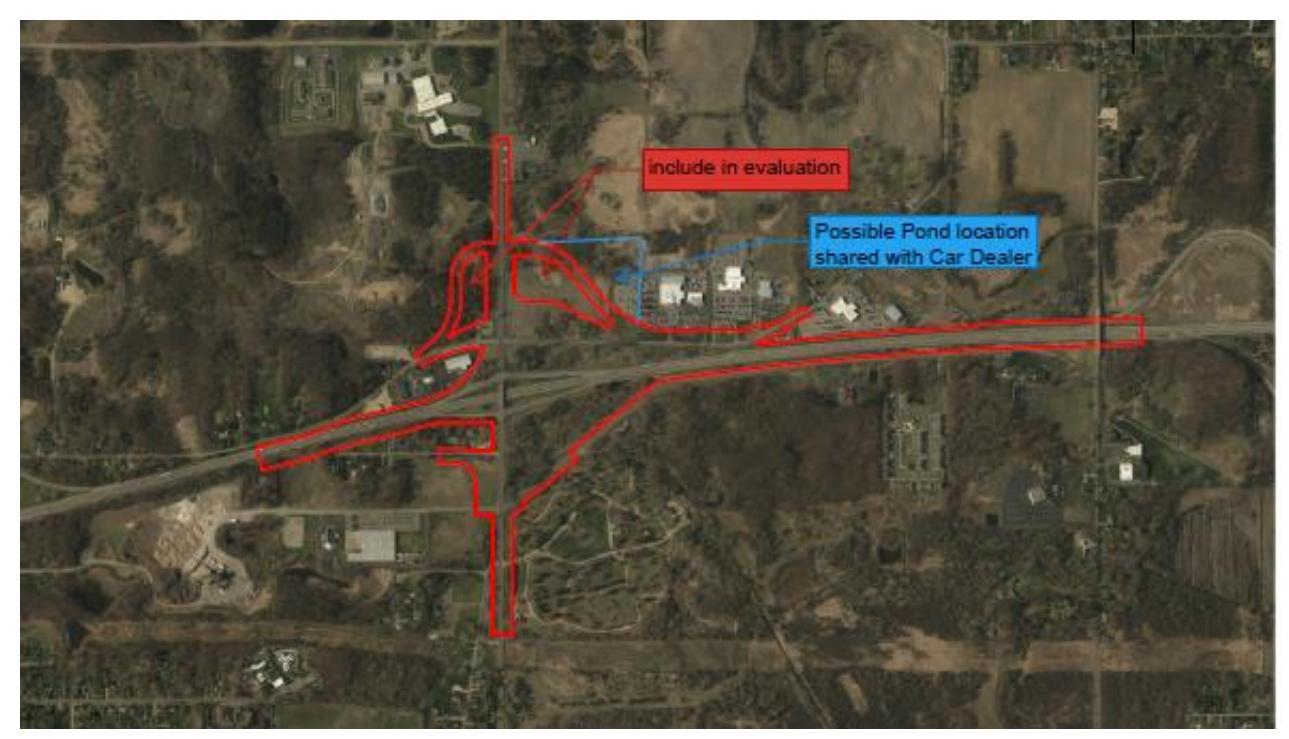
Figure 2. East Survey Area at Elm Ave. and I-94 including potential pond location.

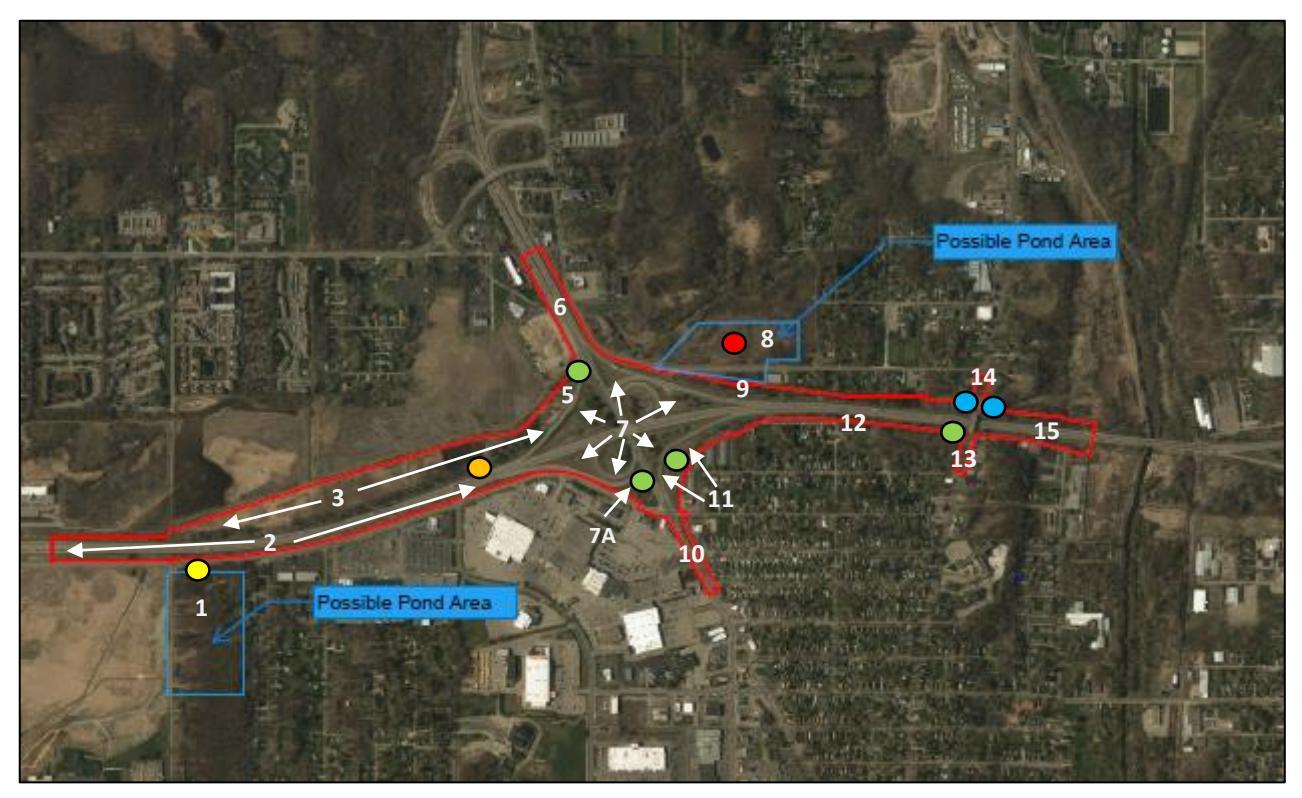
The survey area was generally weedy, and no listed species were observed. Several areas had one or more somewhat conservative prairie species; however, none of these are listed species and other more common and weedy species were interspersed and dominant (Figure 3).

Figure 3. West survey area for I-94 at US-127 showing numbered survey segments and points of interest. O Prairie plants O Japanese knotweed O Bohemian knotweed O Eurasian Phragmites

One occurrence of invasive Japanese knotweed (*Fallopia japonica*) was observed along the northern edge of the wooded portion of the potential pond at Maynard Rd. This appears to be a recent introduction as only a few small stems were observed. Two occurrences of what is likely Bohemian knotweed (*Fallopia x bohemica*) were observed at the northeast and northwest corner of the Lansing Avenue bridge (Area 14). The northeast occurrence is a large, well established colony, while the northwest occurrence is a much smaller outlier. An additional occurrence of Japanese knotweed was observed just north of the project area, on the east side of Elm Ave. across from Chanter Rd. One small occurrence of invasive phragmites (*Phragmites australis*) was observed at a culvert along I-94 along the Hurd-Marvin drain west of the US-127 interchange. One occurrence of wild parsnip was observed in the potential pond area north of Shirley Rd. (Area 8).These occurrences are shown in Figures 3 and 4.

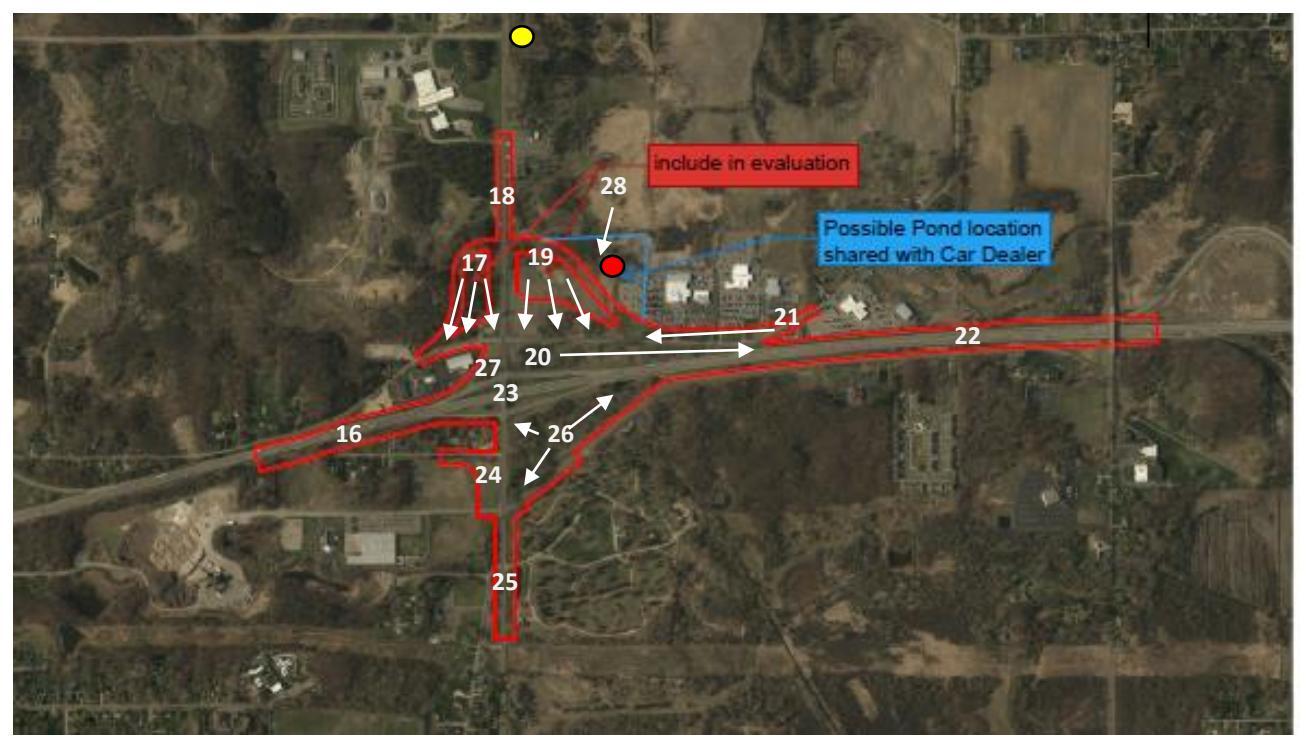
Figure 4. East survey area for I-94 at Elm Ave. showing numbered survey segments and points of interest. OJapanese knotweed • Wild parsnip

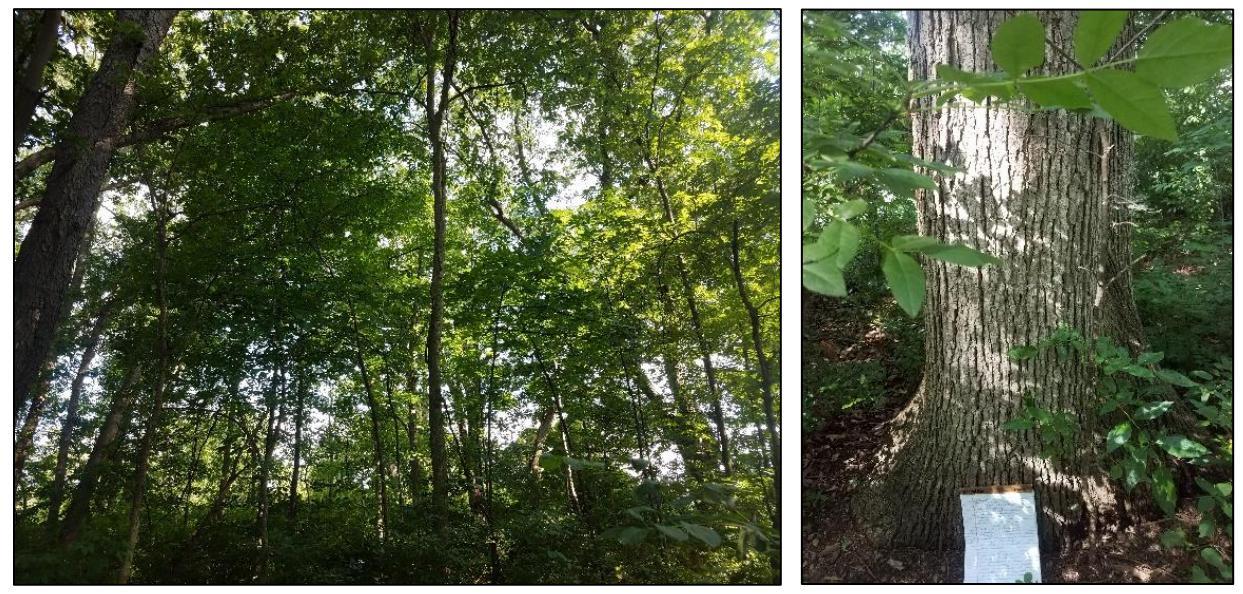
A small diverse forest pocket undergoing invasion occurs in the northern edge of the site Figure 5, 6). The overstory includes white oak (*Quercus alba*), pignut hickory (*Carya glabra*), swamp white oak (*Quercus bicolor*) and cottonwood (*Populus deltoides*). The understory is a mix of native and non-native species including American elm (*Ulmus americana*), bittersweet nightshade (*Solanum dulcamara*), black cherry (*Prunus serotina*), box elder (*Acer negundo*), Canadian fly-honeysuckle (*Lonicera canadensis*), common buckthorn (*Rhamnus cathartica*) gray dogwood (*Cornus foemina*), Eurasian honeysuckles, multiflora rose (*Rosa multiflora*), prickly ash (*Zanthoxylem americanum*), river-bank grape (*Vitis riparia*) and wild red raspberry (*Rubus strigosus*). The ground flora is also a mix of native and non-native species, including Canada thistle (*Cirsium arvense*), enchanter's-nightshade (*Circaea canadensis*), garlic mustard (*Alliaria petiolata*), Jack-in-the-pulpit (*Arisaema triphyllum*), jumpseed (*Persicaria virginiana*), mayapple (*Podophyllum pedatum*), starry false Soloman-seal (*Maianthemum stellatum*), reed canary grass (*Phalaris arundinacea*), tall fescue (*Lolium arundinaceum*) and white avens (*Geum canadense*). Scattered stems of Japanese knotweed (*Fallopia japonica*) were observed along

Figure 5. Forest pocket at Maynard and Boardman Roads, with a large white oak.

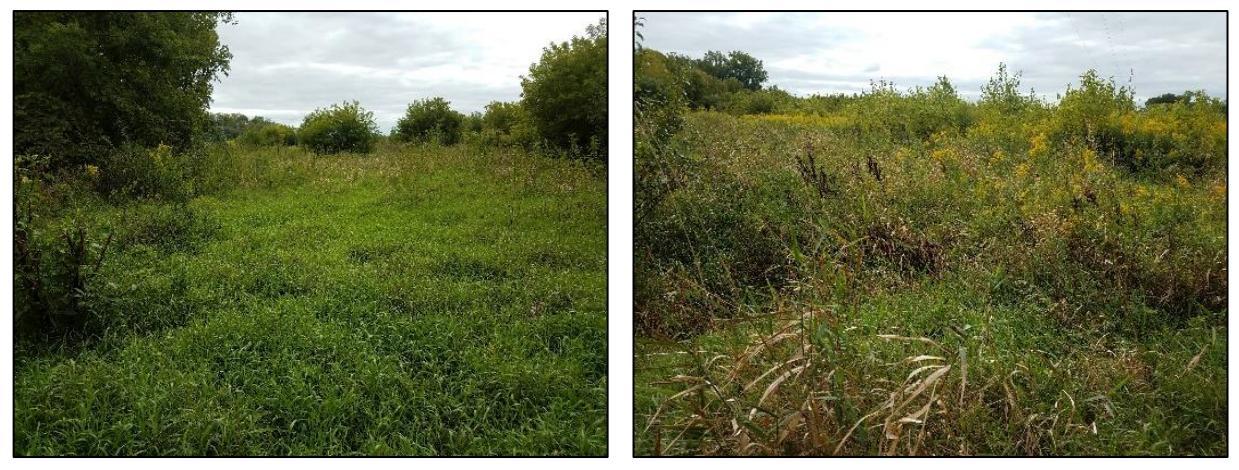
This area is dominated by reed canary grass monocultures interspersed with weedy old field species including brome grass, fescues, orchard grass, timothy, cow vetch (*Vicia villosa*); oxeye daisy, sweet clovers, tall goldenrod and Canada goldenrod (*Solidago canadensis*). Several areas are dominated by narrow-leaved cat-tail and there some large patches of Canada thistle. This zone is bordered on the south by a ditch with a line of trees and shrubs dominated by box elder, cottonwood, green ash, common buckthorn, Eurasian honeysuckles, river-bank grape (*Vitis riparia*), Virginia creeper (*Parthenocissus quinquefolia*) and willows (*Salix* spp).

Figure 8. Reed canary grass dominates Area 3.

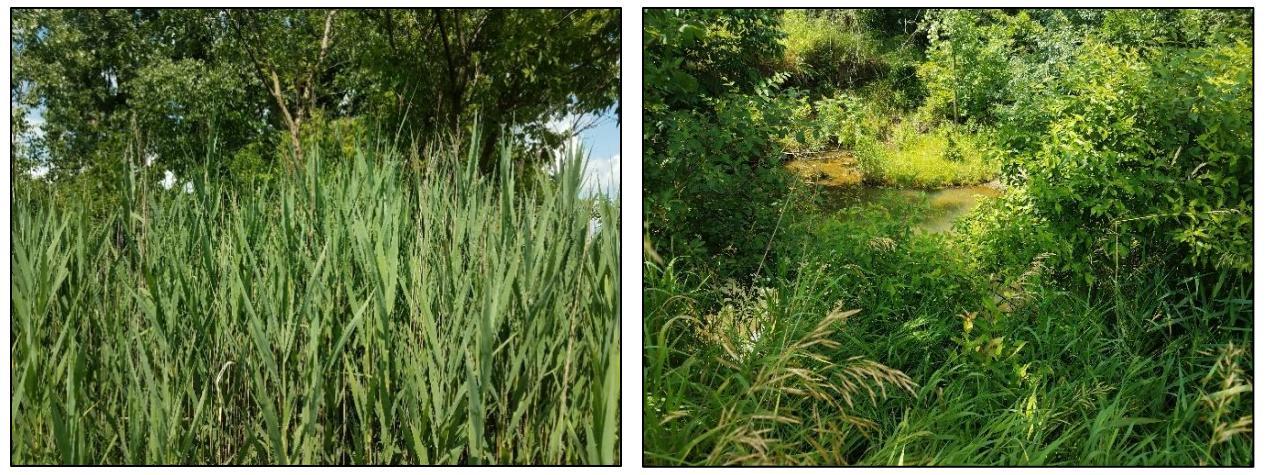
One patch of Eurasian phragmites (*Phragmites australis* subsp *australis*) was observed at a culvert across from Exit 138 (Figure 3, 9). This area is a small pocket of mesic hardwoods with a canopy of sugar maple (*Acer saccharum*), red oak (*Quercus rubra*), and box elder, with forbs such as garlic mustard, enchanter's nightshade (*Circaea canadensis*) and white avens.

Figure 9. Patch of Eurasian phragmites observed in culvert area.

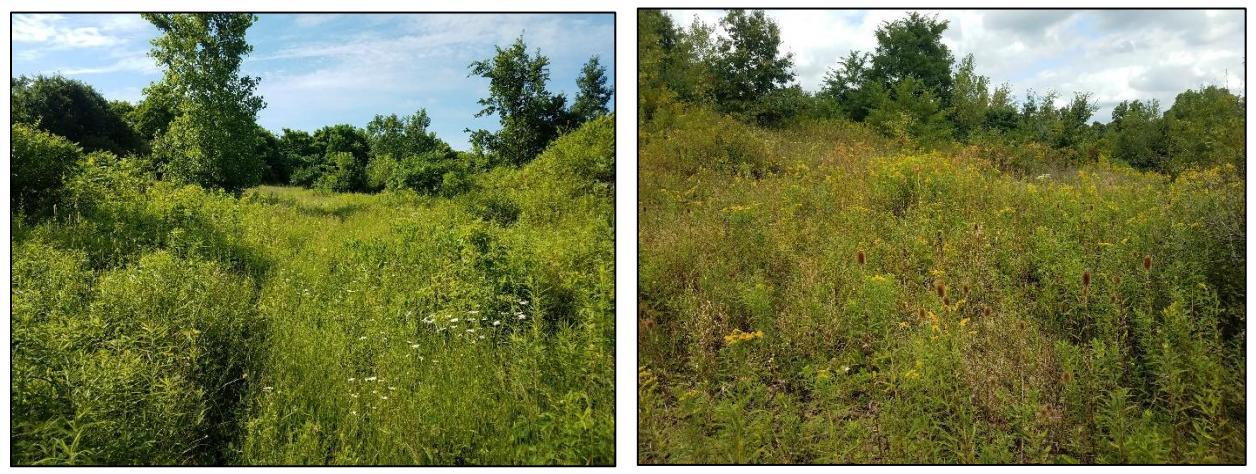
occupying higher elevations (Figure 14), and mats of reed-canary grass dominating the lower ground (Figure 15). Stiff goldenrod was observed in several upland openings (cover photo). Garlic mustard and dame's rocket are well established in the understory of the wooded areas.

Figure 14. Old field openings north of Shirley Rd. in potential pond area.

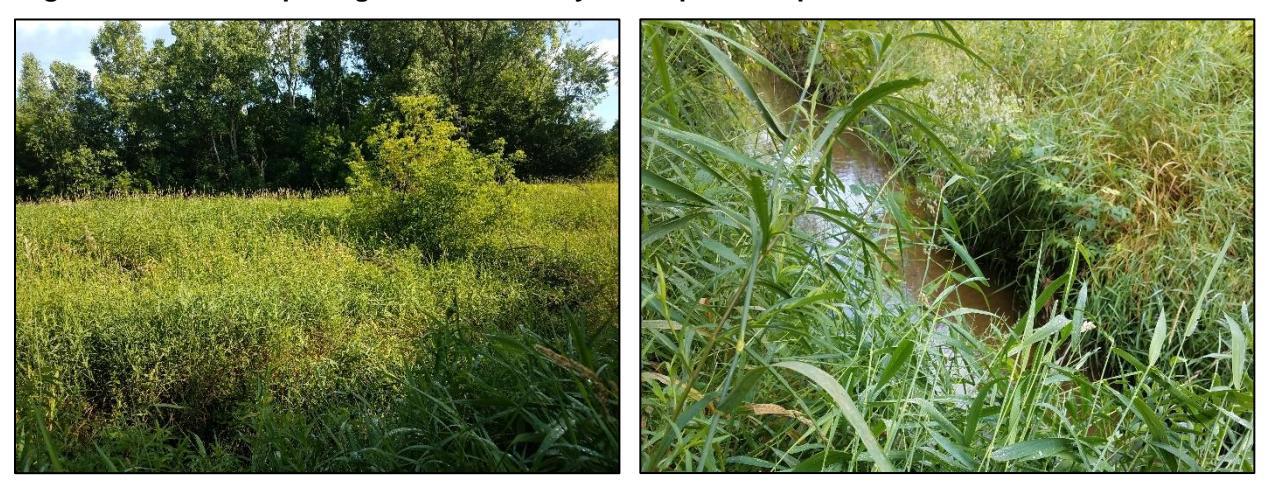
Figure 15. Reed canary grass infestation along ditch.

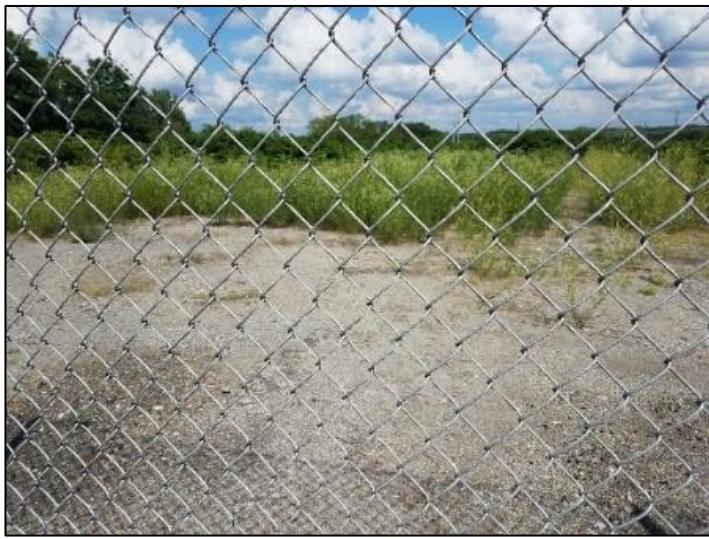
This area is developed and lacks suitable habitat for target species. However, a large, wellestablished colony of knotweed (*Fallopia* sp.) occurs north of a cleared and fenced area on the east side of Elm Ave. (Figure 3) and a smaller outlier patch occurs on the west side of Elm Ave. This appears to be Bohemian knotweed (*Fallopia* x *bohemica*) due to the presence of both flat and lobed leaf bases (Figure 29). This infestation may lie just outside of the right-of-way; however, it will be problematic if not treated.

Figure 28. Looking east from Lansing Ave. north of I-94 with Bohemian knotweed in the background.

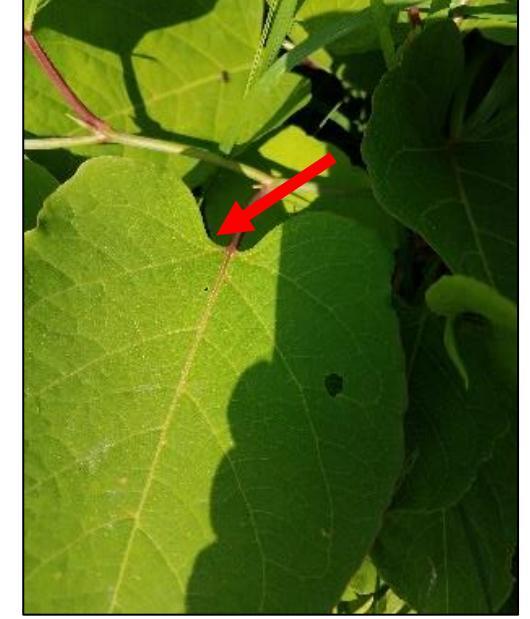
Figure 29. Likely Bohemian knotweed a leaf with a lobed base.

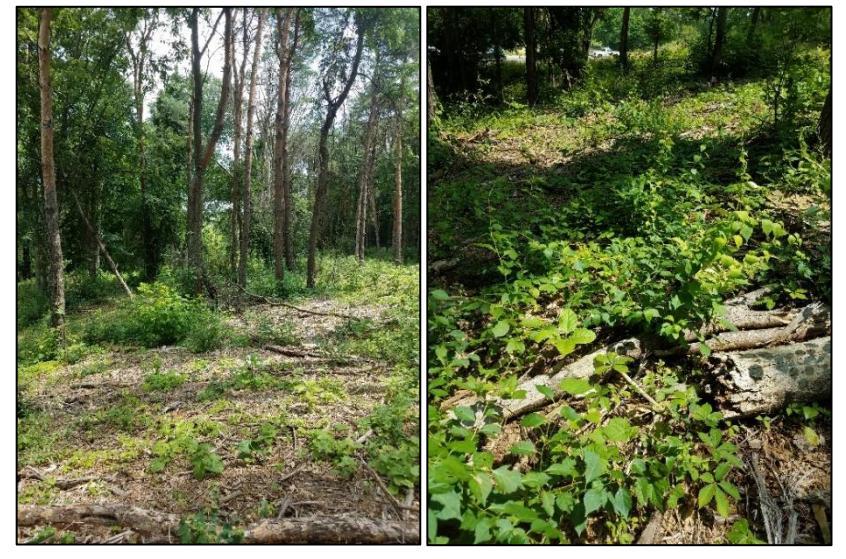
This is a forested area with a canopy of black oak, cottonwood and trembling aspen (*Populus tremuloides*) and an understory of American elm, box elder, river-bank grape and Virginia creeper. It is heavily invaded by autumn olive, black locust, common buckthorn, Eurasian honeysuckles, glossy buckthorn, multiflora rose, Oriental bittersweet (*Celastrus orientalis*), Scotch pine (*Pinus Sylvestris*), and garlic mustard.

Figure 32. Invaded woodland north of Rose Hill Rd.

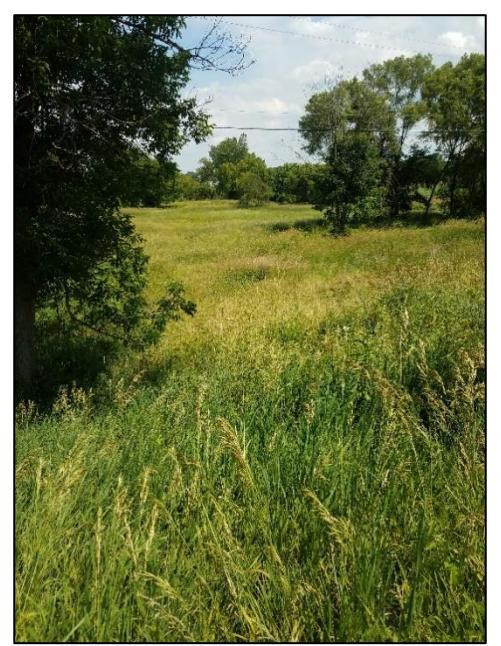
Most of this area is saturated and dominated by reed canary grass. It is bounded by a wet ditch and wooded edge to the south. Weedy forbs and grasses such as Canada thistle, tall goldenrod, Indian hemp, fescues and quack grass also occur in dense patches. Other forbs include blue vervain (*Verbena hastata*), common evening primrose, common milkweed, pokeweed, tall goldenrod, willow-herb (*Epilobium* sp.), and wild parsnip (*Pastinaca sativa*) (Figure 4) were also observed. Sap from the parsnip can cause skin burns when exposed to light.

Figure 48. Potential pond north of Seymour Ave. looking east from Elm Ave.

The project area is highly disturbed and dominated by non-native species, and no listed species were documented during surveys. While a few pockets with prairie species were documented, these do not offer substantial opportunity for restoration due to their small size and fragmented, invaded status. Several invasive species of concern were documented including Japanese knotweed, Bohemian knotweed and Eurasian phragmites (Areas 1, 14 and 3 respectively). These species are rare in the project area, which is unusual for this part of the state, and early treatment is recommended to minimize their spread and the cost of control. They have the potential for degrading road work and pose a long-term threat to the corridor. An occurrence of wild parsnip was documented in the potential pond area east of Elm St. (Area 28). This species typically lies under the radar but is starting to spread rapidly along corridors and is increasingly recognized as a human health risk. Treatment of this species is also recommended.
