Rare Plant Species Surveys for the Michigan Department of Transportation: US-12 from Bertrand/Galien township line to M-139 MDOT project No. 127449

MNFI Report No. 2021-17

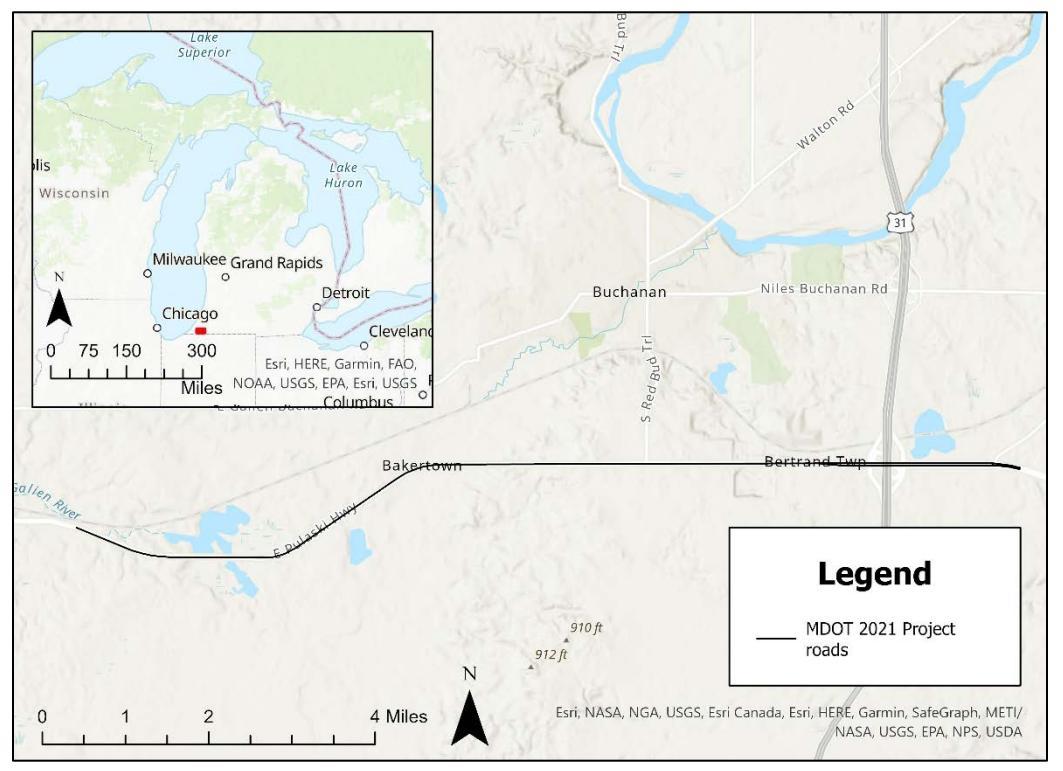
Figure 1: Overview map of MDOT project area 127449. The project area is located in Southwest Michigan in Berrien County on US-12 from M-139 westward to the Bertrand-Galien Township line (red rectangle in insert map). The roads impacted by this MDOT project are shown as black lines in the larger map.

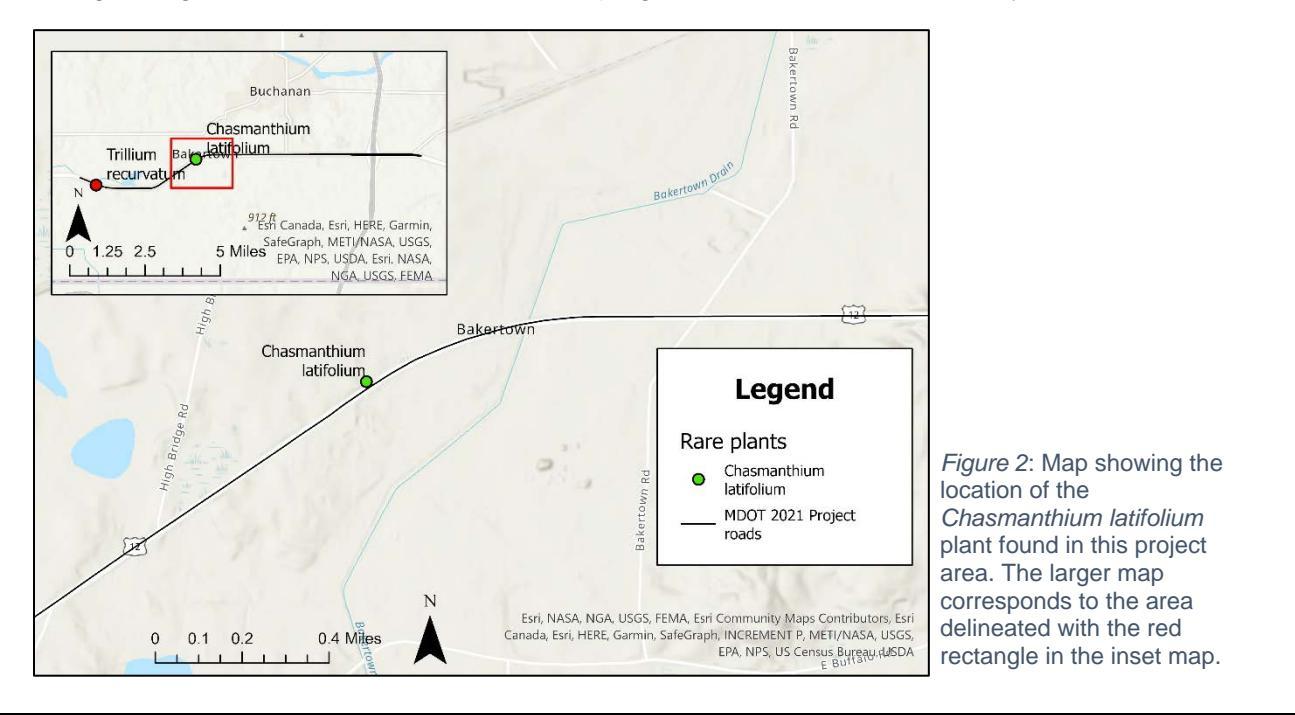
The *Chasmanthium latifolium* plant was found along the north side of US-12 roughly 630 meters west of the culvert at the Bakertown Drain (Figure 2; Table 4). It was found within 2 meters of the pavement, at the margin between the mowed and unmowed parts of the ROW. The plant was growing at the base of a small bank sloping down to US-12 in the front yard of a residence.

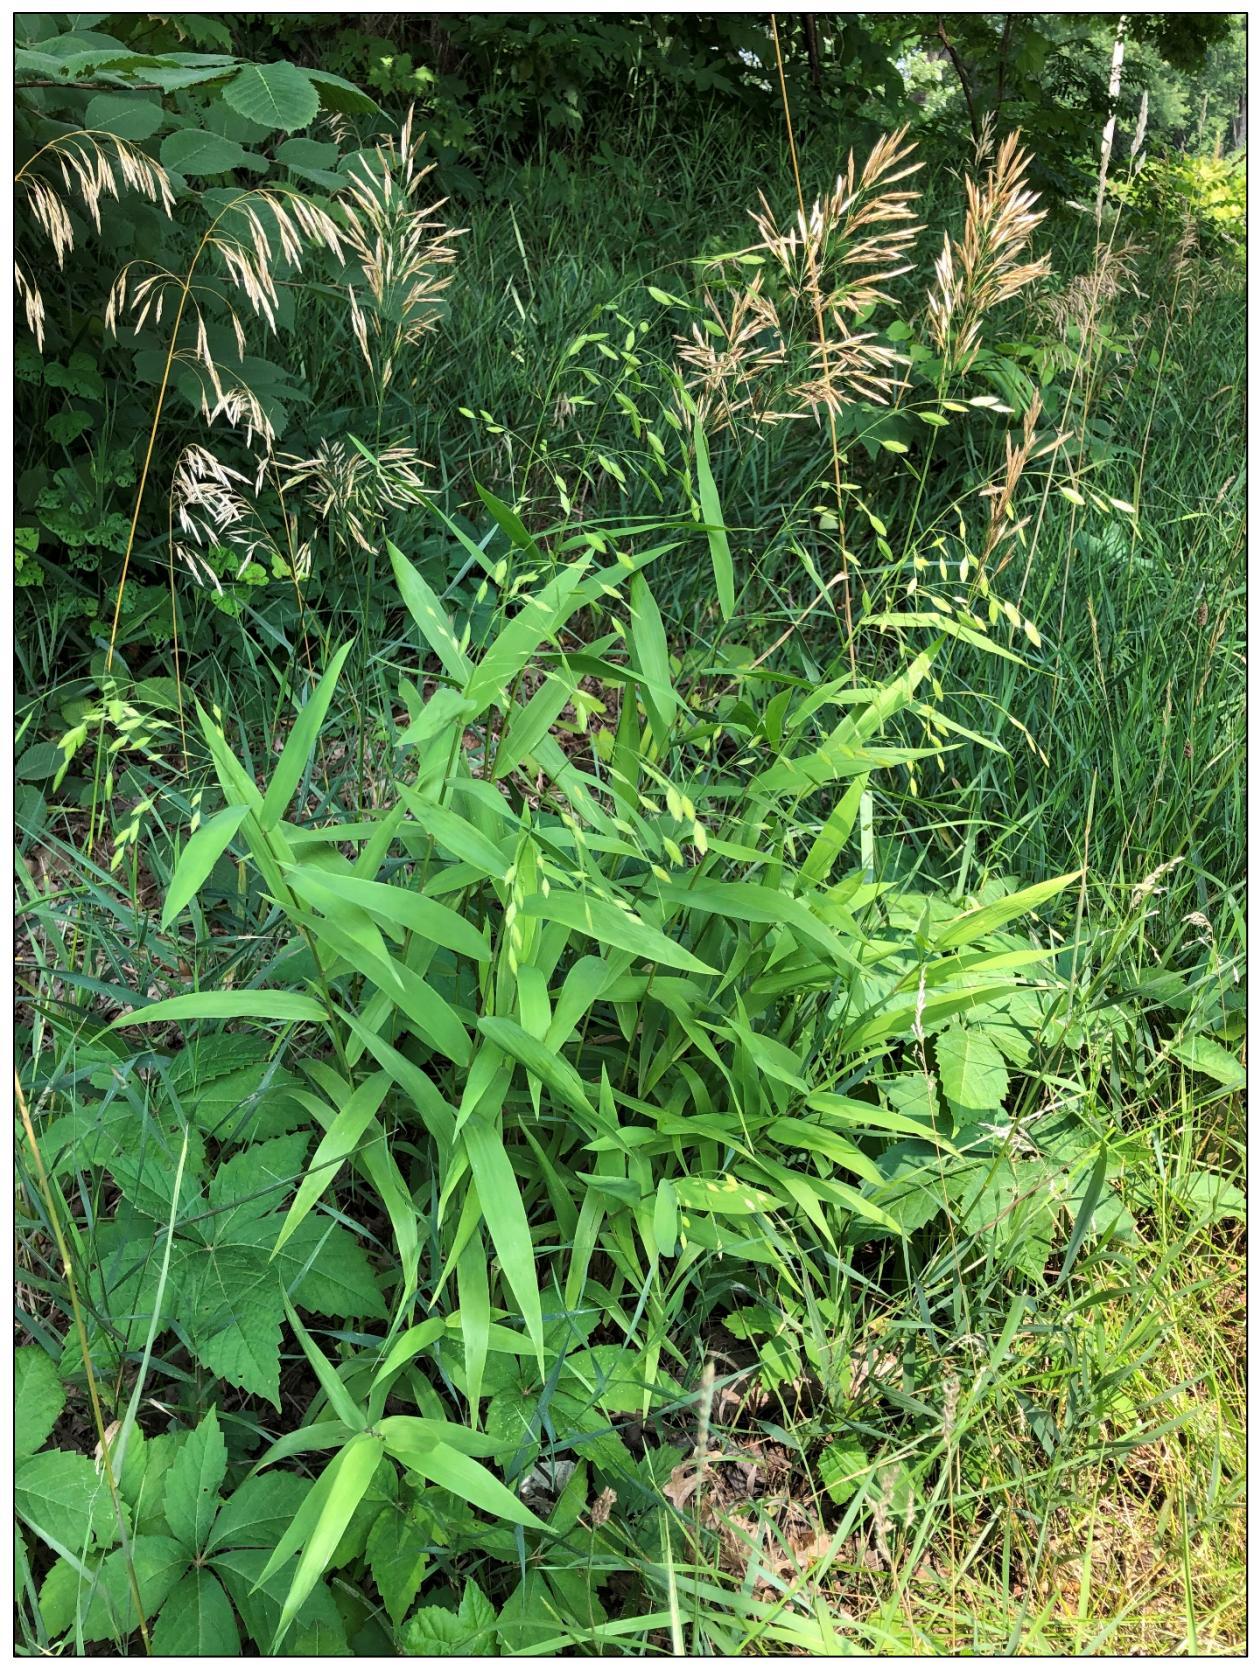
The habitat surrounding the occurrence of *Chasmanthium latifolium* found in this MDOT project area is a degraded roadside. A sparse tree canopy is present and consists of *Acer saccharum* (sugar maple), *Juglans nigra* (black walnut), and *Ulmus americana* (American elm; Figure 3). The vines *Parthenocissus quinquefolia* (Virginia creeper; Figure 3) and *Vitis riparia* (riverbank grape) were also present nearby. The invasive grass *Bromus inermis* (smooth brome; Figure 3) was found growing directly adjacent to the Endangered grass.

Figure 3: Habitat and associated plant species for the *Chamanthium latifolium* observation. *Bromus inermis* (smooth brome), *Parthenocissus quinquefolia* (Virginia creeper), and *Ulmus americana* (American elm) can be seen in this photo growing adjacent to the *Chasmanthium latifolium*.

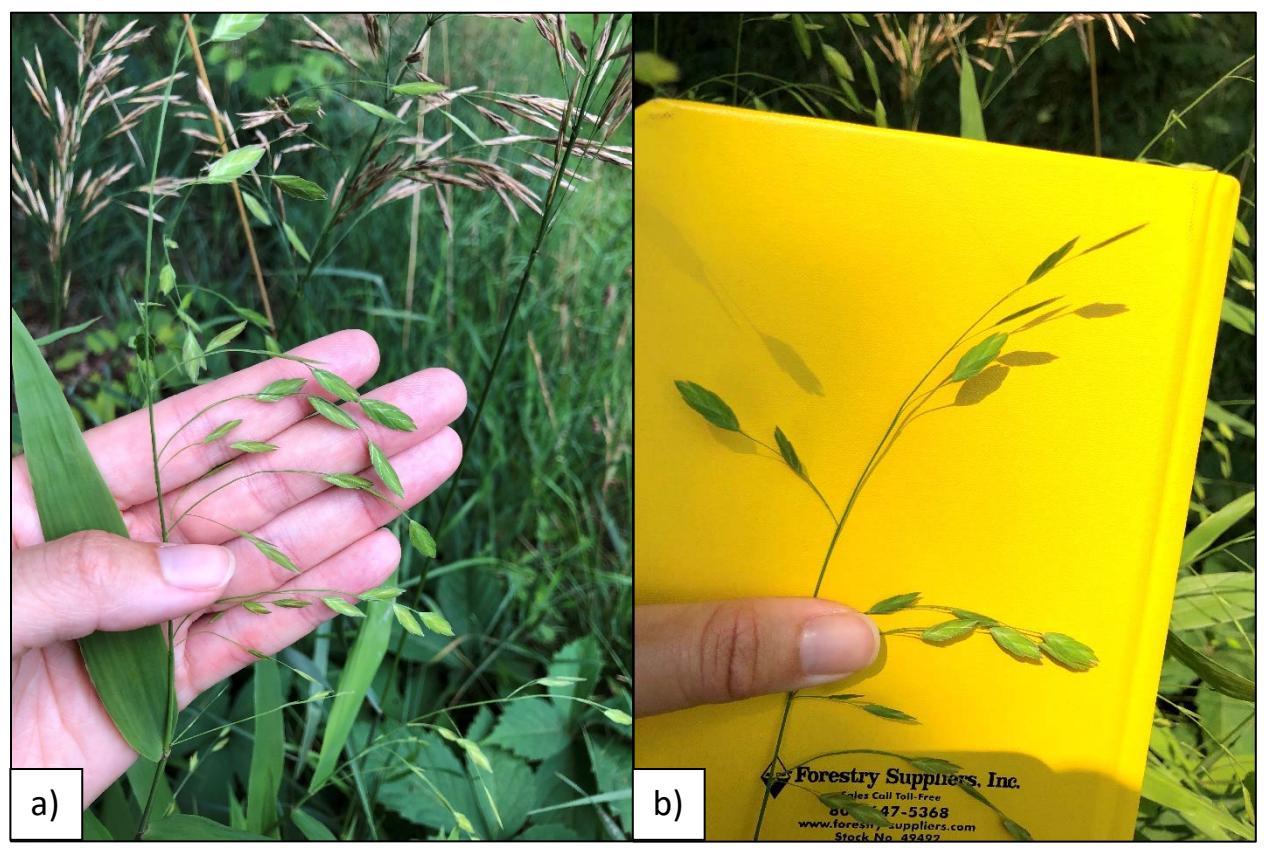
A single clump of this species, most likely representing one individual, was found. Because only one clump was found, this population is highly imperiled and vulnerable to disturbance. Despite the perilous existence of this plant, it seemed healthy and was producing robust foliage and ample fruits (Figure 4).

Figure 4: Chasmanthium latifolium (wild oats) voucher photos. a) Fruiting culm showing one of the broad leaves. b) Spikelets with developing fruits.

The quantity and location of this population of *Chasmanthium latifolium* make it very vulnerable. Paved shoulders in this project area are slated to be expanded, and this expansion could destroy the single wild oats plant since it is located so close to the existing shoulder. Even if the shoulder expansion does not destroy the plant, expanded mowing margins could negatively affect its growth. If it is decided that this plant should be protected, it is recommended that the plant be moved further away from the road margin to protect it from potential harm from mowing or road shoulder expansion. Invasive grasses, such as *Bromus inermis* (smooth brome) are growing directly next to the *Chasmanthium latifolium* (Figure 3). The *Chasmanthium latifolium* plant would benefit from the removal of these invasive grasses.

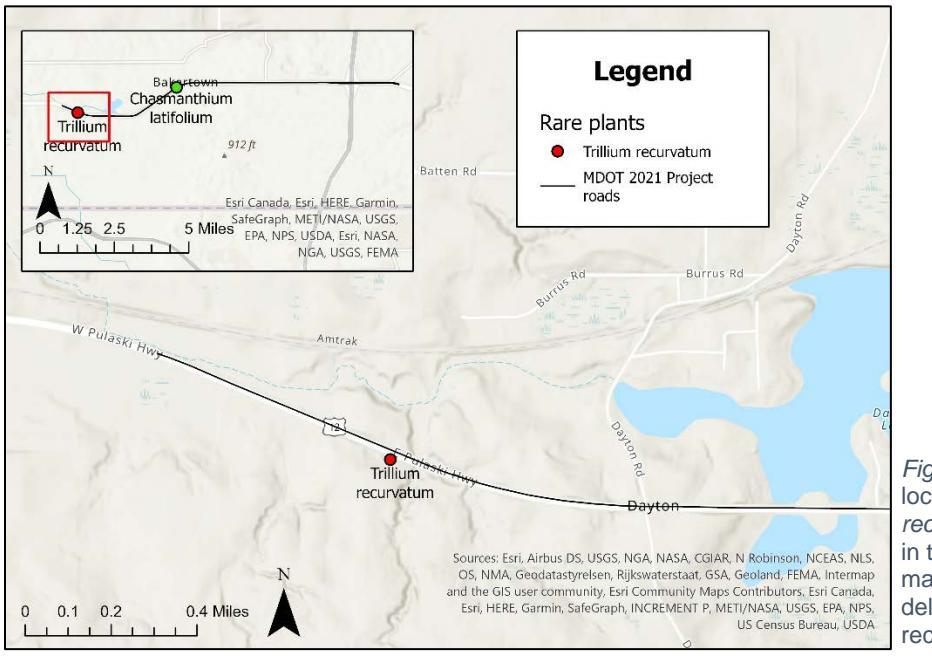
The population of the State Threatened *Trillium recurvatum* found in this MDOT project area is located on the south side of US-12 roughly 950 meters east of the west terminus of the project boundary, and to the west of Dayton Road (Figure 5, Table 5). This population was found at the boundary of the mowed ROW and a high-quality mesic southern forest, and less than 40 meters to the east of a residential yard. An historical observation from 1939 of this species was located "11 miles west of Niles on US-12" in a rich forest. The habitat type and general location of the current *Trillium recurvatum* observation match this historical observation, and therefore this population may be the same population of this species as was observed in 1939. Furthermore, aerial imagery taken in 1938 suggests that the location where the current *Trillium recurvatum* occurrence was found was forested at that time⁴, indicating temporal continuity of supportive habitat.

Figure 5: Map showing the location of the *Trillium recurvatum* population found in this project area. The larger map corresponds to the area delineated with the red rectangle in the inset map.

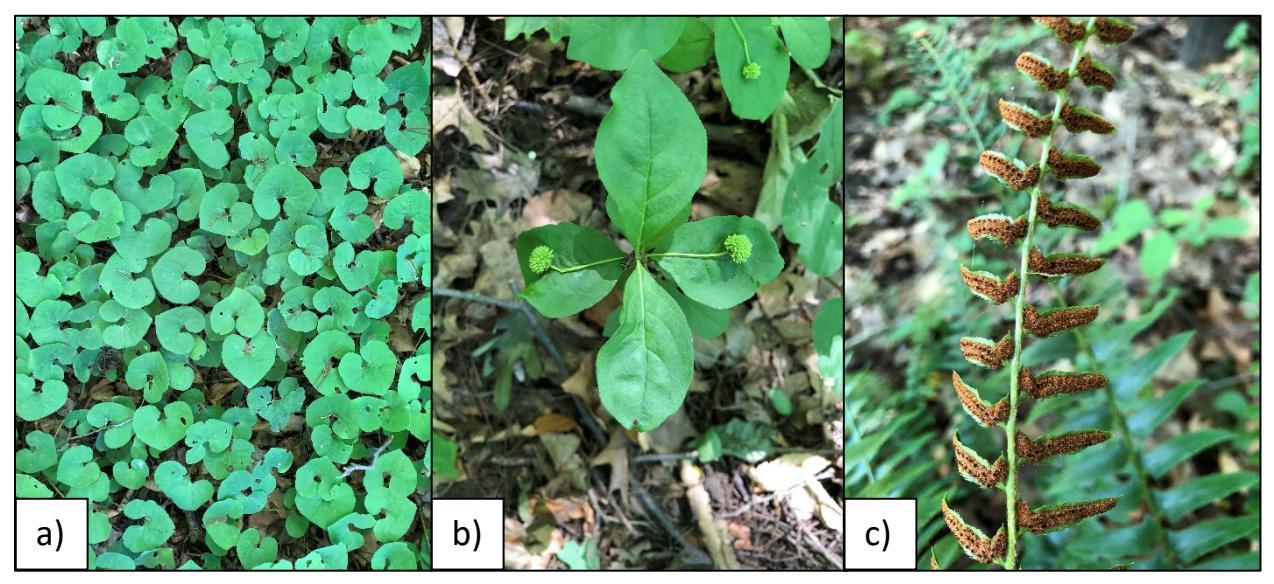
The mesic southern forest in this area has a canopy consisting of *Acer saccharum* (sugar maple), *Fagus grandifolia* (American beech), *Quercus rubra* (red oak), and *Tilia americana* (basswood). The subcanopy consists of *Acer saccharum* seedlings/saplings (sugar maple), *Asimina triloba* (paw paw), *Carpinus caroliniana* (musclewood), *Fraxinus* spp. seedlings/saplings (ash), *Hamamelis virginiana* (witch-hazel), *Lindera benzoin* (spicebush), and *Ostrya virginiana* (hop-hornbeam). The groundcover layer in this forest contains *Asarum canadense* (wild-ginger; Figure 6a), *Epifagus virginiana* (beech-drops), *Euonymus obovatus* (creeping strawberry-bush; Figure 6b), *Geranium maculatum* (wild geranium), *Hepatica acutiloba* (sharp-lobed Hepatica), *Impatiens* sp. (touch-me-not), *Polystichum acrostichoides* (Christmas fern; Figure 6c), and *Trillium grandiflorum* (common Trillium).

Figure 6: Groundcover flora in the mesic southern forest near where the *Trillium recurvatum* plants were found. a) *Asarum canadense* (wild-ginger), b) *Euonymus obovatus* (creeping strawberry-bush), c) *Polystichum acrostichoides* (Christmas fern).

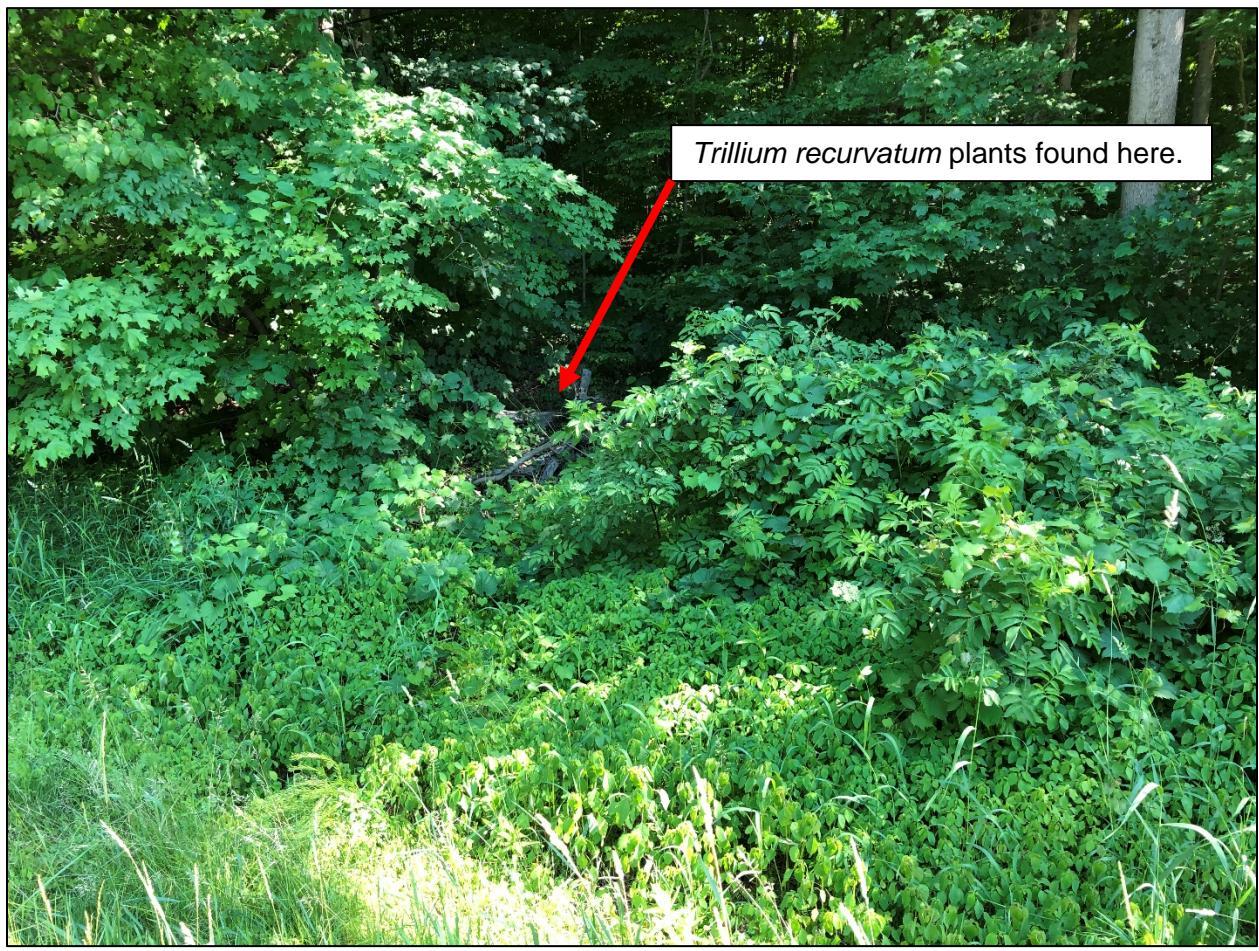
The immediate area where the *Trillium recurvatum* plants were found is a disturbed woodland boundary (Figure 7). No rare *Trillium* plants were found further away from the road and into the forest. A fallen tree had made a small opening in the forest-edge vegetation, and the *Trillium* plants were growing in this small opening. Nearby vegetation includes: *Acer saccharum* saplings (sugar maple), *Euonymus obovatus* (creeping strawberry-bush), *Impatiens* sp. (touch-me-not), *Sambucus racemosa* (red elderberry), and *Vitis riparia* (riverbank grape).

Figure 7: Forest edge habitat where the *Trillium recurvatum* plants were found. Species visible in this photo include: *Acer saccharum* (sugar maple), *Impatiens* sp. (touch-me-not), *Sambucus racemosa* (red elderberry), and *Vitis riparia* (riverbank grape).

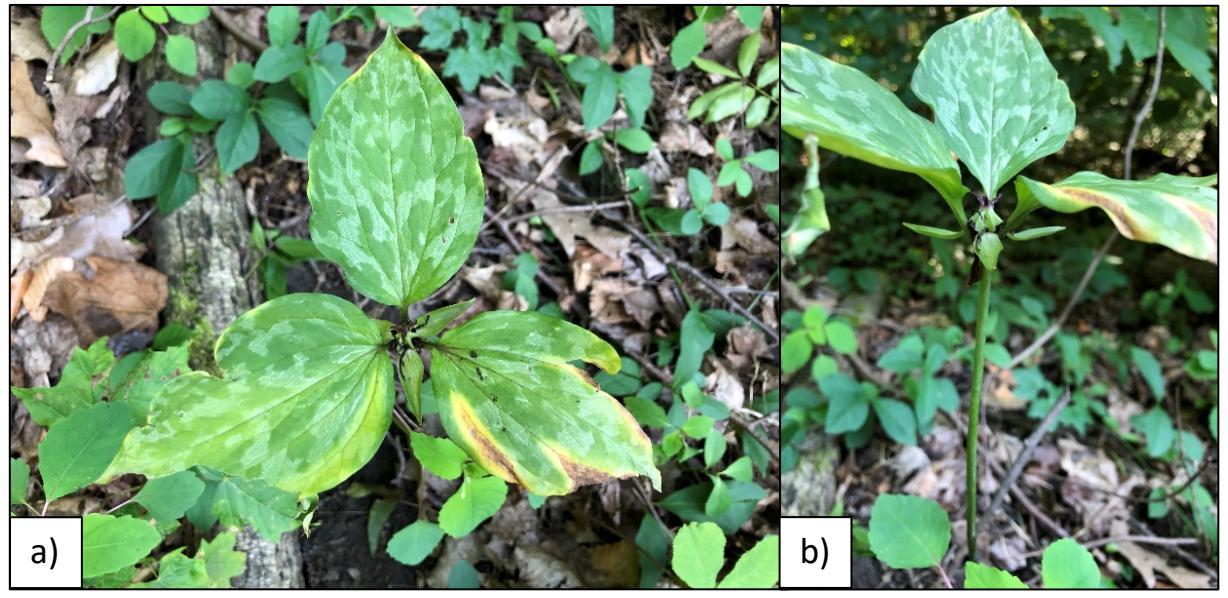
Figure 8: Trillium recurvatum (prairie Trillium) voucher photos. a) Top view of a senescing stem, b) side view of the same stem, showing a developing fruit.

Despite a thorough search in nearby habitat, only two stems of *Trillium recurvatum* were found at this location. Both stems were senescing (Figure 8a), as the timing of the first survey to this project area was toward the end of the species' growing cycle. Although this population consists of very few stems, both were fruiting (Figure 8b), which indicates the population is still able to reproduce.

This population of *Trillium recurvatum* is vulnerable, as it only consists of two stems. When working to expand the road shoulder, care must be taken to avoid harming the population (Figure 9). This means avoiding clearing the canopy near this population, as clearing causes disturbance which could encourage the nearby *Alliaria petiolata* (garlic-mustard) to spread. Also, evidence of deer browse was observed nearby in the mesic southern forest, and deer herbivory is a serious threat to *Trillium* species.

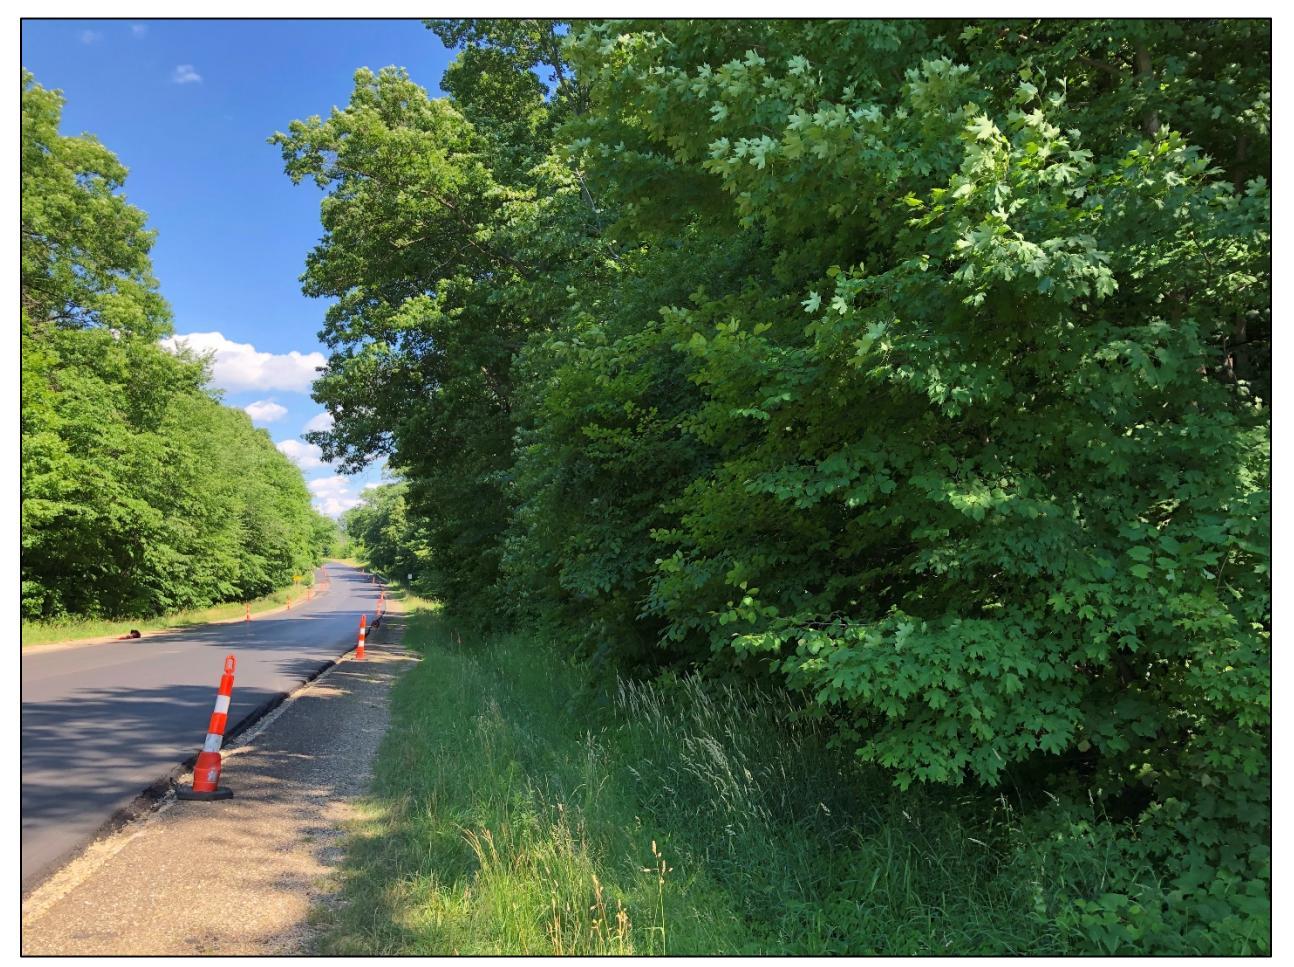
Figure 9: Roadside adjacent to forest boundary where the Trillium recurvatum plants were found.

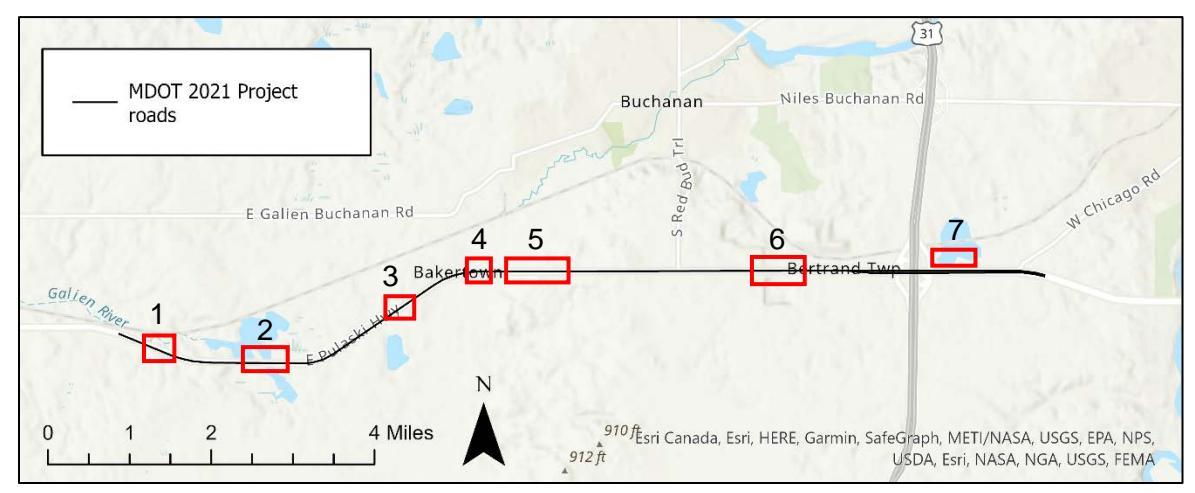
Figure 10: Map of the project area showing the locations of important survey sections.

Suitable habitat for rare plant species was found in four survey sections: sections one, two, three, and five (Figure 10). Section one contains a high-quality mesic southern forest on both sides of US-12, with mature canopy trees and a relatively intact groundcover layer. A population of the State Threatened *Trillium recurvatum* was located here. Section two encompasses the ROW adjacent to Dayton Lake, including a medium-quality submerged/emergent marsh. Section three contains two notable wetlands: a high-quality inundated shrub swamp and a medium-quality southern wet meadow. Lastly, section five contains a medium-quality mesic southern forest on both sides of US-12. This forest, although degraded in some areas, contains large canopy trees and an intact groundcover layer in some areas.

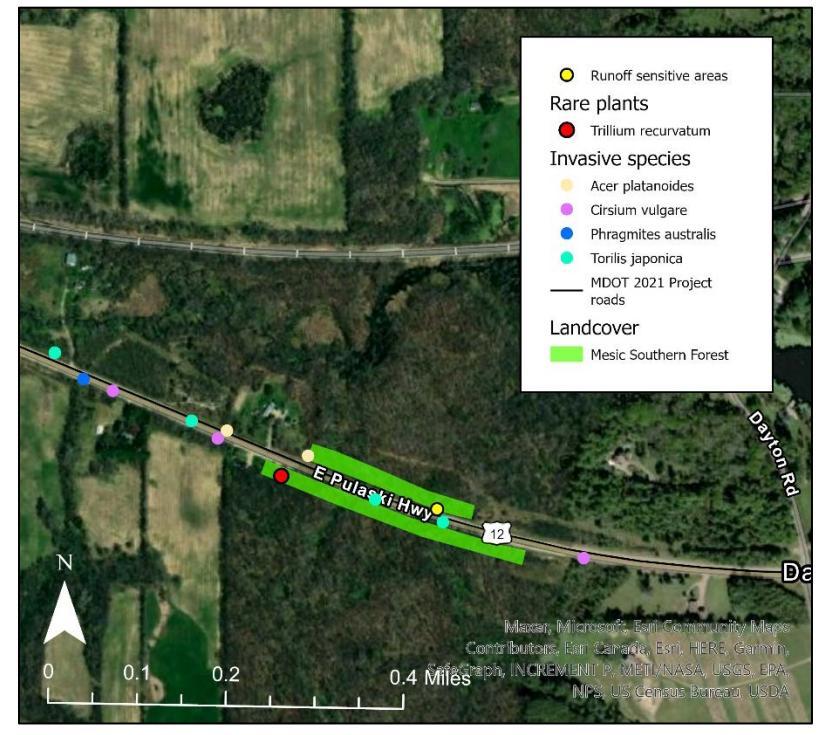
Figure 11: Map of survey section one, including a location that is sensitive to runoff, a location where a rare plant species was found, locations of non-native invasive plant species occurrences collected with the MISIN app, and the extent of high-quality habitat within the ROW.

The mesic southern forest on the north side of US-12, across from the forest where the *Trillium recurvatum* was found, is also of high quality and could potentially host rare plant species, although none were found during the surveys. The canopy and understory are of similar composition to the forest on the south side of the road, with the exception of the area adjacent to a small stream paralleling US-12 and flowing northward into the Galien River. This area is sensitive to runoff and should be protected from sediment input during construction activities.

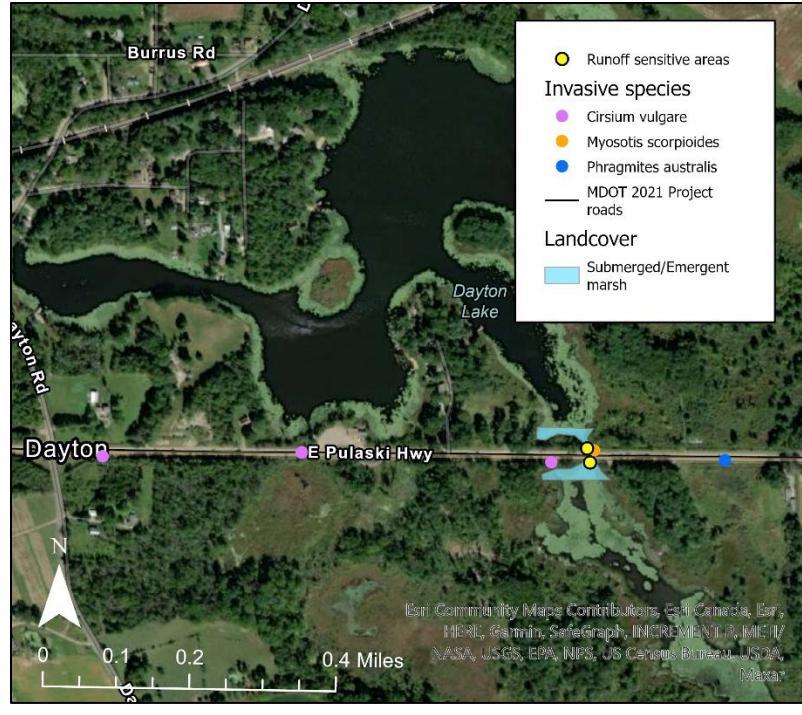
Figure 12: Map of survey section two, including locations that are sensitive to runoff, locations of non-native invasive plant species occurrences collected with the MISIN app, and the extent of medium-quality habitat within the ROW.

of this project area. Concerningly, there is a patch of invasive *Phragmites australis* (reed; Figure 12, blue dot) in one of the wetland habitats in this section. Because there is ample suitable habitat for this invasive species near Dayton Lake, it is recommended that this population of invasive reed be treated to prevent it from spreading. Finally, a small patch of *Myosotis scorpioides* (forget-me-not; Figure 12, orange dot) was located in the emergent marsh habitat on the north side of US-12. This species is an aggressive invader of wetland habitats; therefore, this small patch should be removed before it becomes a larger infestation.

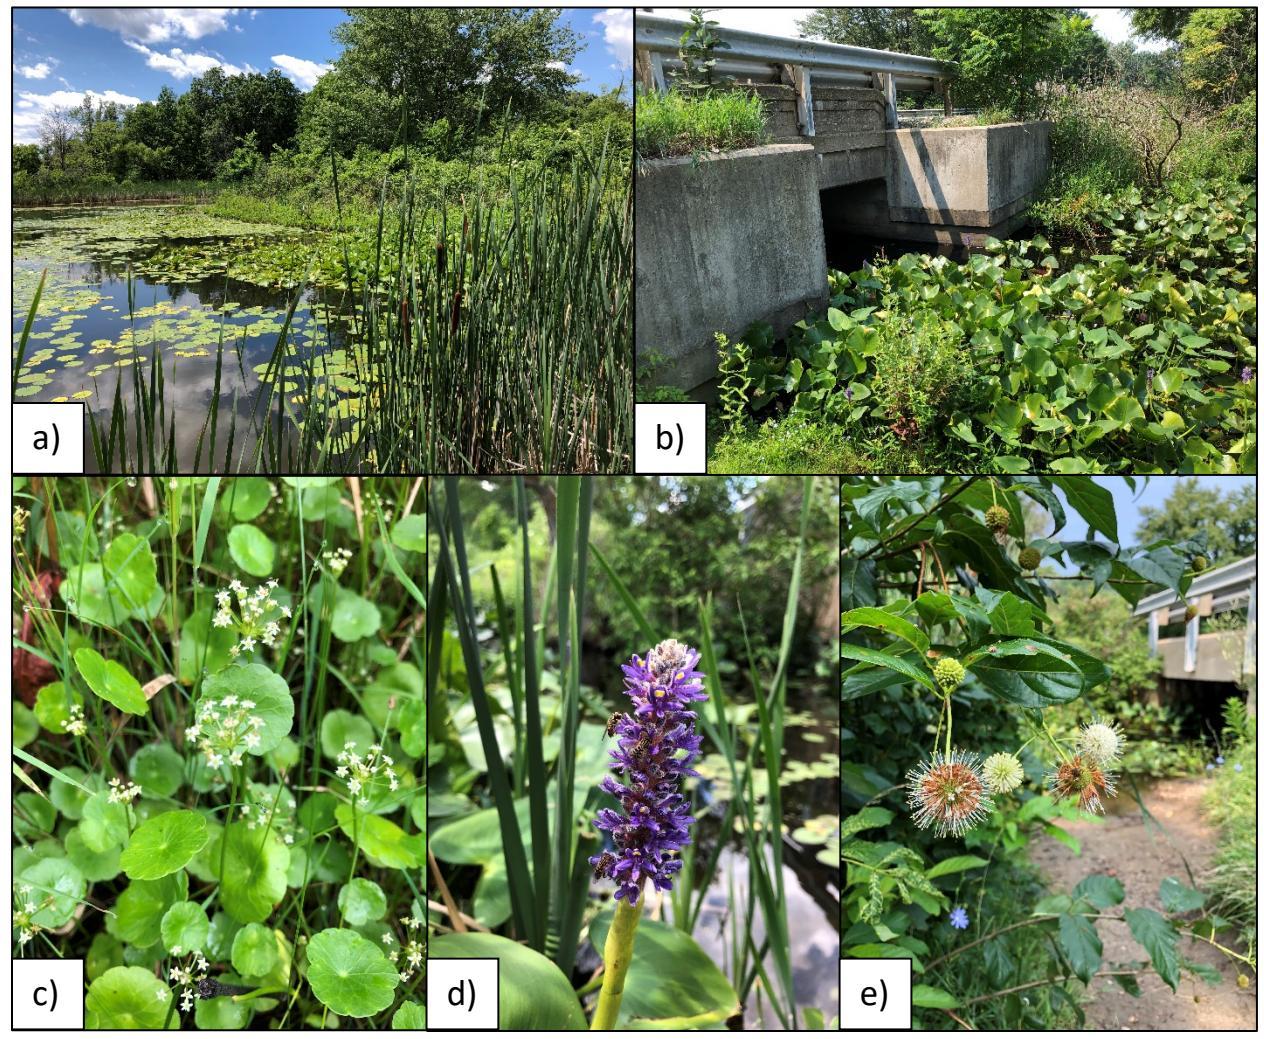
Figure 13: Habitat and vegetation near the US-12 bridge over Dayton Lake. Submerged and emergent marsh natural communities exist on both the a) south side of US-12, and b) the north side of US-12. Plant species in these communities include c) *Hydrocotyle umbellata* (marsh-pennywort), d) *Pontederia cordata* (pickerel-weed), and e) *Cephalanthus occidentalis* (button bush).

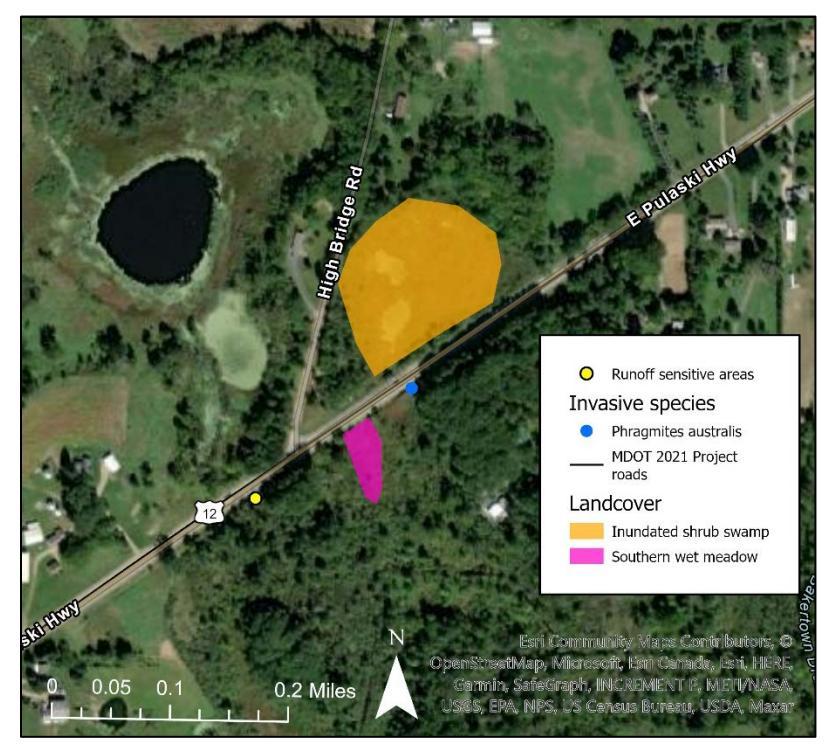
Figure 14: Map of survey section three, including a location that is sensitive to runoff, a location of a non-native invasive plant species occurrence collected with the MISIN app, and the extent of high and medium-quality habitat within the ROW.

Road (Figure 14). These wetlands are between 650 and 700 meters away from the Bakertown Drain, which connects to outstanding natural communities, so the likelihood of finding rare plants in these wetlands was high. Foot surveys during the first visit to this project area covered most of the southern wet meadow and some parts of the inundated shrub swamp which were outside of the ROW. Foot surveys during the second and third visits to this project area only surveyed area which was within the ROW. Despite search effort, no rare species were found in either of these wetlands; however, these two wetlands are of high enough quality to potentially host rare species.

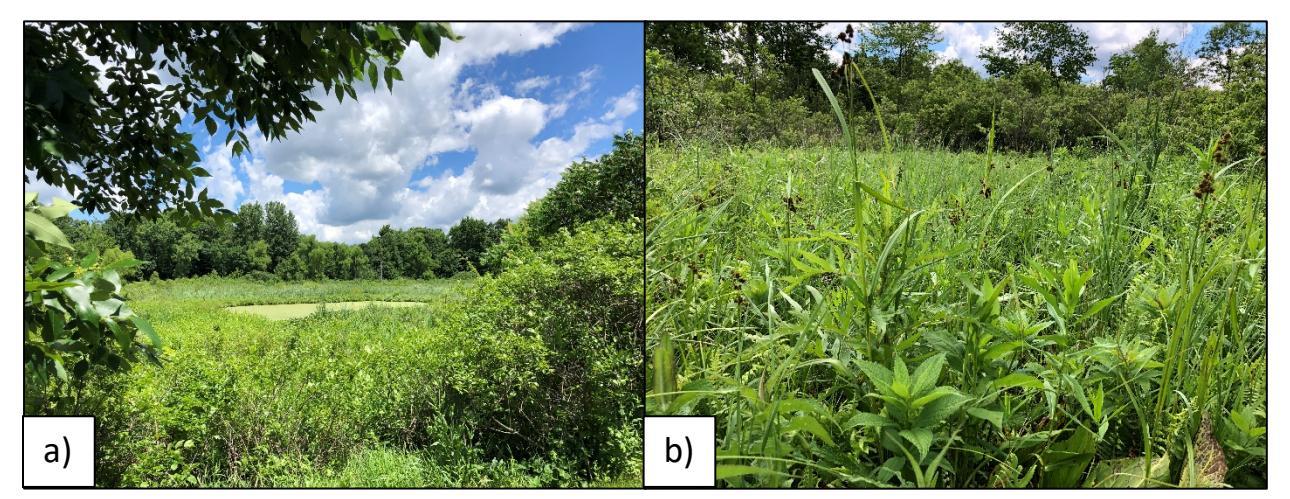
The inundated shrub swamp (Figure 14, orange polygon; Figure 15a) consists of a shallow moat along US-12 which separates a vegetated floating mat with an area of open water in the center from the firm ground in the ROW. The terrain quickly slopes downward from the edge of the pavement toward the wetland. Plant species in the ROW consist of a mixture of weedy upland

Figure 15: Overview photos of wetlands near High Bridge Road. a) Inundated shrub swamp with open water in the center, b) Southern wet meadow.

The southern wet meadow habitat on the south side of US-12 (Figure 14, pink polygon; Figure 15b) is degraded within the ROW and is of higher quality further away from the road. This pattern of degradation indicates that roadside disturbances are detrimental to the health of this wetland. Within the ROW, the habitat contains dense *Phalaris arundinacea* (reed-canary grass) and *Typha* x glauca (hybrid cattail). Further away from the road, the habitat begins to grade into a higher-quality southern wet meadow. Native species in the wet meadow habitat include: *Asclepias incarnata* (swamp milkweed; Figure 16d), *Calamagrostis canadensis* (Canada bluejoint), *Campanula aparinoides* (marsh bellflower), *Carex pellita* (woolly sedge), *Cirsium muticum* (swamp thistle), *Cornus foemina* (gray dogwood; Figure 16e) along the margins, *Eupatorium perfoliatum* (boneset), *Eutrochium maulatum* (Joe-Pye weed), *Iris virginica* (southern blue flag), *Lysimachia terrestris* (swamp-candles), *Onoclea sensibilis* (sensitive fern), *Schoenoplectus tabernaemontani* (softstem bulrush), *Scirpus atrovirens* (bulrush), *Symplocarpus foetidus* (skunk-cabbage), and *Thelypteris palustris* (marsh fern).

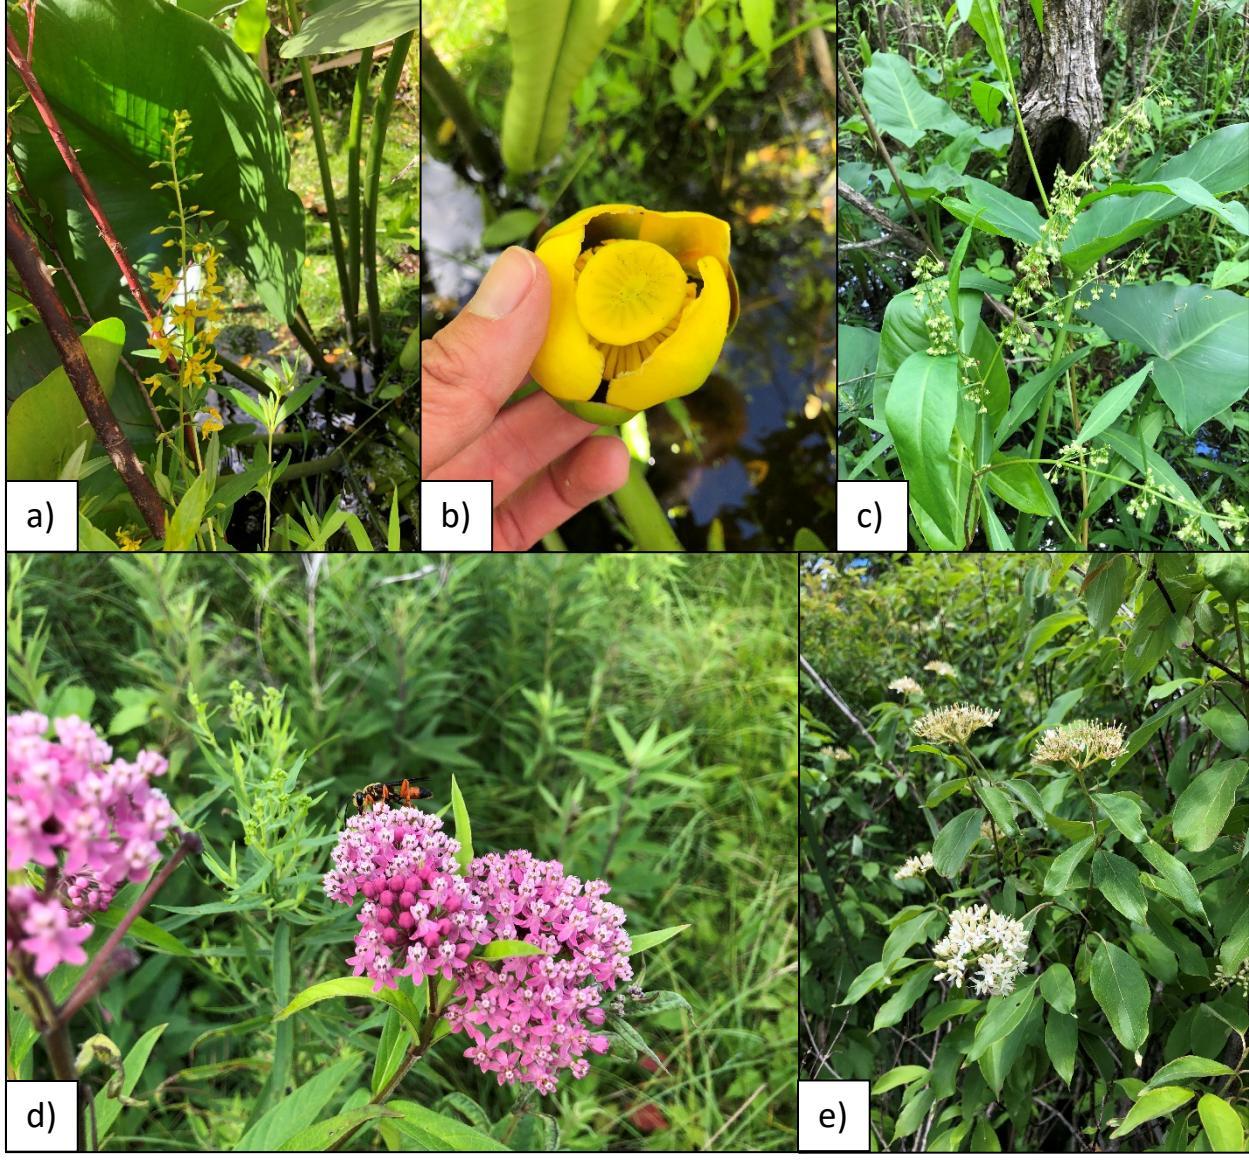
Figure 16: Plant species found in the inundated shrub swamp (a-c) and southern wet meadow (d-e) near High Bridge Road. a) *Lysimachia terrestris* (swamp-candles), b) *Nuphar advena* (yellow pond-lily), c) *Rumex verticillatus* (water dock), d) *Asclepias incarnata* (swamp milkweed) with a digger wasp (*Sphex* sp.), d) *Cornus foemina* (gray dogwood).

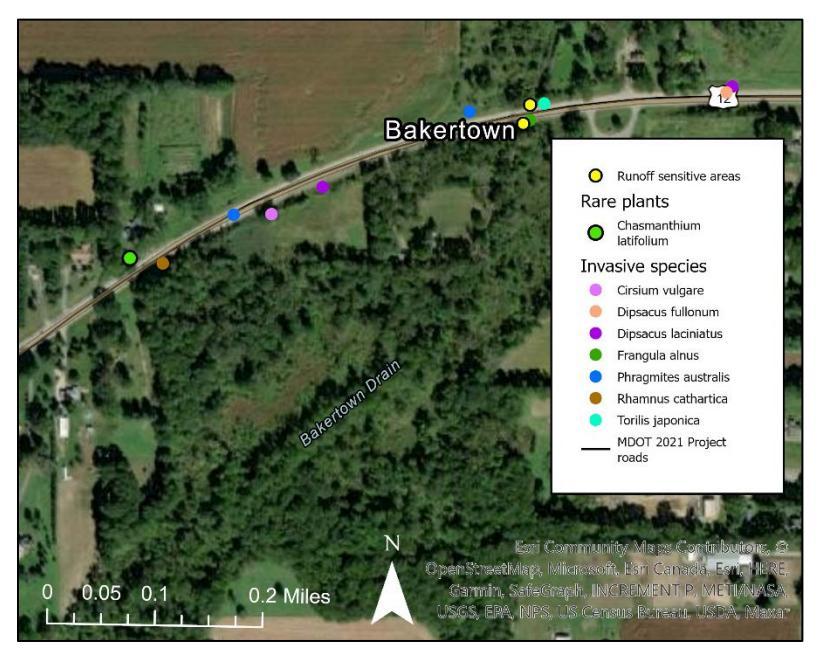
Figure 17: Map of survey section four, including locations that are sensitive to runoff, locations where a rare plant species was found, and locations of non-native invasive plant species occurrences collected with the MISIN app.

Several clumps invasive *Phragmites australis* (reed) were observed to the west of the Bakertown Drain (Figure 17, blue dots). This species is an aggressive invader of wetland habitats and should be removed before it can spread downstream into the high-quality natural communities to the north.

A single plant of State Endangered *Chasmanthium latifolium* (wild oats) was found in this section of the project area in a degraded roadside habitat (Figure 17, medium green dot). See the section of this report titled "*Chasmanthium latifolium* (wild oats) observation" on pages 4-7 for more information about the habitat in the area where this plant was found.

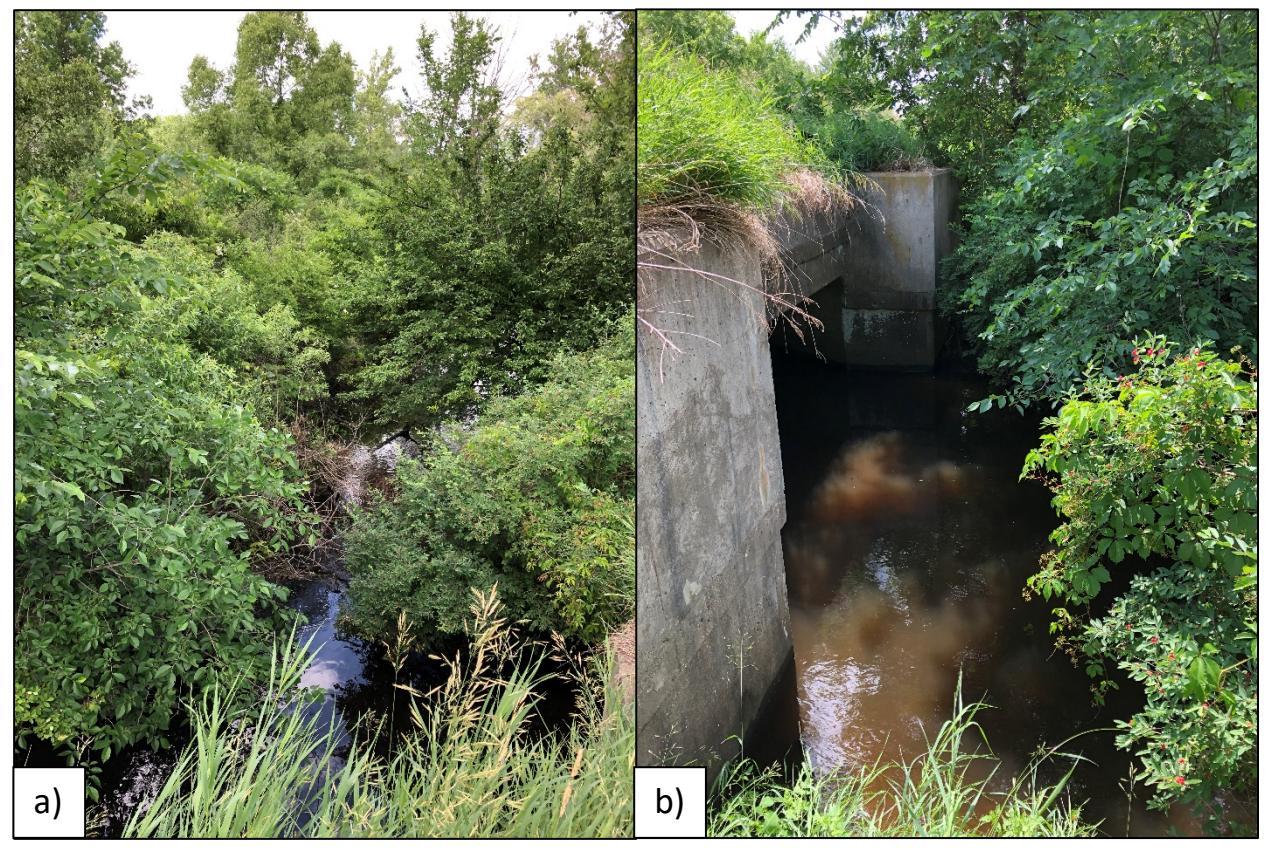
On the north side of US-12 at the intersection with the Bakertown Drain, the habitat consists of disturbed shrub thicket along the banks of the waterbody (Figure 18). The shrub and tree species on this side of US-12 consist of mostly weedy and invasive species: *Juglans nigra* (black walnut), *Ligustrum vulgare* (common privet), non-native *Lonicera* spp. (honeysuckles), *Morus alba* (white mulberry), *Salix* spp. (willows), and *Viburnum opulus* (European highbush-cranberry). A concerningly large patch of *Lonicera japonica* (Japanese honeysuckle) was found

Figure 18: Bakertown Drain north of US-12. a) Shrubs along the banks of the waterbody. b) The Bakertown Drain as it flows out from under US-12.
