Rare Plant Species Surveys for the Michigan Department of Transportation: US-12 from Bertrand/Galien township line to M-139 MDOT project No. 127449

MNFI Report No. 2021-17

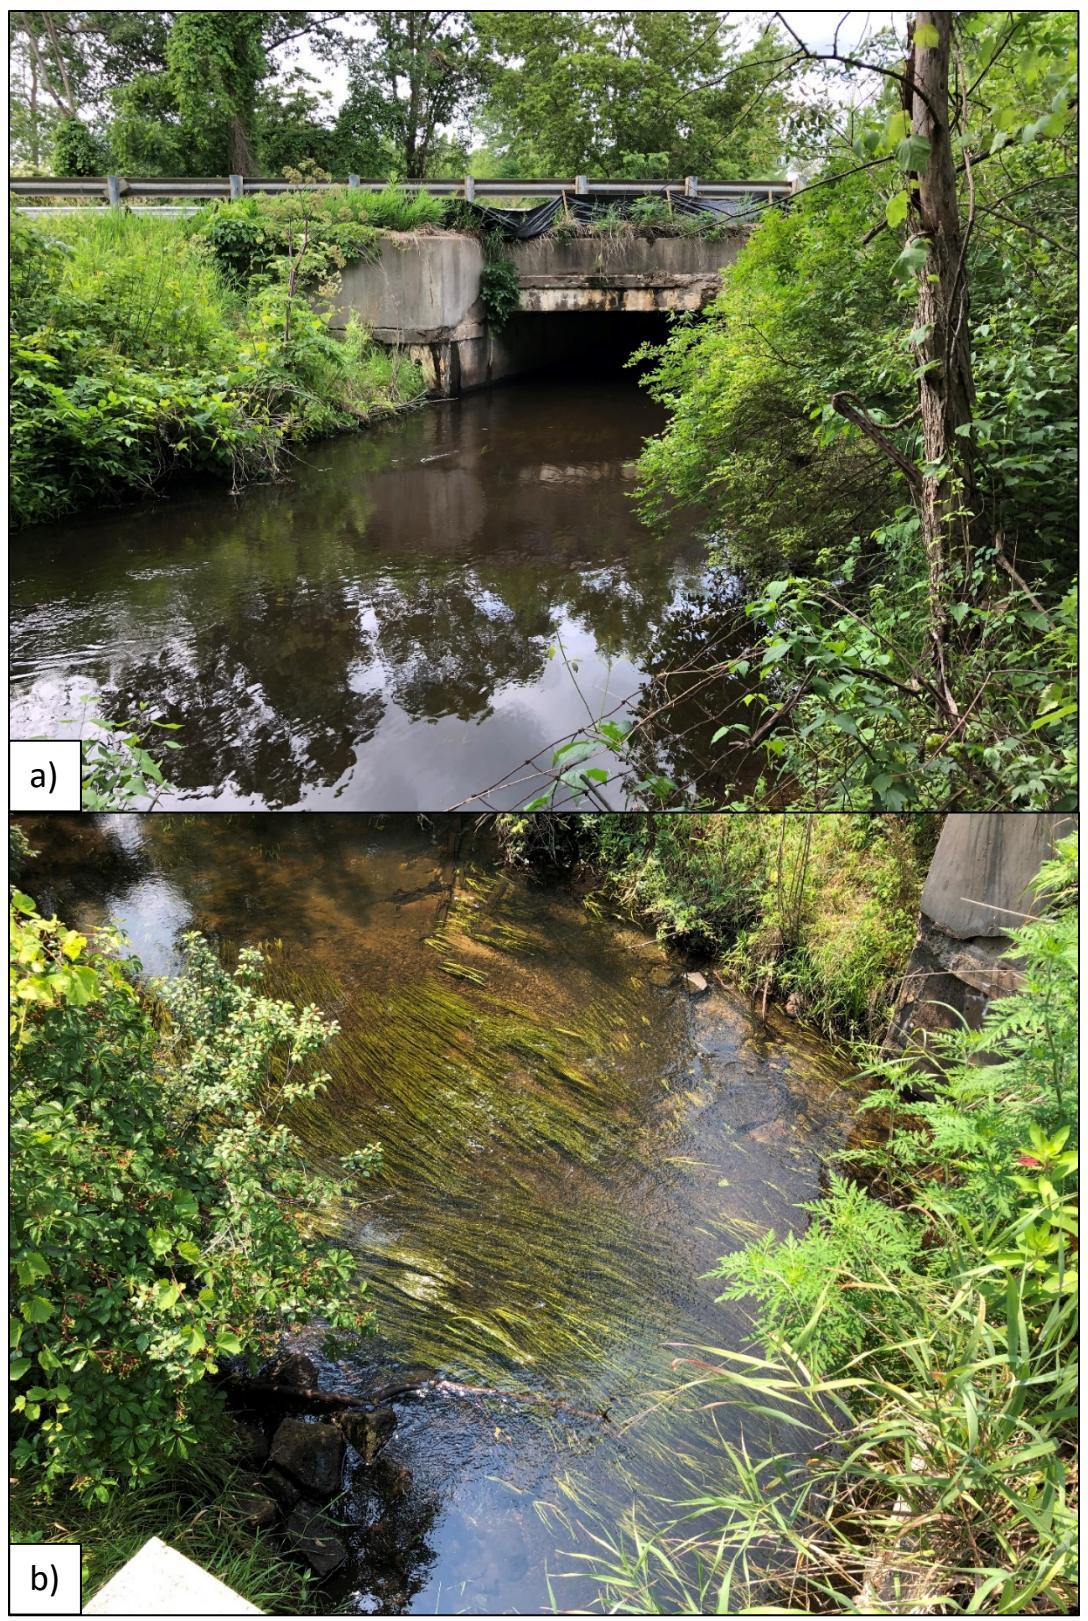
The habitat near the Bakertown Drain on the south side of US-12 is more open than that on the north side of US-12 and contains a slightly higher quality wetland plant community (Figure 19). Invasive species are still prevalent here, with *Cirsium arvense* (Canada thistle), *Frangula alnus* (glossy buckthorn; Figure 17, dark green dot), non-native *Lonicera* spp. (honeysuckles), and *Rosa multiflora* (multiflora rose) present. However, a native wetland community persists here and includes *Alisma* sp. (water-plantain), *Angelica atropurpurea* (purplestem angelica; Figure 19a), *Carex vulpinoidea* (fox sedge), *Impatiens* sp. (touch-me-not), *Eupatorium perfoiatum* (boneset), *Eutrochium maculatum* (Joe-Pye weed), *Onoclea sensibilis* (sensitive fern), *Quercus palustris* (pin oak), *Scirpus atrovirens* (bulrush), and *Ulmus americana* (American elm).

Figure 19: Bakertown Drain to the south of US-12. a) Open habitat along the west (left) bank of the stream and shrubby habitat along the east (right) bank. *Angelica atropurpurea* (purplestem angelica) can be seen along the west bank of the stream. b) Waterflow northward under the US-12 bridge.

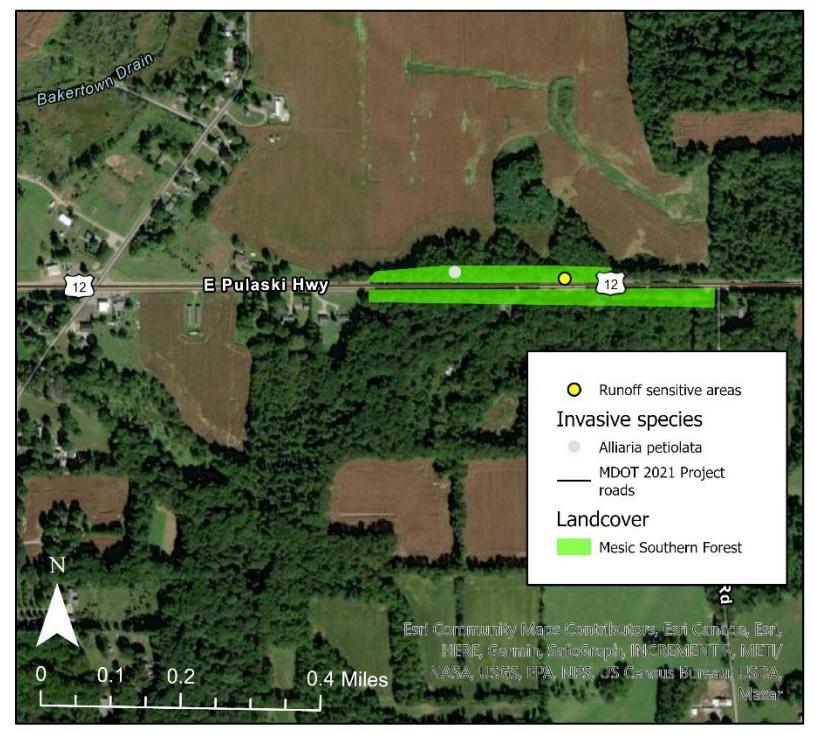
Figure 10: Map of survey section five, including a point that is sensitive to runoff, a location of a non-native invasive plant species occurrence collected with the MISIN app, and the extent of medium-quality habitat within the ROW.

The intersection of US-12 and Bakertown Road (Figure 20, west side of section map) will be altered during the planned construction activities; therefore, this section was surveyed by foot during each of the three visits to the project area. The landcover adjacent to this intersection consists of mowed yards in front of residential and commercial buildings (Figure 21). No suitable habitat for rare species occurs at this intersection.

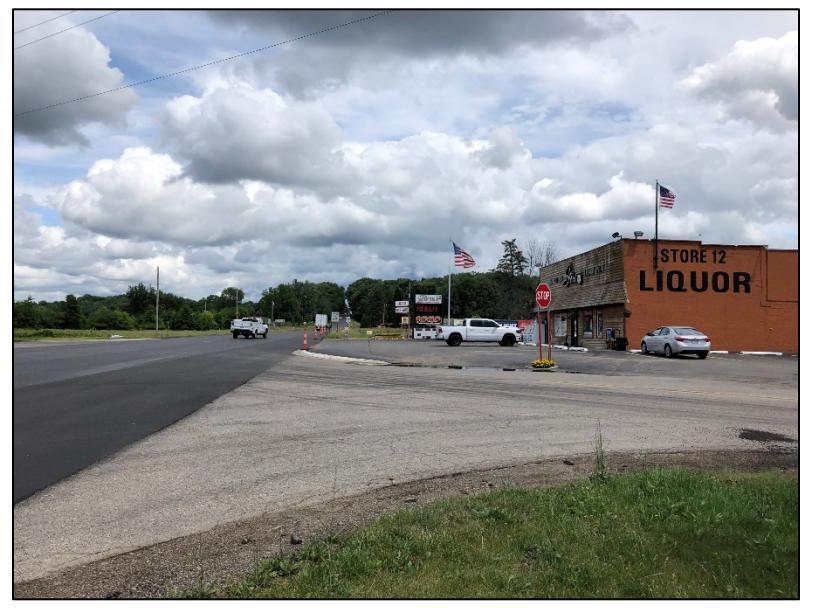
Figure 11: Commercial property at the intersection of Bakertown Road and US-12.

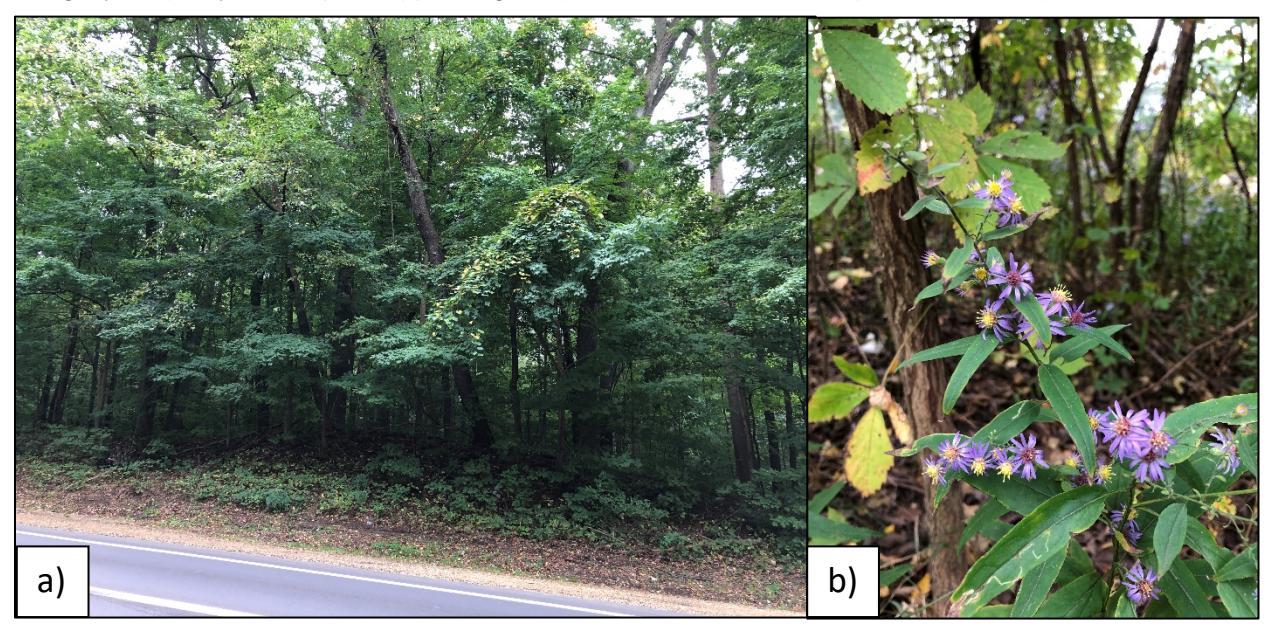
(American elm). The shrub layer includes Asimina triloba (paw paw), Fraxinus americana saplings (white ash), Lindera benzoin (spicebush), and Sassafras albidum (sassafras). The understory contains Arisaema triphyllum (Jack-in-the-pulpit), Elymus hystrix (bottlebrush grass), Solidago flexicaulis (zig-zag goldenrod), Symphyotrichum shortii (Short's aster), and Thalictrum dioicum (early meadow-rue). Several non-native species were found while surveying along the roadside adjacent to the mesic southern forest habitat: Alliaria petiolata (garlic-mustard; Figure 20, grey dot), Elymus repens (quack grass), and Rosa multiflora (multiflora rose).

Figure 12: Mesic southern forest habitat to the east of Bakertown Road. a) Photo showing the general structure of the forest, b) *Symphyotrichum shortii* (Short's aster).

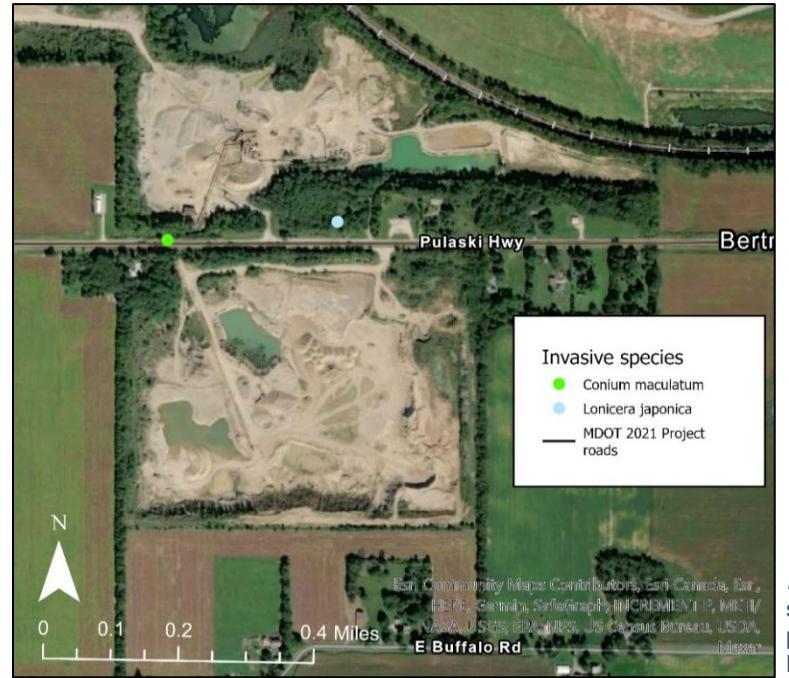
The section of US-12 near Michiana Aggregate (Figure 23) is slated for widening in this project. Therefore, the roadsides near the quarry were surveyed by foot to check for rare species and/or rare species habitat. Neither rare species nor rare species habitat was found in the ROWs near Michiana Aggregate.

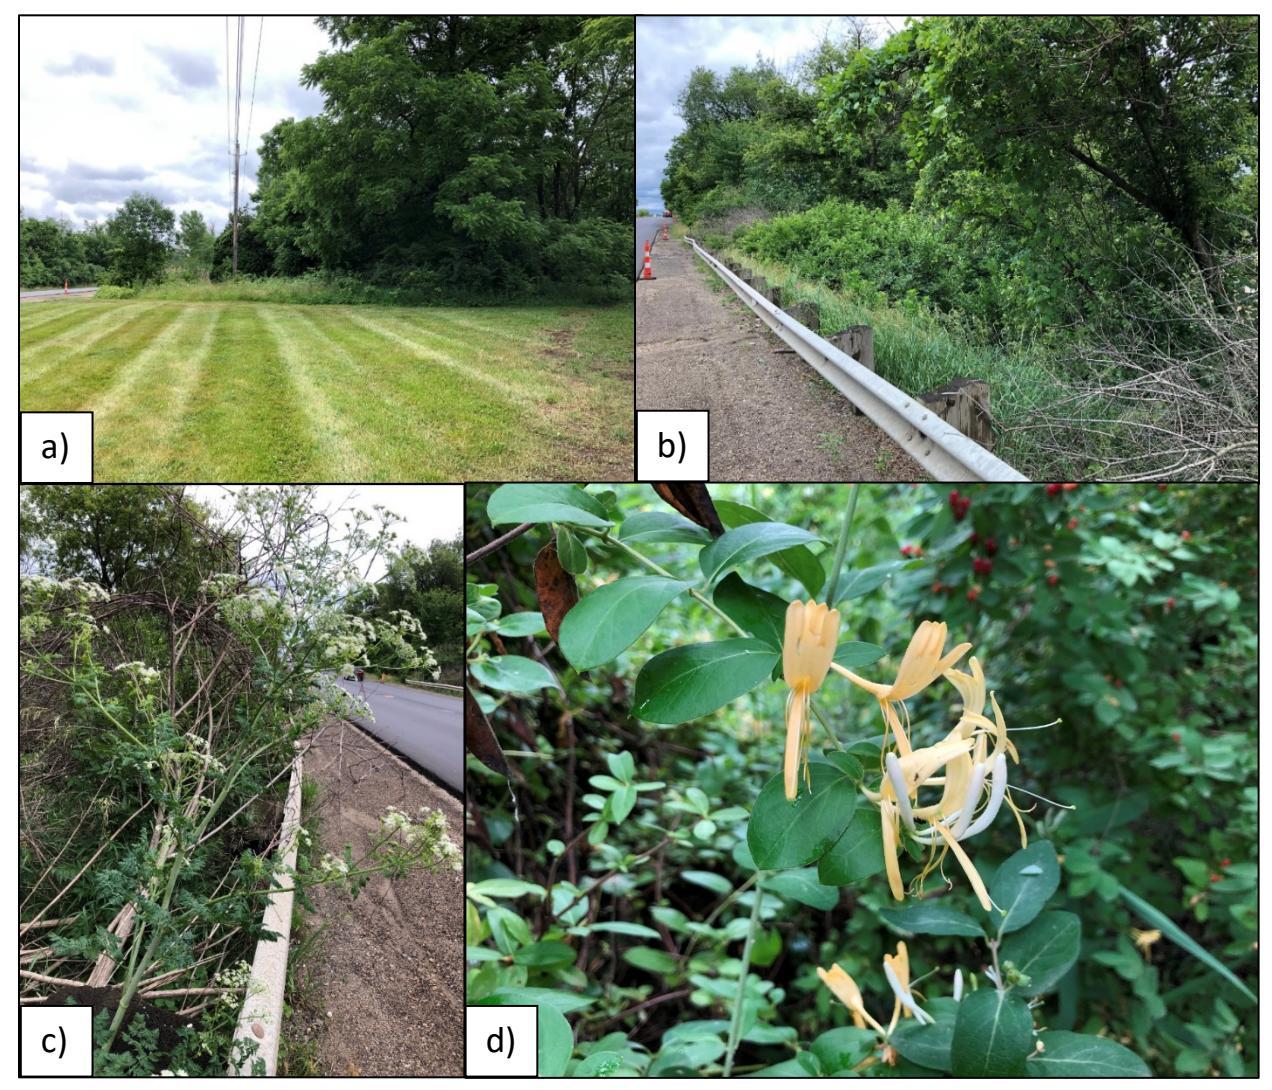
woodland habitat, and a ditch to the east of the driveway dominated by invasive *Phragmites australis* subsp. *australis* (reed). The ROW on the south side of US-12 in this survey section consists of a thin strip of degraded wooded thicket which slopes sharply downward to the quarry (Figure 24b).

Several additional invasive plant species were observed in this section of the project area. On the north side of US-12, a clump of *Conium maculatum* (poison-hemlock) was observed to the west of the quarry driveway (Figure 23, light green dot; Figure 24c). Continuing westward on the north side of US-12, *Dipsacus fullonum* (wild teasel) and *Frangula alnus* (glossy buckthorn) were also observed. Additionally, several species of invasive honeysuckles were observed in the woodland to the east of the quarry driveway, on the north side of US-12, including a large patch of *Lonicera japonica* (Japanese honeysuckle; Figure 23, light blue dot, Figure 24d). Along the guardrail on the south side of US-12, the invasive shrubs *Elaeagnus umbellata* (autumnolive) and *Rosa multiflora* (multiflora rose) were observed.

Figure 14: Habitat and invasive species observed near Michiana Aggregate. a) Mowed ROW on the north side of US-12, b) steeply sloping wooded thicket on the south side of US-12, c) *Conium maculatum* (poison-hemlock), and d) *Lonicera japonica* (Japanese honeysuckle).

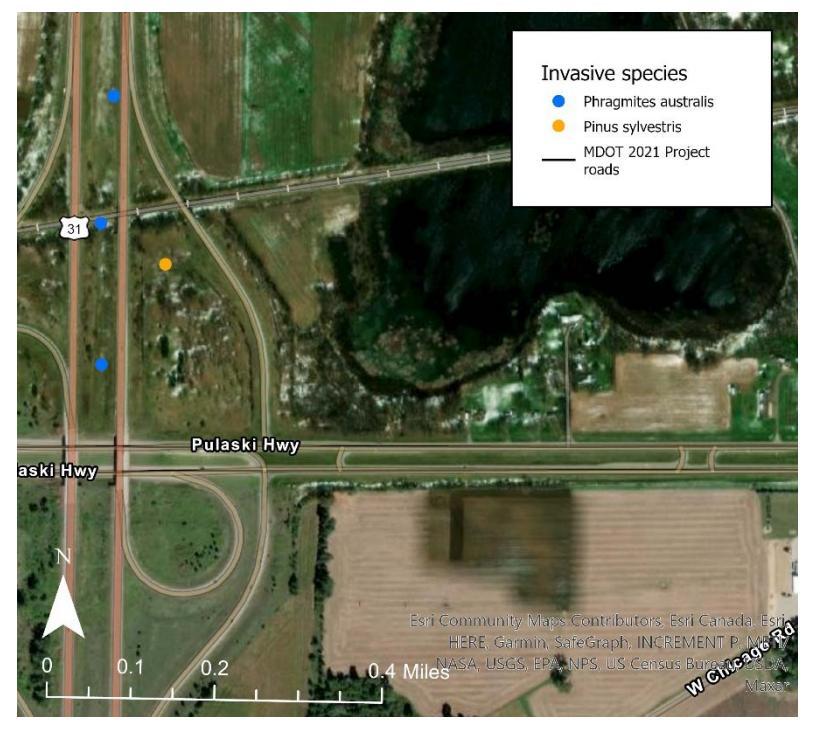
Figure 15: Map of survey section seven, showing locations of non-native invasive plant species occurrences collected with the MISIN app.

The median between the onramp to northbound US-31 and northbound US-31, and the median between the northbound and southbound US-31 lanes were surveyed by foot as well. Plant communities containing wetland species were located in several areas of these medians; however, no rare species were found and no suitable habitat for rare species was observed. In the median between northbound and southbound US-31, three patches of *Phragmites australis* (common reed) were found in areas where water accumulates (Figure 25, blue dots). Other wetland invasive species, including *Lythrum salicaria* (purple loosestrife) and *Typha x glauca* (hybrid cattail) were also found near the *Phragmites australis* patches. A few *Pinus sylvestris* (Scots pine) trees were found in the median between northbound US-31 and the onramp to northbound US-31 (Figure 25, orange dot).
