Rare Plant Species Surveys for the Michigan Department of Transportation: M–139 Benton Harbor. MDOT Project No. 210875

MNFI Report No. 2022-30

McLaughlin, J.B. 2022. Rare Plant Species Surveys for the Michigan Department of Transportation: M-139 from 0.44 miles south of I-94 south to I-94 BL. MDOT project No. 210875. Michigan Natural Features Inventory, Report No. 2022-30, Lansing, MI. 14 pp.

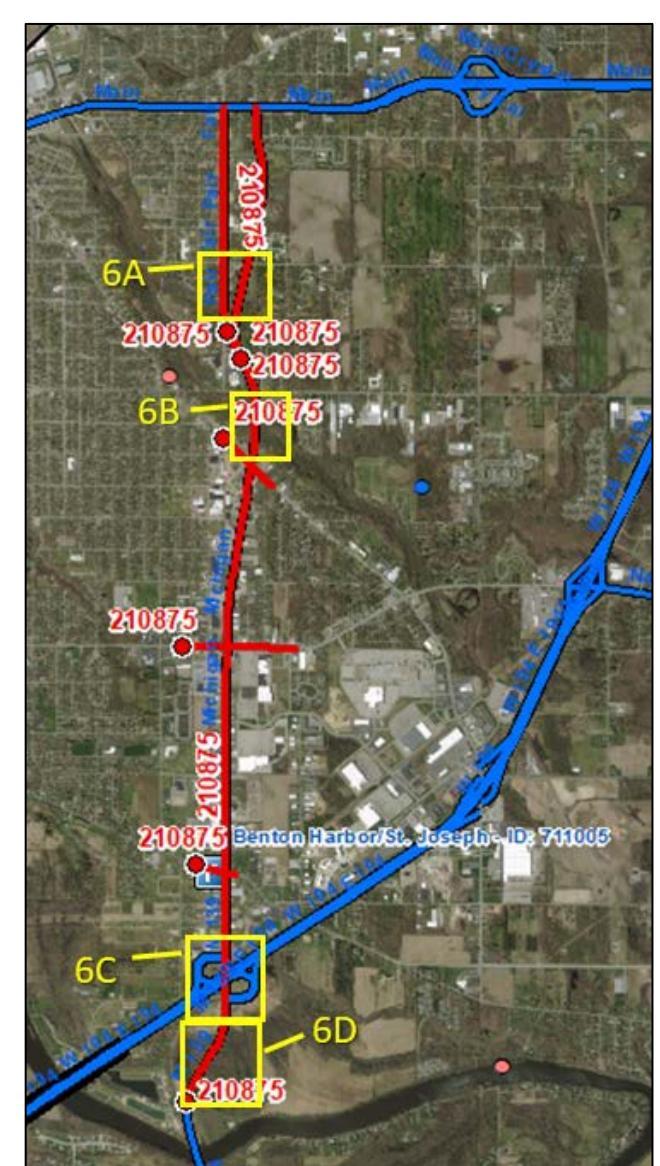
Figure 1. Map of project area in red with survey sections in yellow. The project area is located along M-139 from 0.5 mile south of I-94 to I-94 BL (Main St.) in Benton Harbor and Fair Plain, Berrien County.

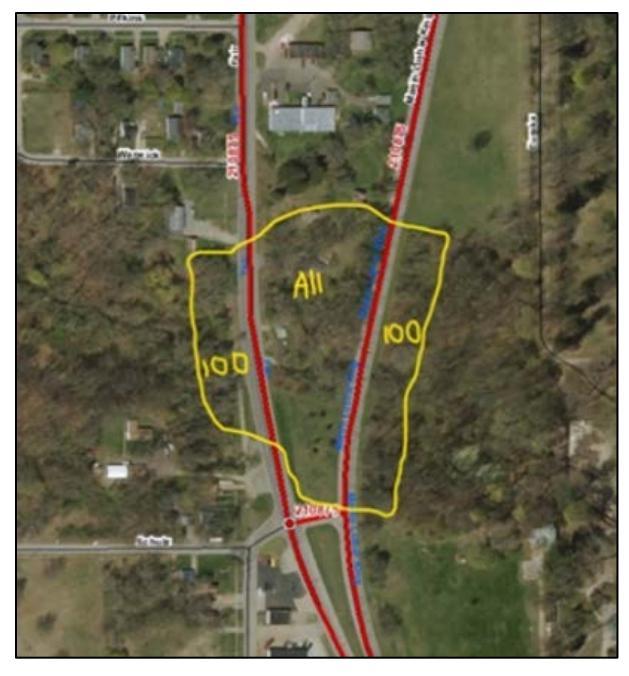
Figure 2. Map of Section 6A, with survey area in yellow.

The northernmost survey area is located north of Schulz Drive and south of Britain Avenue in Benton Harbor (Fig. 2). An unnamed creek crossing, a 100-foot buffer east and west of the roads or until reaching the right of way fence, and the wooded median between the two roads, were surveyed.

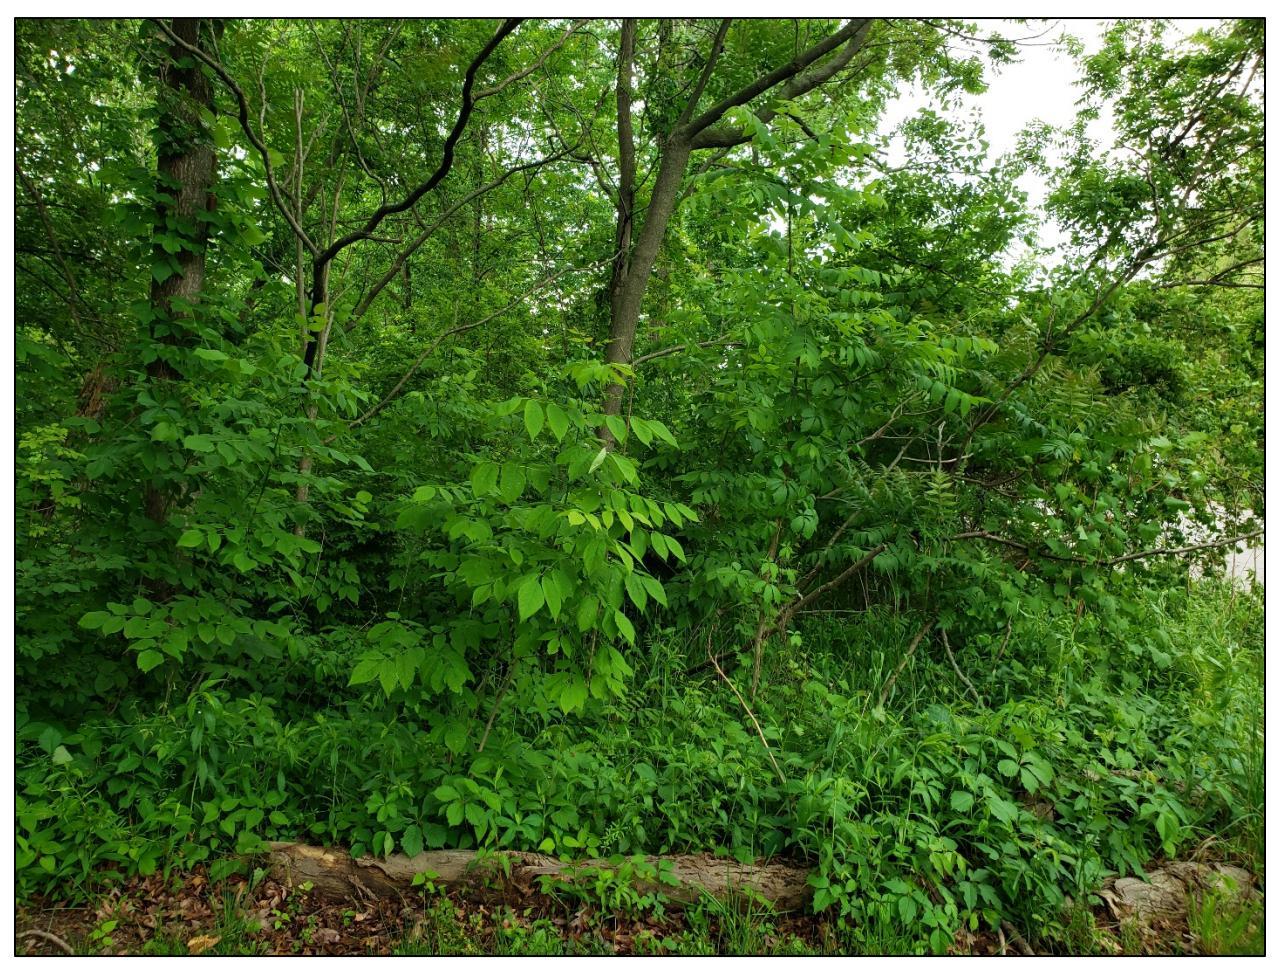
The canopy of the forest includes red and sugar maple (*Acer rubrum, A. saccharum*), red oak (*Quercus rubra*), eastern cottonwood (*Populus deltoides*), bass-wood (*Tilia americana*), black cherry (*Prunus serotina*), American elm (*Ulmus americana*), sassafras (*Sassafras albidum*), and hickory (*Carya* spp.). The shrub and vine layer is dominated by a mix of native and non-native species (Fig. 3). Native species include hackberry (*Celtis occidentalis*), pawpaw (*Asimina triloba*), ash (*Fraxinus* spp.), box elder (*Acer negundo*), dogwood (*Cornus* sp.), spicebush (*Lindera benzoin*), redbud (*Cersis canadensis*), elderberry (*Sambucus* sp.), black raspberry (*Rubus occidentalis*), wild grape (*Vitis riparia*), Virginia creeper (*Parthonicissus quinquefolia*). Invasive species include non-native honeysuckles (*Lonicera maackii, L. tatarica and L. japonica*), multiflora rose (*Rosa multiflora*), winged wahoo (*Euonymus alatus*), mock-orange (*Philadelphus* spp.), English ivy (*Hedera helix*), periwinkle (*Vinca minor*), and oriental bittersweet (*Celastrus orbiculatus*).

Figure 3. Wooded habitat within Section 6A.

This segment is a complex of mesic southern forest and southern hardwood swamp which is suitable habitat for many of the targeted rare woodland species. However, it is highly degraded by invasive species and no rare species were found.

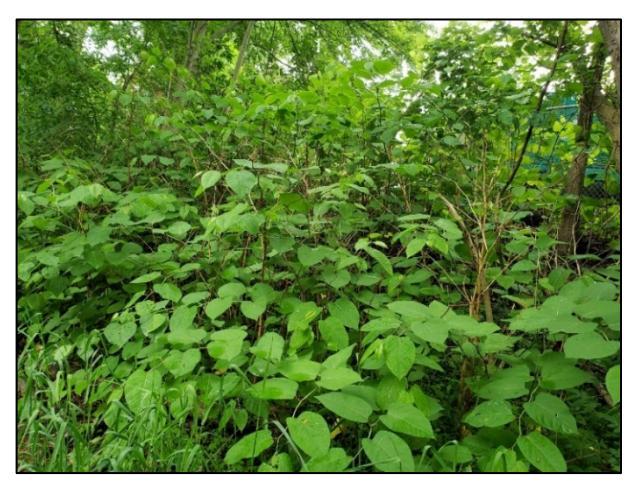
The herbaceous layer is dominated by invasive species, including significantly large and dense patches of Japanese knotweed (*Fallopia japonica*) along roadsides and clearings (Fig. 4), dame's rocket (*Hesperis matronalis*), lily-of-the-valley (*Convallaria majalis*), garlic mustard in forest edges, reed canary grass (*Phalaris arundinacea*), bittersweet nightshade (*Solanum dulcamara*), and purple loosestrife (*Lythrum salicaria*) along the creek and in wetter areas.

Figure 4. Dense Japanese knotweed infestation on forest edges in Section 6A.

Treatment of invasive species within higher quality habitat is recommended. Although widespread invasive species are noted throughout the project area, the infestations of garlic mustard, Japanese knotweed, and Non-native honeysuckles in high-quality areas are a threat to native species that occur there, including the rare trilliums. Shapefiles for Japanese knotweed have been submitted to the Midwest Invasive Species Information Network (MISIN) and provided to MDOT. In addition, it is recommended that the large diameter oaks in the northwest interchange circle in Section 6C.

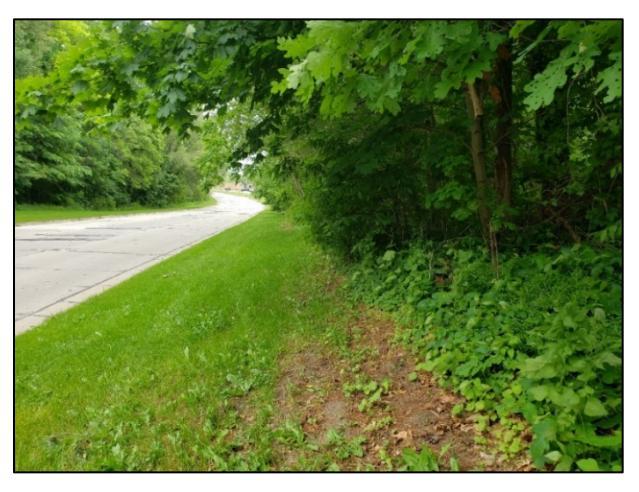
Non-native trees along roadsides and clearings include several large invasive tree-of-heaven (*Ailanthus altissima*), as well as Siberian elm (*Ulmus pumila*), black locust (*Robinia pseudoacacia*), and white mulberry (*Morus alba*). Mowed areas adjacent to the road and under utility rights-of-way consist predominantly of roadside weeds (Fig. 5, Table 2).

Figure 5. Mowed roadside adjacent to forested habitat in Section 6A.

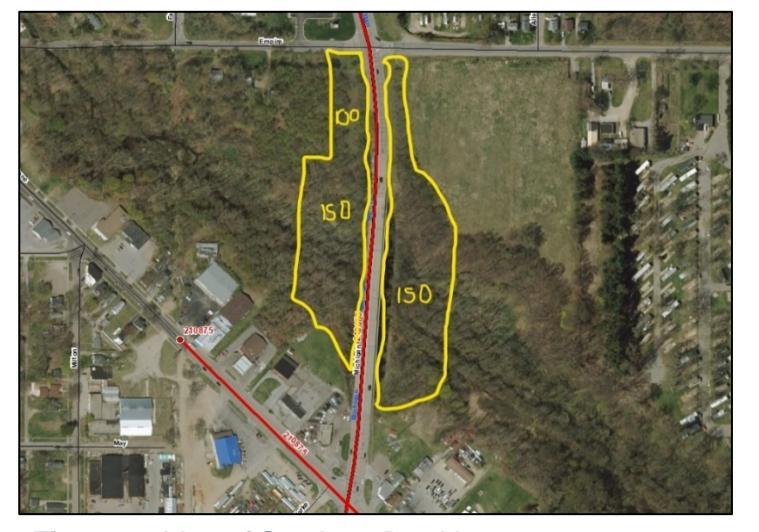
Figure 6. Map of Section 6B, with survey area in yellow.

Section 6B includes the Ox Creek crossing which spans the area directly underneath the bridge plus a 100-150 foot buffer on both sides, as shown in Figure 6. The entire section was surveyed on foot during the initial early season visit. The creek floodplain and northern woodlands were surveyed during mid and late season visits because of the large project footprint and the diversity of wetland species in the area.

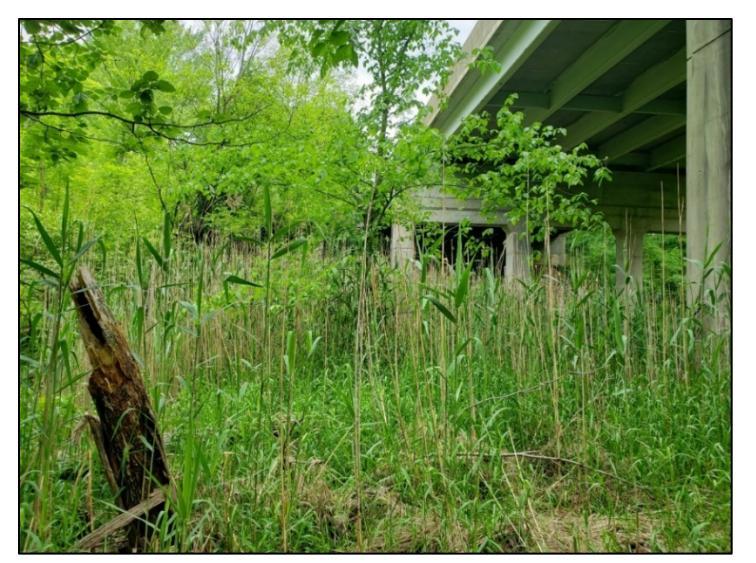
Figure 7. Non-native phragmites (Phragmites australis) under the bridge in Section 6B.

The habitat surrounding Ox Creek is a mix of non-forested wetlands resembling southern wet meadow, and pockets of inundated shrub swamp, southern hardwood swamp, and southern shrub-carr. These habitats have been degraded by human disturbance, including dumping and invasive species-not only invasive plants but also emerald ash borer and Dutch elm disease. This has resulted in the loss of ash (*Fraxinus* spp.) and elm (Ulmus spp.) in the canopy as evidenced by the multiple large standing snags and remaining saplings of these species. The dominant invasive species in this area

are reed canary grass and non-native phragmites (*Phragmites australis*; Fig. 7). There is also a dense infestation of moneywort (*Lysimachia nummularia*) throughout the floodplain.

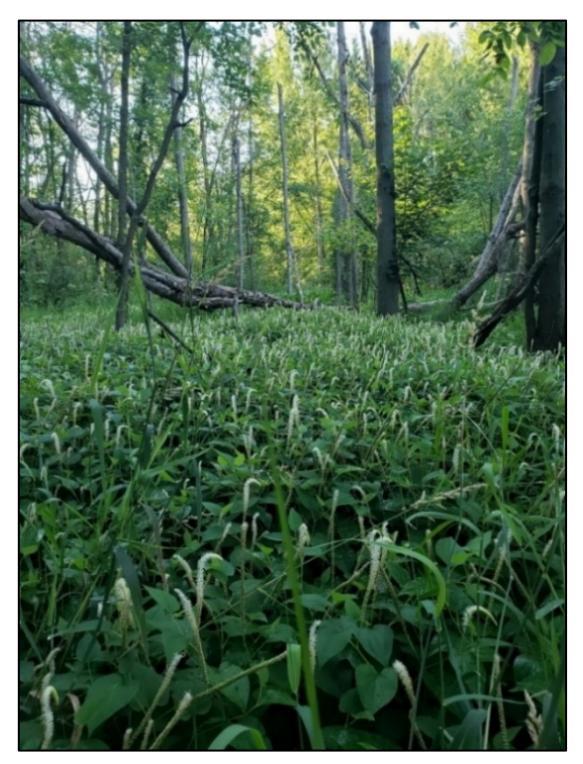
Figure 8. Large population of Lizard's tail (Saururus cernuus) in Section 6B.

Herbaceous species include arrow-arum (*Peltandra virginica*), skunk cabbage, jewelweed, marsh marigold (*Caltha palustris*), Joe-pye weed (*Eutrochium maculatum*), blue flag iris, lizard's tail (*Saururus cernuus*; Fig. 8), beggars-ticks (*Bidens connata*), swamp milkweed (*Asclepias incarnata*), and clearweed (*Pilea pumila*), as well as several sedges (*Carex grayi, C. lacustris, C. stipata*), and grasses, cut grass (*Leersia oryzopsis*), and fowl manna grass (*Glyceria striata*).

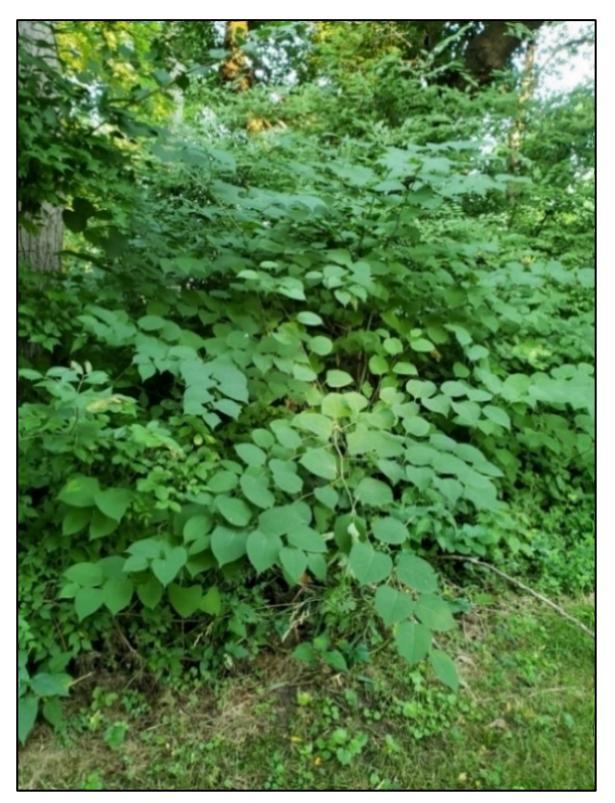
Surrounding these natural areas are significant areas of weedy and invasive species. The flat upland on the northwest side is mowed with brush piled in the middle and is dominated by species such as black locust, box elder, mulberry (*Morus alba*), black raspberry, grape, honeysuckles (*Lonicera* spp.), garlic mustard, and typical roadside weeds (Table 2). There is a wire fence near the street. The southern boundary west of the bridge is a mowed area bordered by a wall of Japanese knotweed (*Fallopia japonica*; Fig. 9).

Figure 9. Dense infestation of Japanese knotweed (Fallopia japonica) in Section 6B.

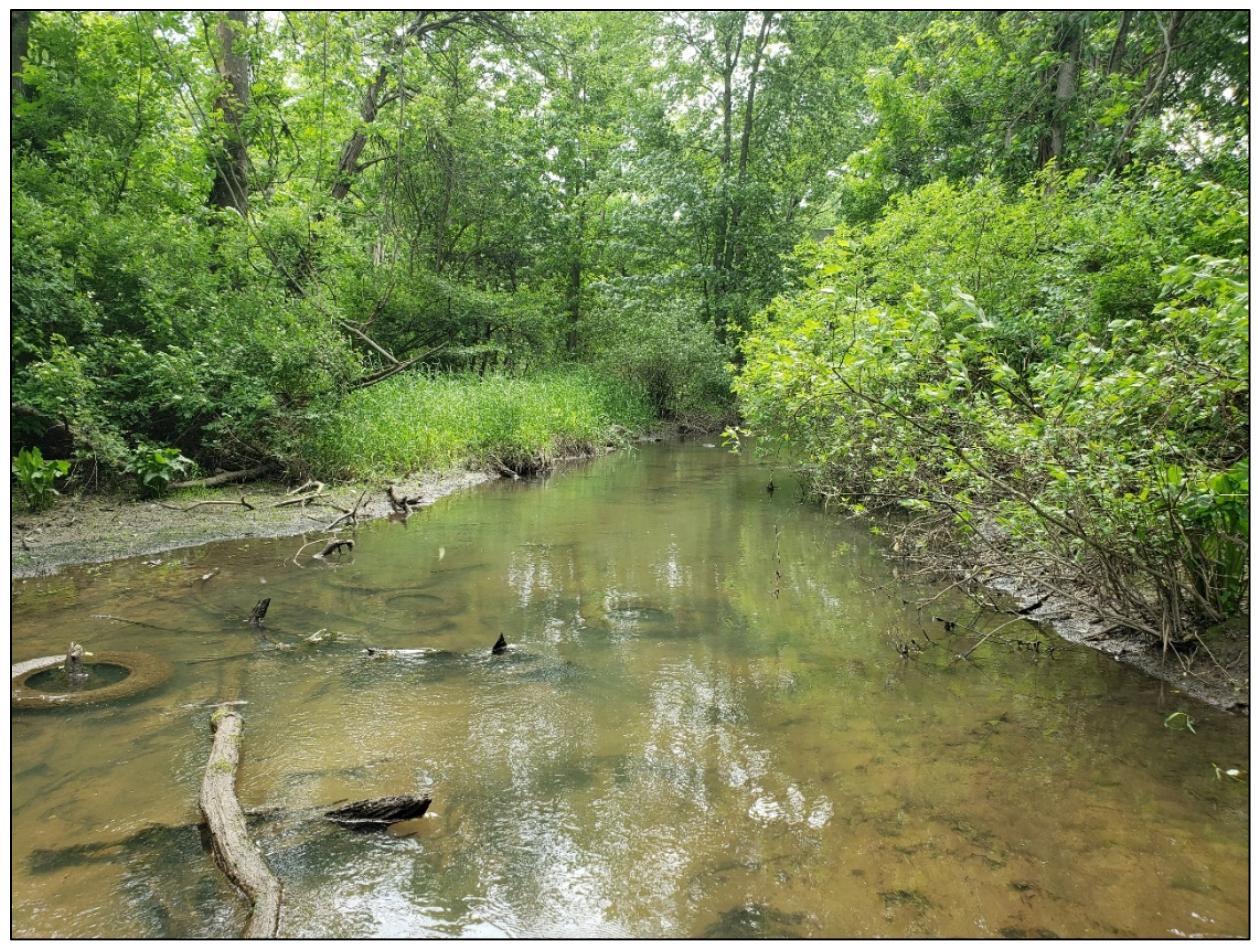
There is also significant trash in this section including a historic dump site along the southwest boundary and tires and other debris in Ox Creek and the adjacent floodplain (Fig. 10).

Figure 10. Tires dumped in Ox Creek in Section 6B.

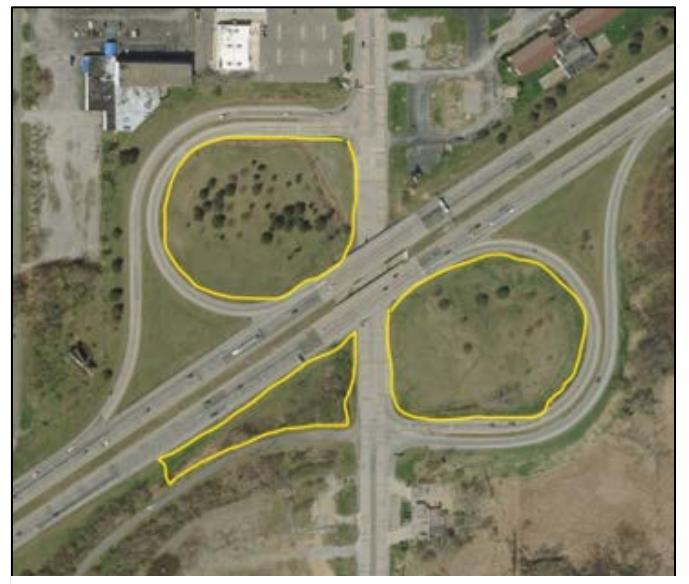
Figure 11. Map of Section 6C, with survey area in yellow.

Section 6C includes the cloverleaf I-94 and M-139 interchange at the southern end of the project area (Fig. 11). The entire project area was surveyed on foot during the initial visit. This area was highlighted for survey because these interchange loops will be used for staging and a concrete batch plant, which will likely impact the entire area.

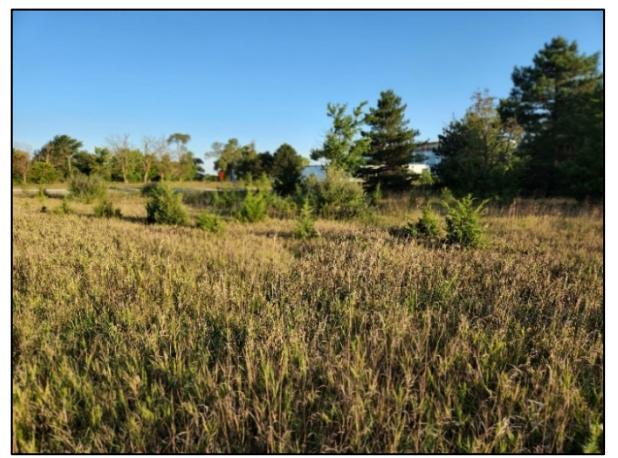
The habitat within the two interchange circles contains several large white oaks and red pine (*Pinus resinosa;* Fig. 12.) but is otherwise dominated by autumn-olive (*Elaeagnus umbellata*), roadside weeds, and disturbance-loving native species

Figure 12.. Large pines and oaks within cloverleaf in Section 6C.

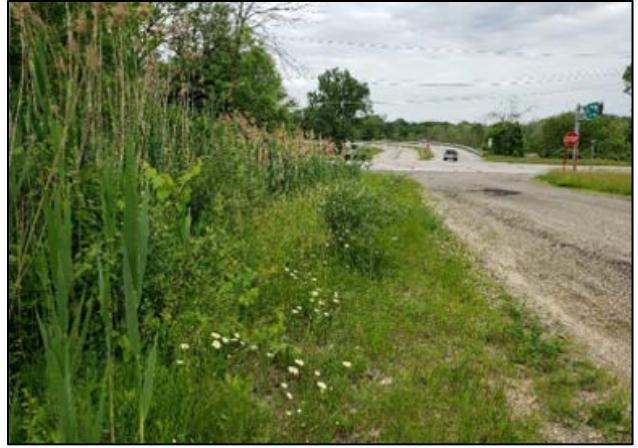
Figure 13. Non-native phragmites (Phragmites australis) and other roadside weeds in the southwest corner of Segment 6C

The triangular section in the southwest corner (Fig. 11) contains a small wetland dominated by non-native phragmites, cat-tails, and roadside weeds (Fig. 13). The southern portion does contain many native species such as ash (*Fraxinus* spp.), American elm, elderberry (*Sambucus canadensis*), dogwood (*Cornus* spp.), boneset (*Eupatorium perfoliatum*), ironweed (*Vernonia missurica*), New England aster (*Symphyotrichum novae-angliae*), and blue vervain (*Verbena hastata*). There is a fence running lengthwise through the middle of this unit, serving as a mowing break. Upland areas of the unit are dominated by non-native honeysuckles and roadside weeds. This area is highly disturbed and managed through mowing. No suitable habitat for rare plant species occurs in this section.

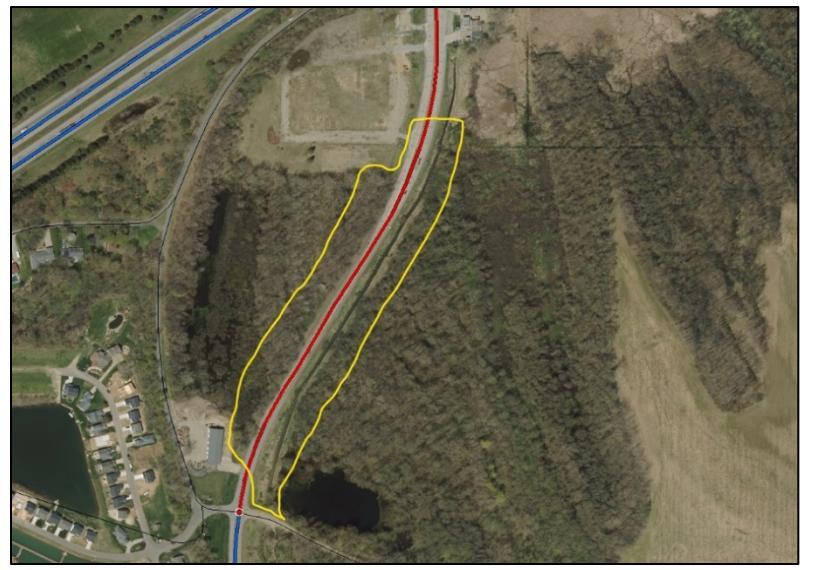
Section 6D consists of 100' width on both sides of M-139 north of Diller Rd. This area was highlighted for survey as it contains visible forest and wetland landcover that could provide suitable habitat for rare woodland species (Fig. 14). Each side of M-139 is described separately below.

Figure 14. Map of Section 6D, with survey area in yellow.

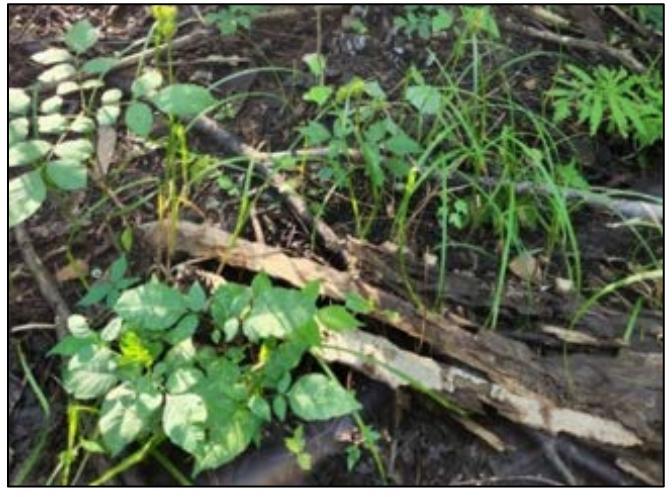
The ground layer is dominated by wild ginger, moonseed (*Menispermum canadense*), and poison ivy, along with sedges, sensitive fern, and early meadow-rue (*Thalictrum dioicum*) (Fig. 15). Abundant state threatened prairie trillium was also documented here (Fig 16). Invasive plants within the prairie trillium population include Non-native honeysuckles (*Lonicera* spp.), garlic mustard, and periwinkle (*Vinca major*). The southern end includes a small buttonbush swamp.

Figure 15. Typical understory species in vernal pool on west side of Section 6D.

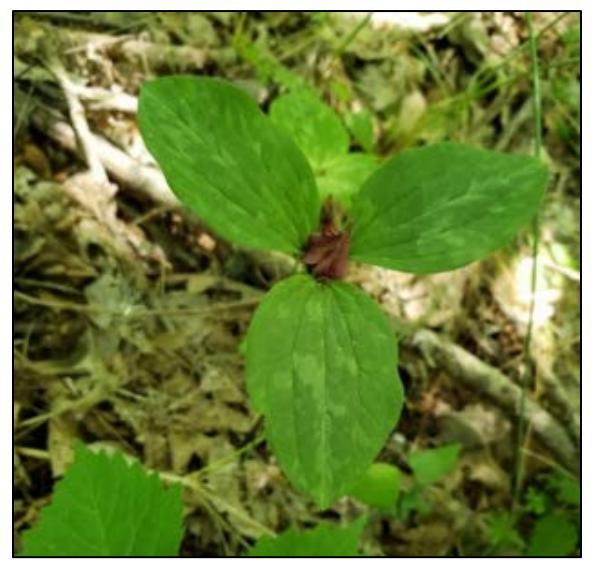
Figure 16. Prairie trillium (Trillium recurvatum) in Section 6D.

Figure 18 shows the distribution of prairie trillium in Section 6D on both sides of M139/I-94 Emergency, north of Diller Road. The population appears to be healthy to the west of M-139. Over 1000 individual stems were counted in the right-of-way and the apparent vigor of the individuals (Fig. 16) was rated as good, with 40-50% of stems fruiting.

The significant population of state threatened *Trillium recurvatum* documented in Section D is vulnerable to anticipated road work. As construction is expected to include full road reconstruction in some places, care must be taken to keep the canopy intact to maintain suitable habitat conditions for prairie trillium, which does not do well under increased light (Fig. 19). Additionally, disturbance in a closed-canopy forest is known to assist the spread of invasive plant species.

Ensuring that this location is not disturbed during road work and treatment of invasive species at this location will be necessary to ensure population health and sustainability. Alternatively, trillium plants could be transplanted to a suitable site elsewhere. Prairie trillium prefers rich woodlands with limestone-derived soils in floodplain forests, moist ravines, and mesic forests.

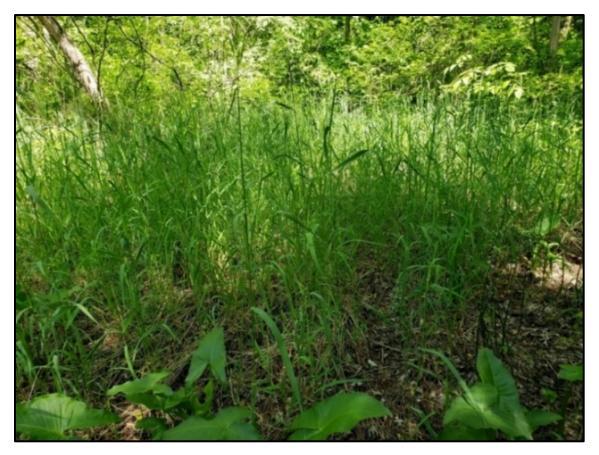
The east side of M-139/I-94 contains a large drain and adjacent right-of-way dominated by reed canary grass (Fig. 17) with scattered native species including, wood-sage (*Teucrium canadense*), gray's sedge, ironweed, and blue vervain. The woods to the north of the drain rightof-way is a lower quality forest with significant disturbance and invasive species, yet a large, scattered population of prairie trillium persists (Fig. 18). Spicebush, wild ginger, scouring rush (*Equisetum hyemale*), non-native honeysuckles (*Lonicera* spp.), autumn-olive, are abundant.

Figure 17. Vegetation along right-of-way on east side of *M*-139 in Section 6D.

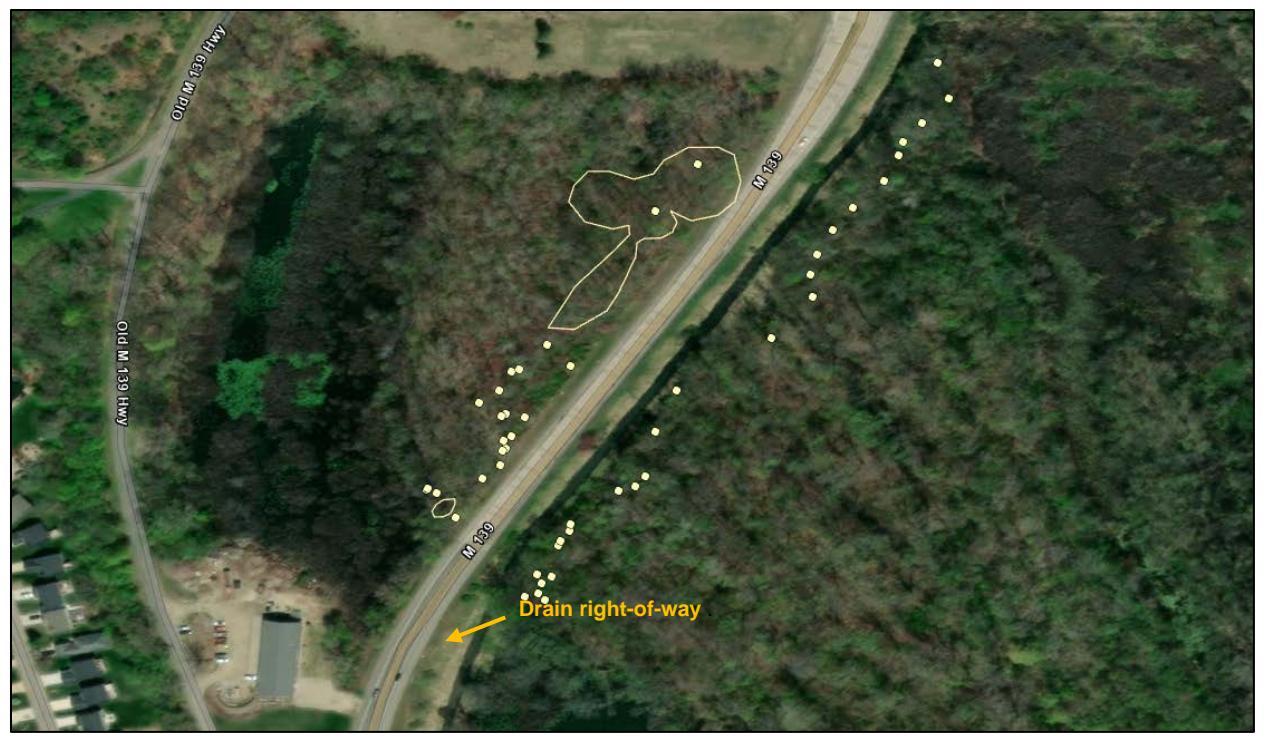
Figure 18. Map of prairie trillium (Trillium recurvatum) was found in Section 6D along M-139 between the St. Joseph River to the south and I-94 interchange to the north.

In contrast, prairie trillium is much more dispersed and less robust on the east side of M-139 (Fig. 19). In some areas as few as 5% of plants were flowering. An attempt was made to count individual stems starting from the southern end of the area. However, with so many stems located in dense groundcover (Fig. 20), they could not be practically counted, so points were taken frequently along the path walked from south to north (Fig. 18).

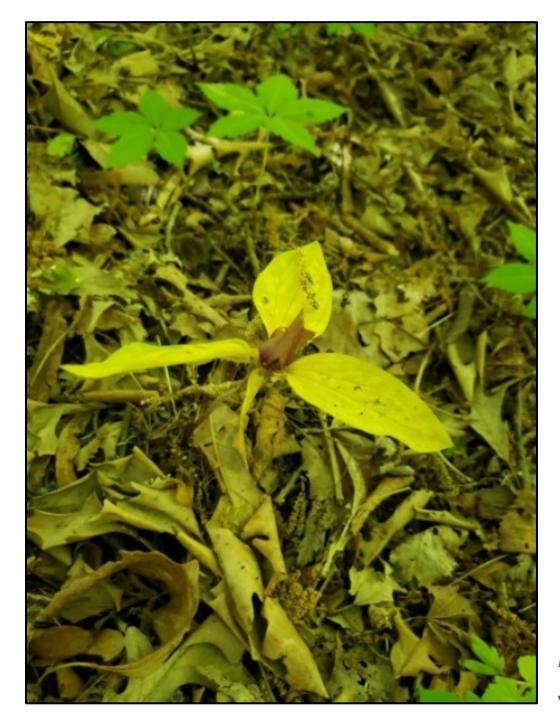
Both areas where prairie trillium was found contain invasive plant species, including aggressive invasive shrubs like non-native honeysuckles (Lonicera spp.) and autumn-olive (primarily on the east side), and a limited amount of garlic mustard. The trillium appears

Figure 19. Prairie trillium (Trillium recurvatum) in sunnier areas on the east side of M-139.

to be doing poorly in dense honeysuckle compared to less invaded areas. There is also evidence of deer browsing in these areas, which is a serious threat to trillium species, as they preferentially eat native species such as trillium. Invasive species control is essential if the prairie trillium populations are to be preserved.

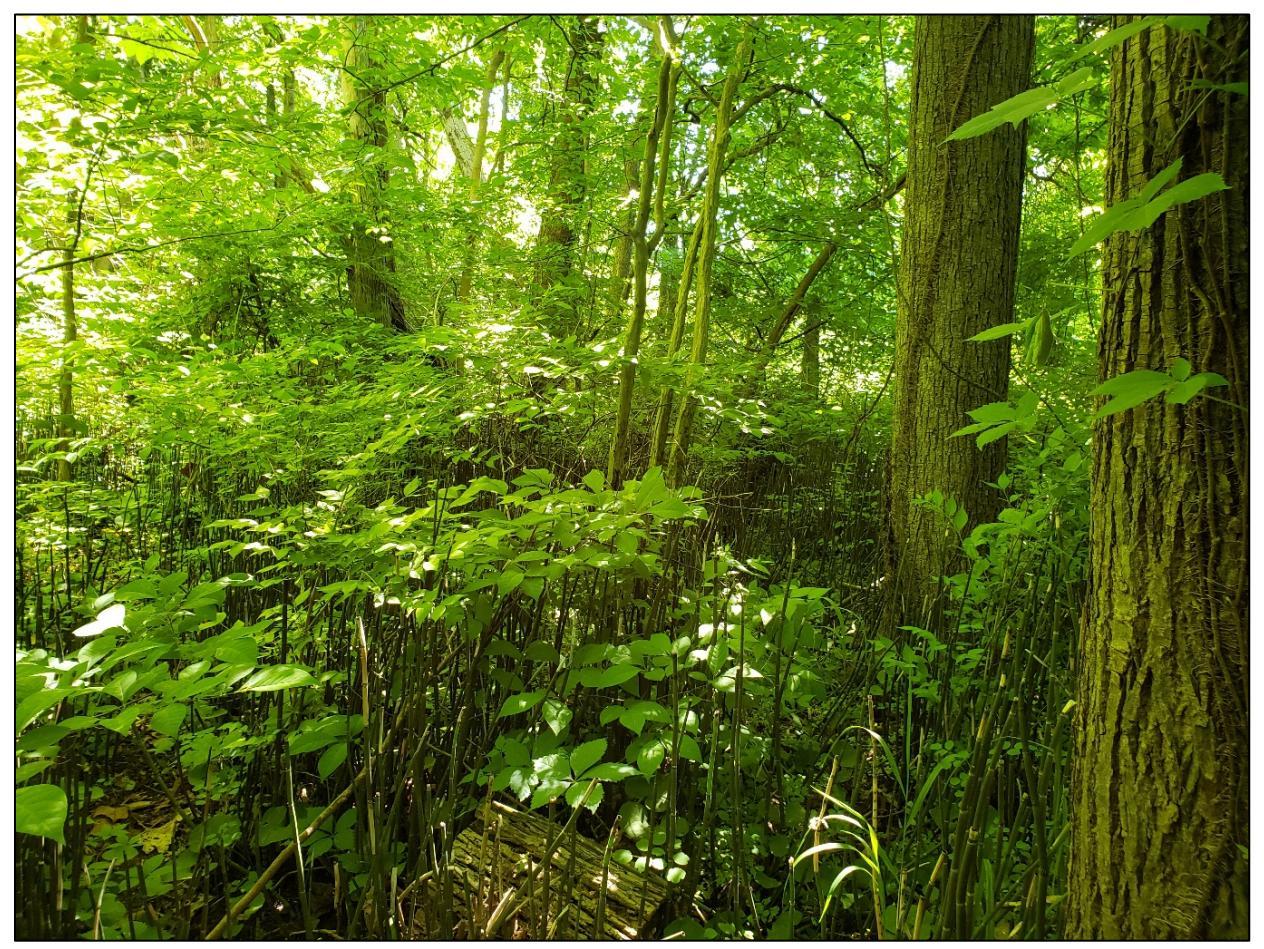
Figure 20. Habitat where trillium is located on east side of M-139.
