Rare Plant Species Surveys for the Michigan Department of Transportation: M–37 Kraft Ave to 92nd St, Kent County. MDOT Project No. 210063

MNFI Report No. 2022-51

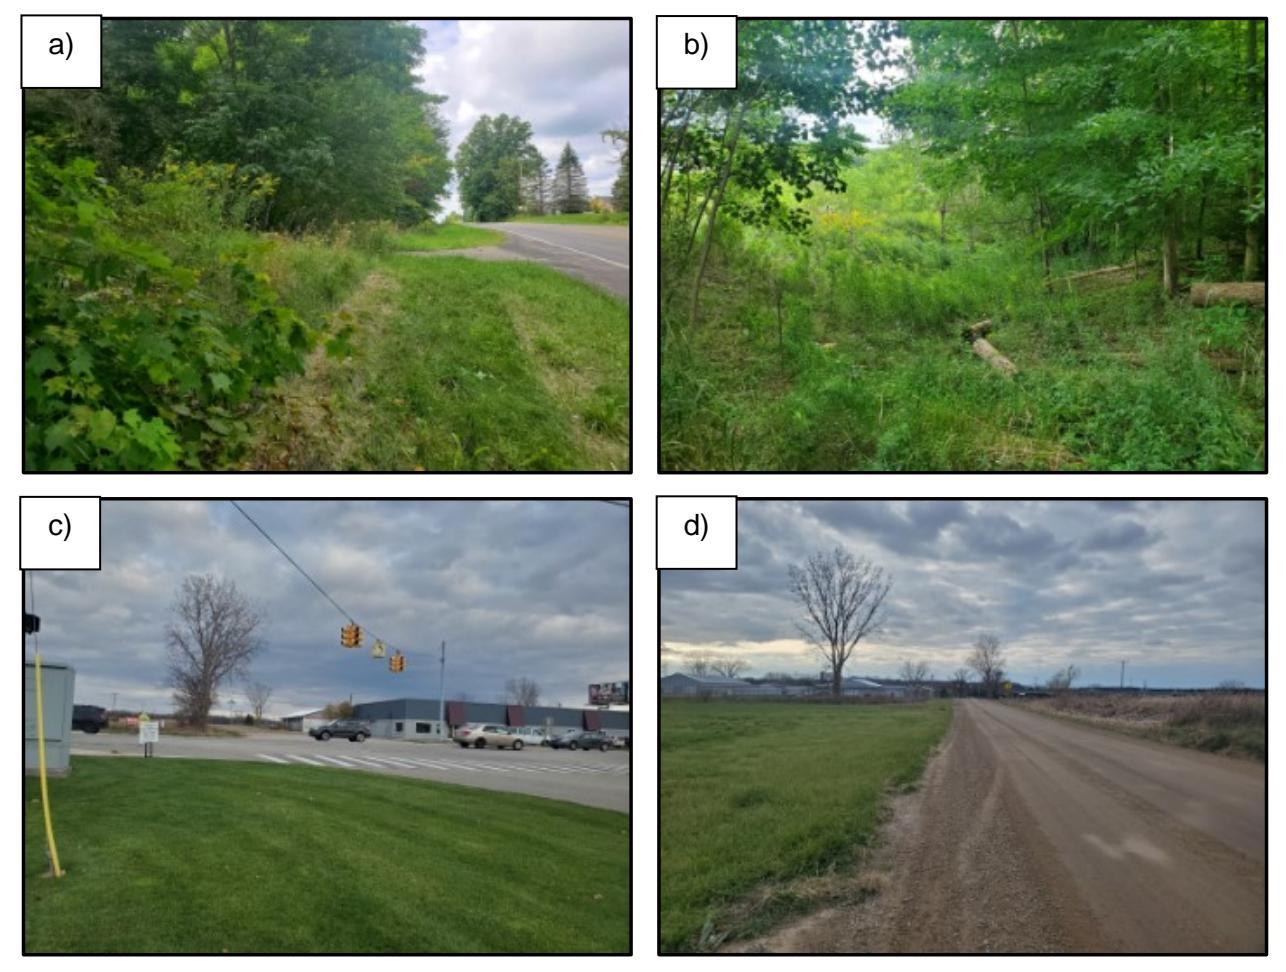
Segment 1 and Segments 4-6 are all fairly similar in composition. They are fairly developed with inclusions of disturbed or depauperate hardwood forest and many areas dominated by weedy and invasive species (Fig. 2).

Disturbed and depauperate hardwood forests are mostly found in the southern portion of Segment 1 and scattered along Segments 4 and 5. These forests variy in topography and composition, but are generally dominated by sugar maple (*Acer saccharum*), green ash (*Fraxinus pensylvanica*), black walnut (*Juglans nigra*), black locust (*Robinia pseudoacacia*), gray dogwood (*Cornus foemina*), Virginia creeper (*Parthenocissus quinquefolia*), river-bank grape (*Vitis riparia*), Morrow's honeysuckle (*Lonicera morrowii*), tall goldenrod, heal all (*Prunella vulgaris*), Canada thistle (*Cirsium arvense*), and reed canary grass (*Phalaris arundinacea*).

Figure 2. Photos of unsuitable habitat types in Segments 1, 4, 5, and 6: a) Typical roadside vegetation (Table 2), b) Disturbed hardwood forest and weedy opening, c) Commercial development, and d) Agricultural development.

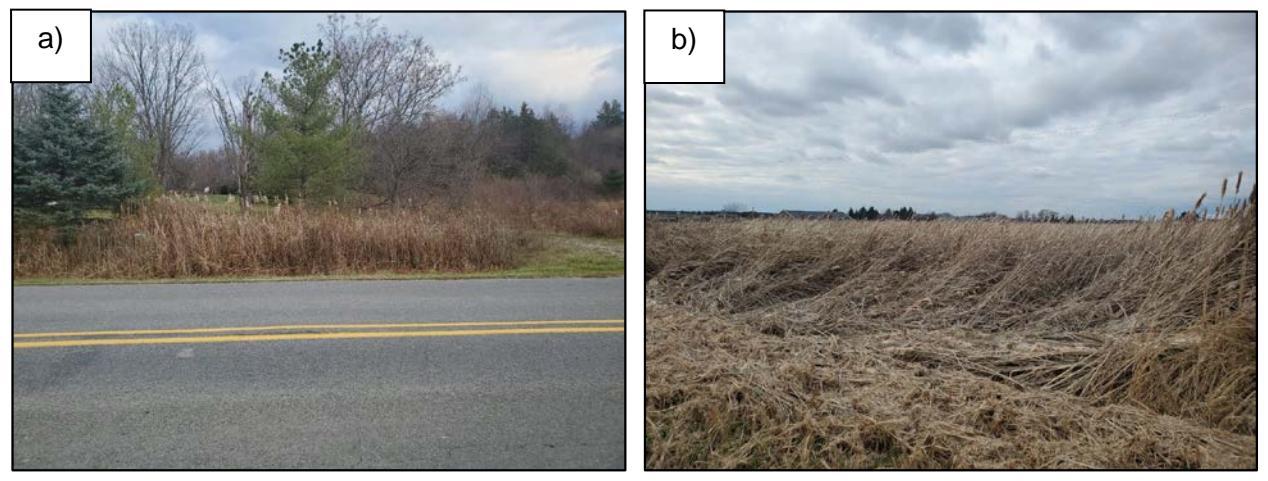
Other invasive species found in the upland habitats of these segments include, teasel (*Dipsacus fullonum*), burdock (*Arctium minus*), bittersweet nightshade (*Solanum dulcamara*), and multiflora rose (*Rosa multiflora*). Species commonly found in roadside marshes, ditches, swales, and other wet pockets include reed canary grass, purple loosestrife (*Lythrum salicaria*), and hybrid catt-tail (*Typha* ×*glauca*) (Fig. 4).

Figure 3. Cat-tail patches found in a) Segment 4, and b) Segment 6.

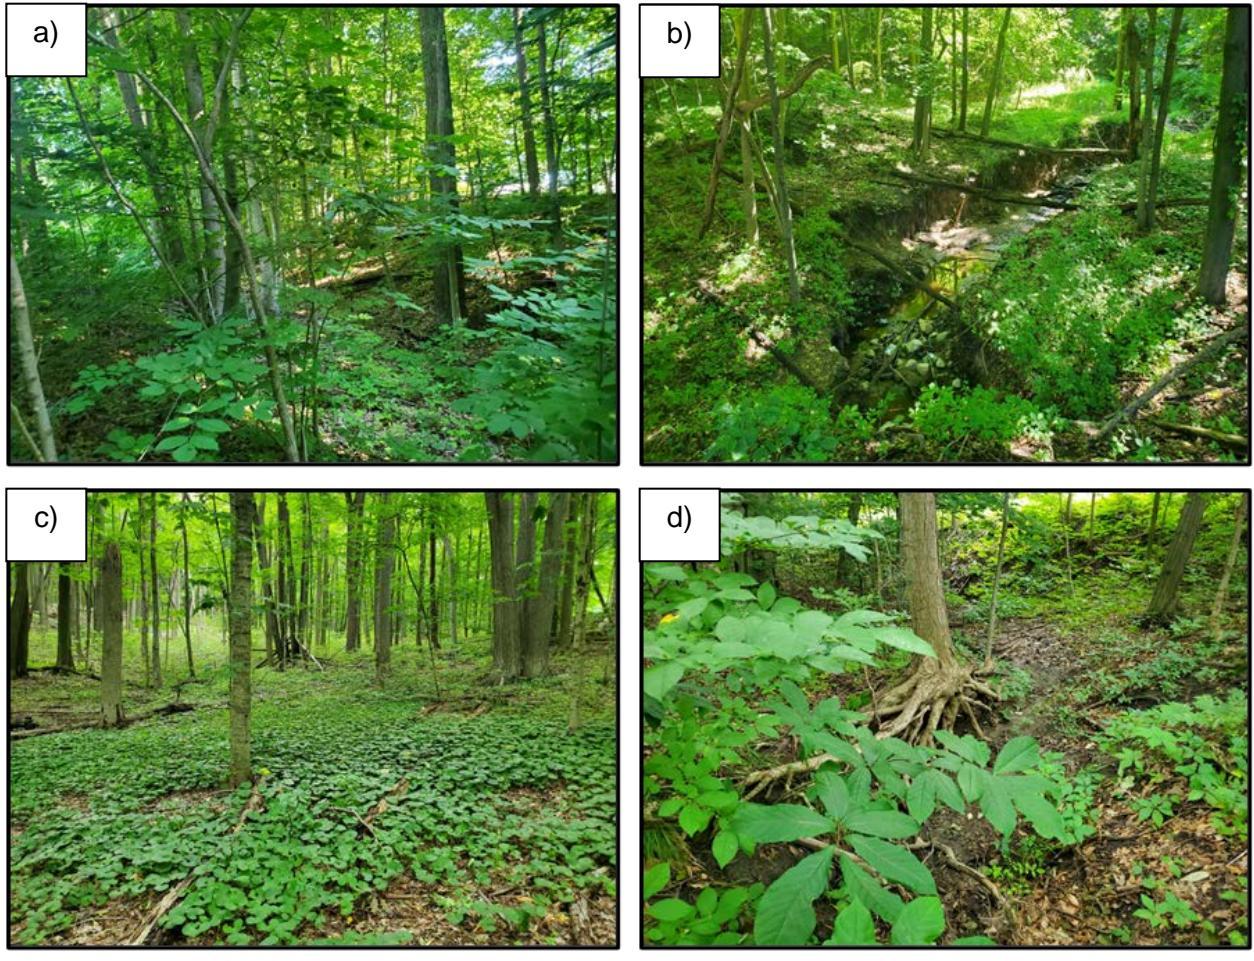
The mesic southern forest found in these segments has varying topography including steep slopes angling toward the road, rolling undulations, and ravines created by culverts and other drainage features (Fig. 5). The consistently dense canopy is dominated by sugar maple, bitternut hickory *(Carya cordiformis),* American elm (*Ulmus americana*), and black walnut.

Figure 5. Photos of Segments 2 and 3: a) Mesic southern forest located on the east side of M-37, b) Heavily eroded stream located on the east side of M-37, c) Mesic southern forest with wild ginger on the south side of 76th St. SE, and d) Mesic southern forest with pawpaw on the north side of 76th St. SE.

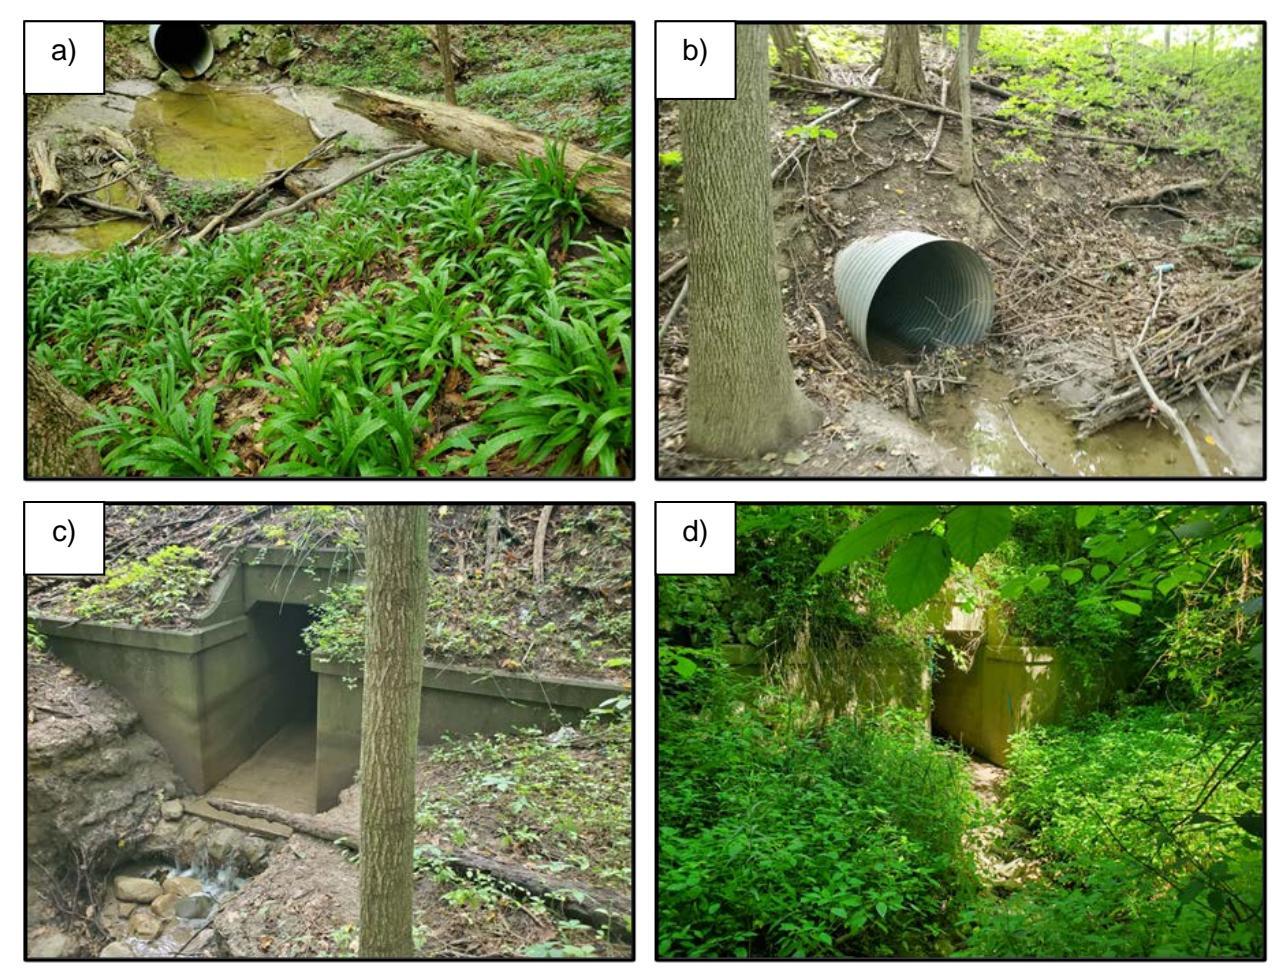
There were two sets of culverts noted during surveys due to their presence within higher quality sections of southern mesic forest. Culvert 1 runs north to south underneath 76th St SE, and Culvert 2 runs east to west underneath M-37 (Fig. 7). Any changes to these structures during road work could impact the hydrology of the area and alter the quality of associated plant communities.

Figure 7. Culverts located in regions of higher quality mesic southern forest: a) Culvert 1 opening on the south side of 76th St. SE, b) Culvert 1 opening on the north side of 76th St. SE, c) Culvert 2 opening on the east side of M-37, and d) Culvert 2 opening on the west side of M-37.

Any potential alterations to two major culverts located within these high-quality areas should be avoided or minimized as much as possible to avoid disrupting the hydrology and quality of the plant communities present.

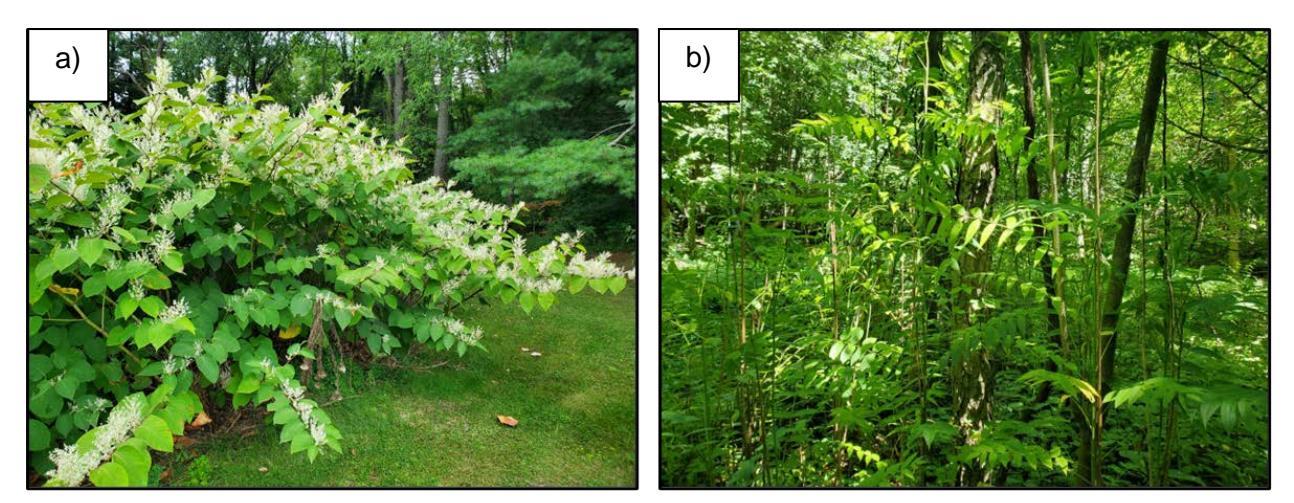
The upland invasive species found here are the same as those found in Segments 1, 4, 5, and 6; however, two additional species found in Segments 2 and 3 are worthy of note. These include Japanese knotweed (*Fallopia japonica*) and tree-of-heaven (*Ailanthus altissima*), both of which are high-impact invasive species that spread aggressively (Fig. 8). Shapefiles for these infestations have been provided to MDOT. Other invasive species found in Segments 2 and 3 include Morrow's honeysuckle, Japanese barberry (*Berberis thunbergii*), English ivy (*Hedera helix*), garlic mustard (*Alliaria petiolata*), periwinkle (*Vinca minor*), autumn olive (*Elaeagnus umbellata*). Because they are more widespread, they were not mapped specifically.

Figure 8. Aggressive invasive species found in small, discrete populations within Segment 3: a) Japanese knotweed, and b) Tree-of-heaven.

Two invasive species are of immediate concern in Segments 2 and 3: tree-of-heaven and Japanese knotweed. These aggressive spreaders are currently contained within small, discrete areas and it is recommended that they be treated before construction begins. Multiflora rose, Morrow's honeysuckle, and garlic mustard are more widespread in these two segments but could be treated with the assistance of adjacent landowners. Regular decontamination procedures should be followed during construction to minimize further spread of these species.
